LIMITED ACCIDENT INVESTIGATION REPORT
--

Reference Number		CA18/2/3/10113					
Classification	Accident	Date	8 February 2022		Time	0900Z	
Type of Operation		Aerial Survey (Part 135)					
Location							
Place of Departure		Kitty Hawk Aerodrome (FAKT)		Place of Intended Landing		Kitty Hawk Aerodrome (FAKT)	
Place of Accident		Farm near Matla Power Station					
GPS Co-ordinates	Latitude	S26°19'31.5"	Longitude	E029°07'01.6"	Elevation	1 606ft	
Aircraft Information							
Registration		ZS-SYW					
Make/Model		Cessna U206G (Serial Number: U206-06056)					
Damage to Aircraft		Substantial		Total Aircraft Hours		5 047.7 hobs	
Pilot-in-command							
Licence Valid		Yes		Gender		Female	
						Age	
						45	
Licence Type		Commercial Pilot Licence (Aeroplane)					
Total Hours on Type		966.1		Total Flying Hours		6 757.5	
People On-board	1+1	Injuries	0	Fatalities	0	Other (On Ground)	0
What Happened							
<p>On the morning of 8 February 2022, a pilot accompanied by a camera operator on-board a Cessna aircraft with registration ZS-SYW took off on a survey flight from Kitty Hawk Aerodrome (FAKT) in Gauteng province to Matla Power Station in Mpumalanga province. The planned survey of power lines str

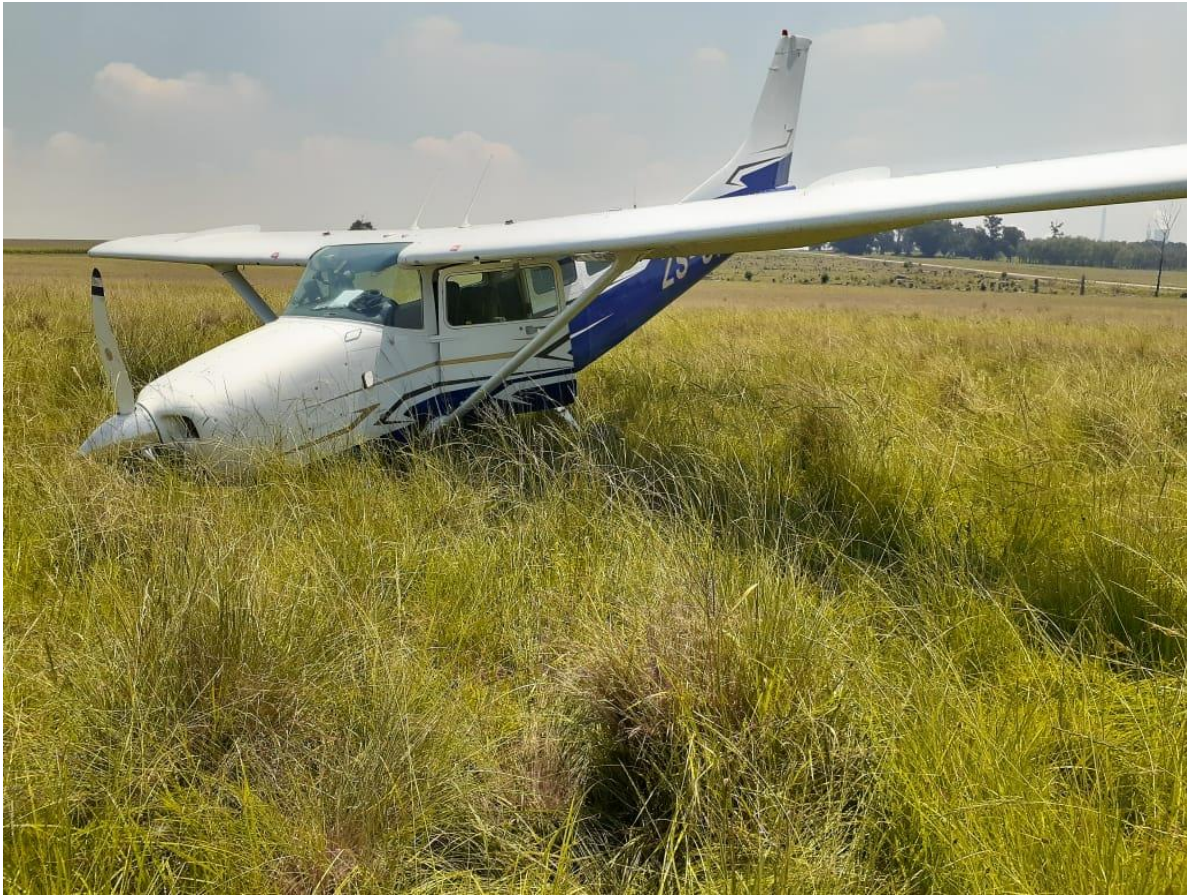
ground. The pilot and the camera operator were not injured during the forced landing, and the aircraft was substantially damaged.

Figure 1: The aircraft as it came to rest. (Source: Pilot)

The engine stopped in-flight as a result of fuel starvation, causing the pilot to execute a forced landing on an unprepared field (with overgrown grass concealing holes on the ground).

1. In the interest of safety, a recommendation to the DCA is to investigate the possibility to have operations such as the power line surveys to be a two-crew operation.
2. In the interest of safety, a recommendation to operators is to consider a two-crew operation for operations such as power line surveys which, in this case, resulted in an accident.

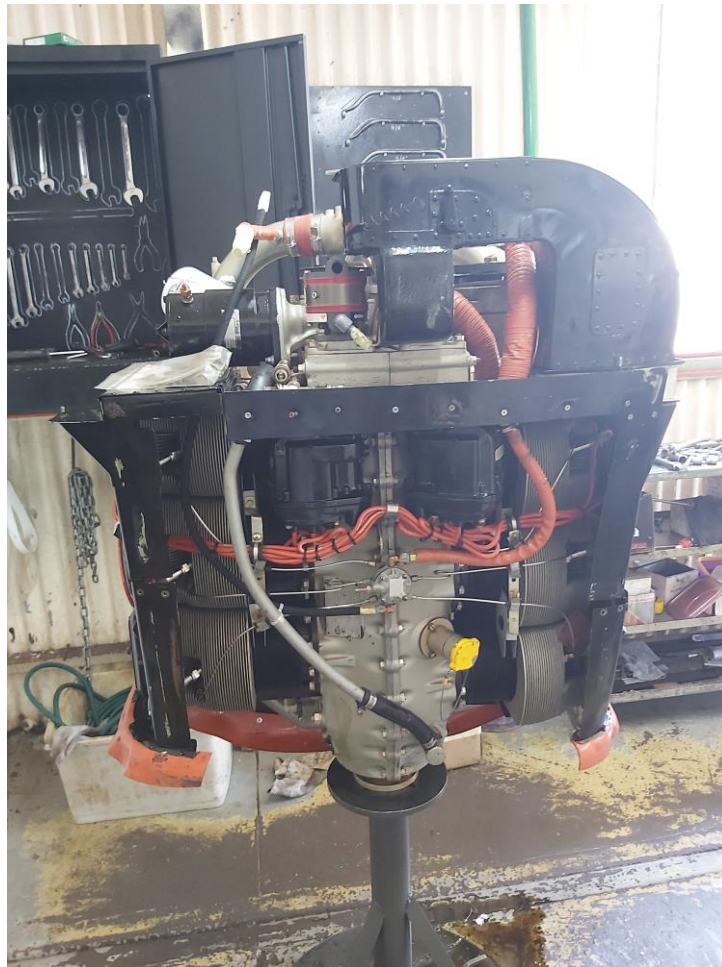
- Once the aircraft was recovered, it was taken to the AMO where the engine was removed and sent to an engine shop for inspection and testing. After the engine was dismantled and inspected, its parts were tested, and they were found to be serviceable. The fuel system was then put on a testbench to be tested separately, and it was found to be serviceable.

Figure 2: The engine whilst at the engine shop for inspection.

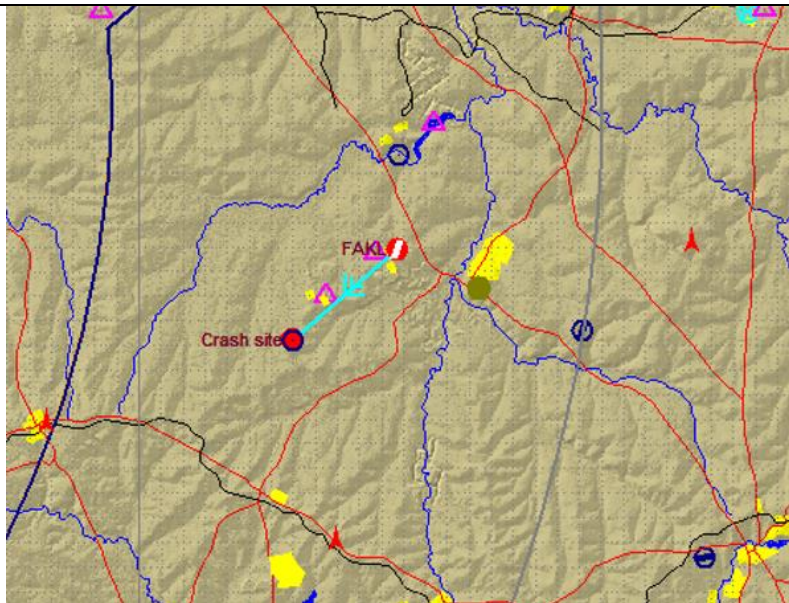
Figure 3: The position of the aircraft south-west of FAKL. (Source: Pilot)

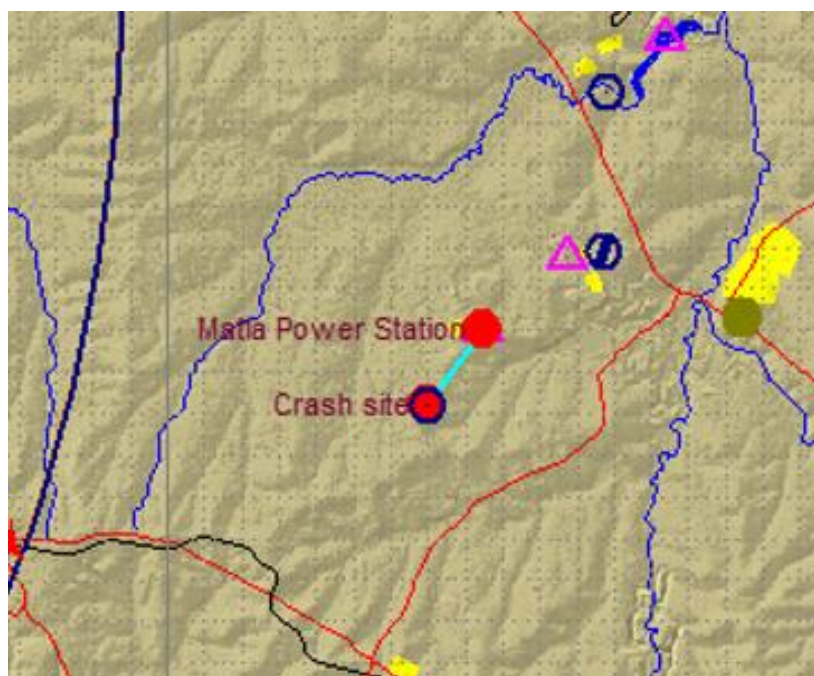
Figure 4: The position of the aircraft 1nm south-west of Matla power station. (Source: Pilot)
