<b>AIRCRAFT ACCIDENT REPORT AND EXECUTIVE SUMMARY</b>
---

<b>Reference:</b>		CA18/2/3/10114	
<b>Aircraft Registration</b>	ZS-MRL	<b>Date of Accident</b>	9 February 2022		<b>Time of Accident</b>	1430Z	
<b>Type of Aircraft</b>	Beechcraft Baron 58		<b>Type of Operation</b>		Private (Part 91)		
<b>Pilot-in-command Licence Type</b>	Private Pilot Licence		<b>Age</b>	50	<b>Licence Valid</b>	Yes	
<b>Pilot-in-command Flying Experience</b>	<b>Total Flying Hours</b>		1584.35		<b>Hours on Type</b>	152	
<b>Last Point of Departure</b>	Saldanha Aerodrome (FASD), Western Cape Province						
<b>Next Point of Intended Landing</b>	George Aerodrome (FAGG), Western Cape Province						
<b>Damage to Aircraft</b>	Substantial						
<b>Location of the accident site with reference to easily defined geographical points (GPS readings if possible)</b>							
During take-off on Runway 20 at Saldanha Aerodrome at Global Positioning System (GPS) coordinates determined to be 32°57'48.0" South 017°58'12.0" East at an elevation of 50 feet (ft)

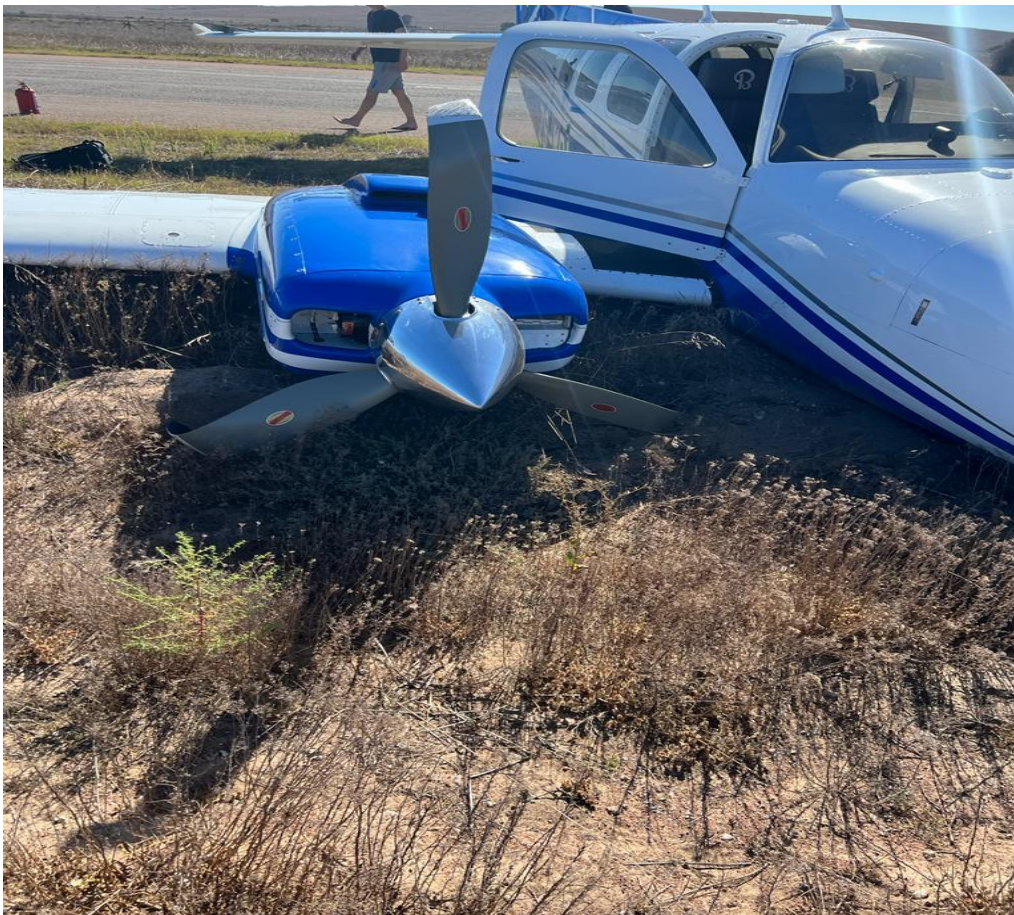
1.3.1 The aircraft sustained substantial damages to the propeller, wings and the underbelly during the accident sequence.

**Figure 2:** The aircraft on the side of the runway post-accident. (Source: Owner)

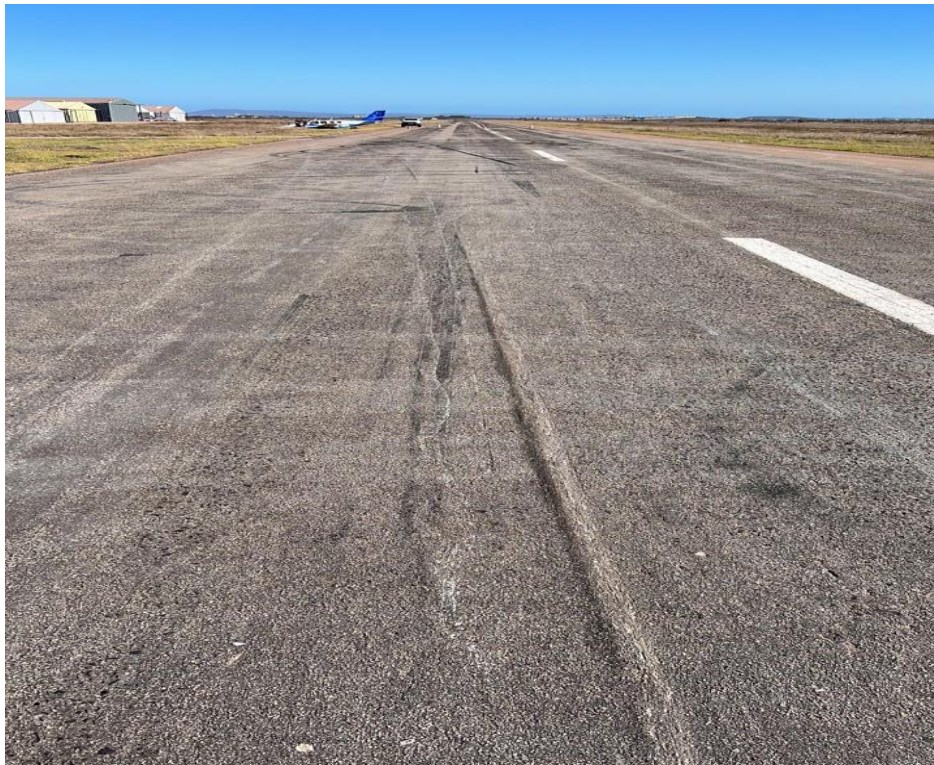
1.12.1 During landing on Runway 20, the undercarriage collapsed, and the aircraft skidded on its underbelly before it came to rest on the left-side of the runway.

**Figure 3:** The skid marks on Runway 20. (Source: Owner)

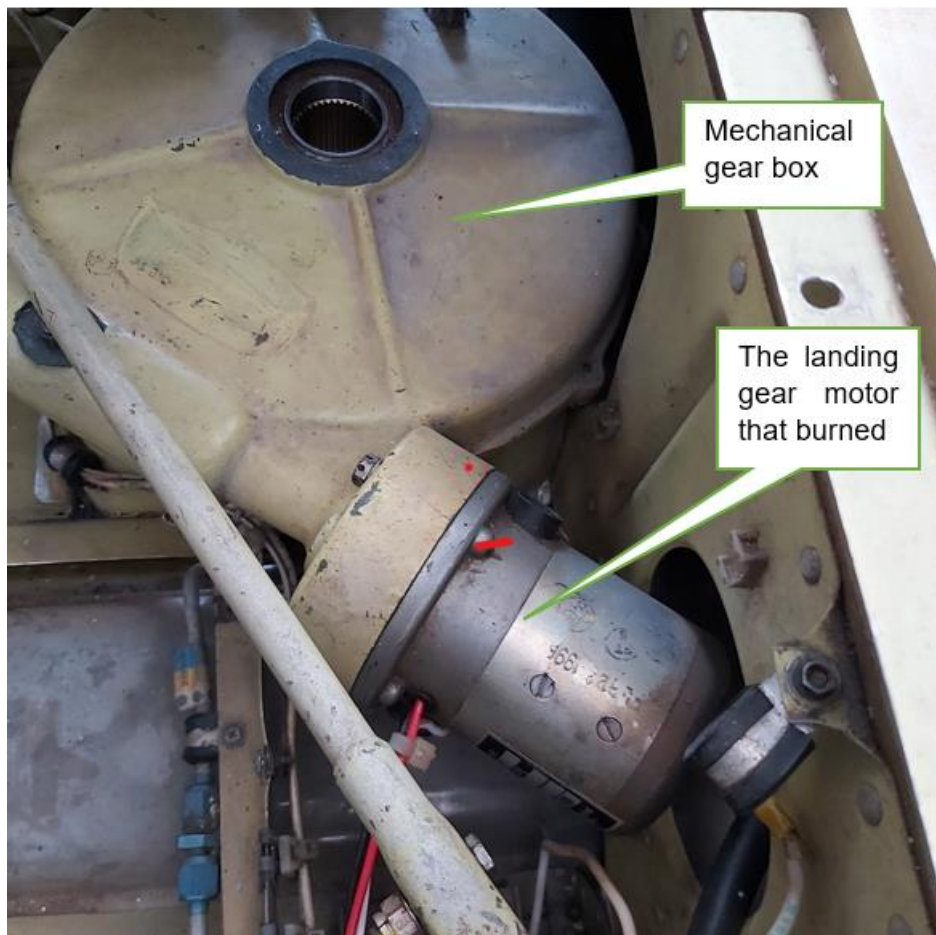
1.16.1 Following the accident, the aircraft was recovered to the aircraft maintenance organisation (AMO) at Wonderboom Aerodrome (FAWB) in Gauteng province for examination. It was found that the landing gear motor had burned out, which caused the gear electric motor circuit breaker to trip. The investigation was unable to determine the cause of the gear electric motor failure. The mechanical gear box and the relay were found to be in good condition. The manual gear extension was tested; however, the gear did not properly lock into position.

**Figure 4:** The landing gear motor.

2.2.2 The last MPI was certified on 10 December 2021 at 4728.8 airframe hours. The aircraft had accumulated a further 8.1 airframe hours since the last inspection. The landing gear motor burned out, which caused the gear circuit breaker to trip. The investigation was unable to determine the cause of the electric motor failure.

- 3.3.1 The landing gear collapsed during the landing roll because it was not in the down and locked position due to the gear motor that burned out.
