LIMITED INVESTIGATION ACCIDENT REPORT

Reference Number	CA18/2/3/10115						
Classification	Accident	Date	10 February 2022	Time	1130Z		
Type of Operation	Private (Part 94)						
Location							
Place of Departure	Light Flight Aerodrome Cato Ridge, KwaZulu-Natal Province			Place of Intended Landing	Light Flight Aerodrome Cato Ridge, KwaZulu-Natal Province		
Place of Accident	Open grass area at Light Flight Aerodrome						
GPS Co-ordinates	Latitude	29°45'58.48" S	Longitude	030°35'14.35" E	Elevation	2 497 ft	
Aircraft Information							
Registration	ZU-LIZ						
Make / Model	Rotorway Executive 162F (Serial No. 7039)						
Damage to Aircraft	Substantial			Total Aircraft Hours	644.0		
Pilot-in-command							
Licence Valid	Yes			Gender	Male		Age: 71
Licence Type	Private Pilot Licence (PPL)						
Total Hours on Type	683.0			Total Flying Hours	2 631.0		
People On-board	1 + 0	Injuries	0	Fatalities	0	Other (On Ground)	0
What Happened							
<p>On Thursday, 10 February 2022, the pilot who was also the owner of the helicopter, a Rotorway Executive 162F registered ZU-LIZ stated that he had just performed some maintenance on the helicopter when he found some play on the swashplate/slider ball as

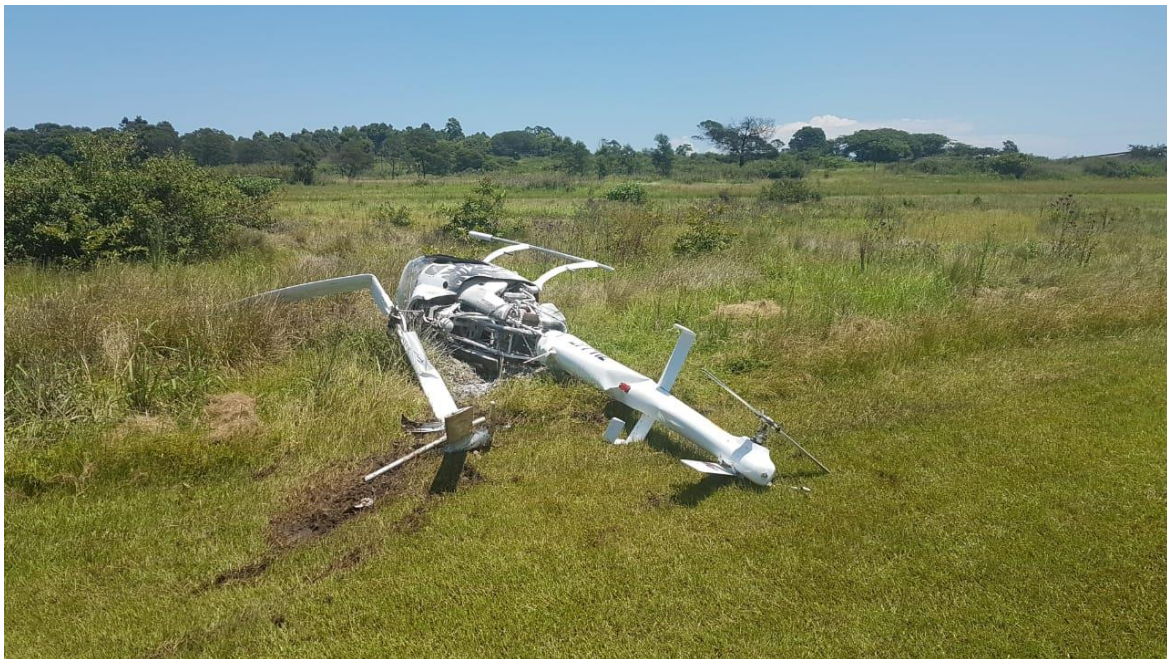
As he lowered the collective pitch lever for touch down, the cyclic pulled very hard to the left. The left skid contacted the ground while the right skid gear was still in the air. He attempted to level the helicopter off by adding some collective pitch, but this had no effect. At this stage, the helicopter was airborne but out of control and it yawed approximately 170° to the left. Whilst yawing, the left skid impacted the ground and broke off, this caused the helicopter to roll over to the left. Figures 1 and 3 show the main rotor blade markings on the grass surface. The helicopter was substantially damaged. The pilot stated that after all the rotating parts came to a stop, he was able to climb out of the cockpit unassisted. He was not injured but was badly shaken.

Figure 1: The helicopter as it came to rest.

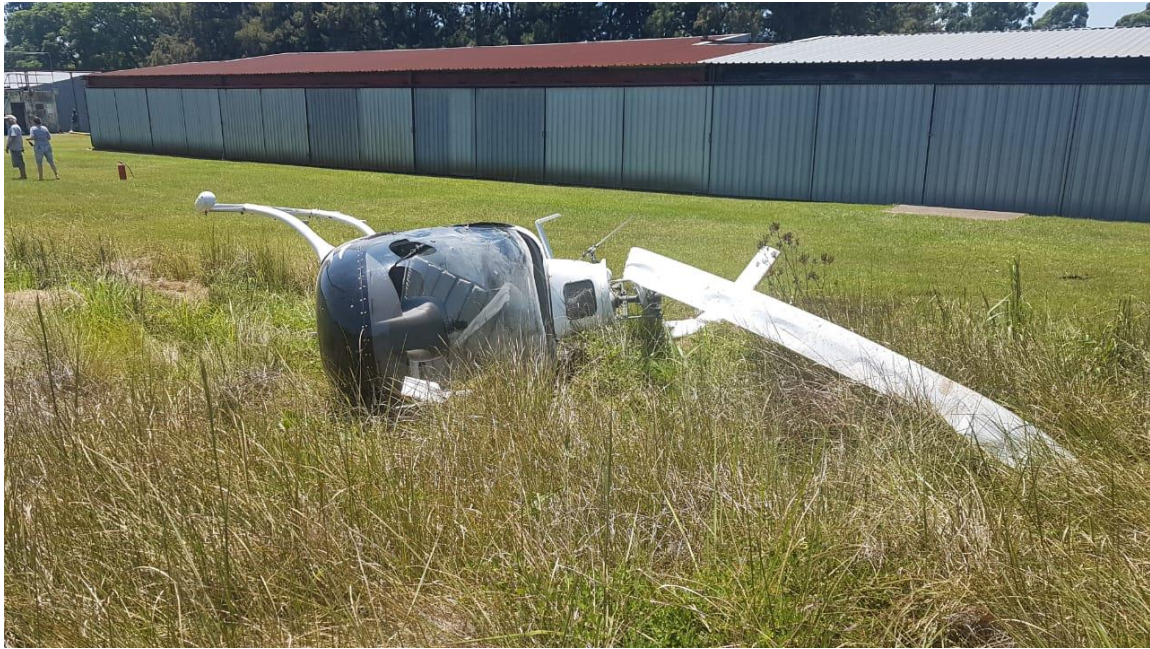
Figure 2: A front view of the helicopter.

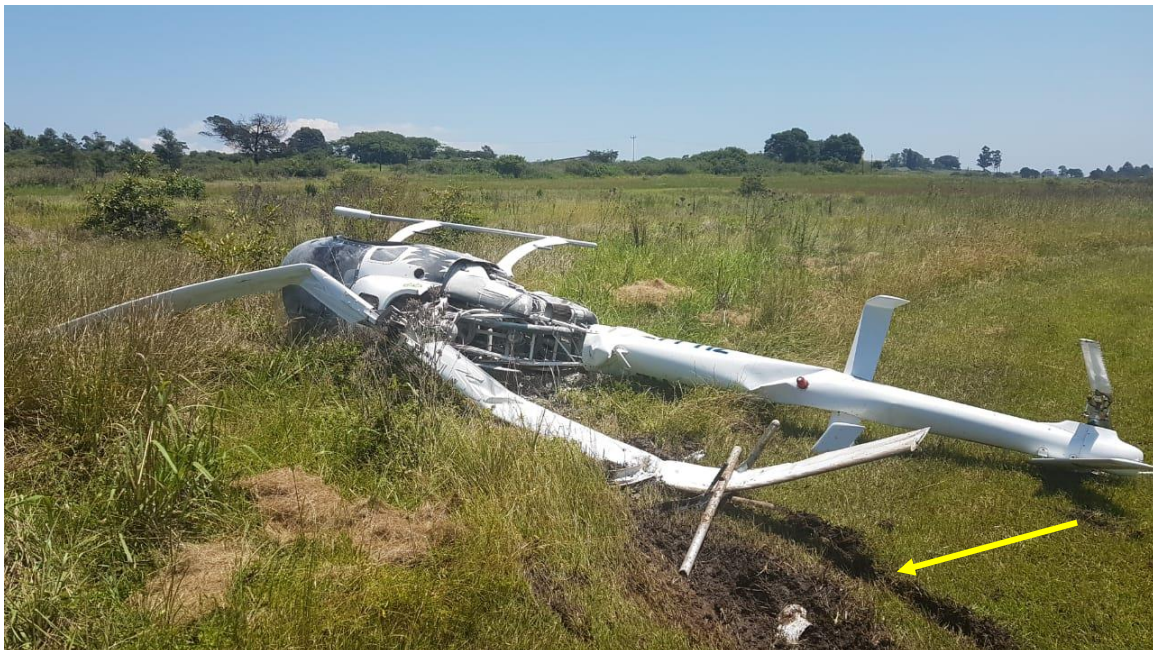
Figure 3: Main rotor blade strike markings visible on the ground.

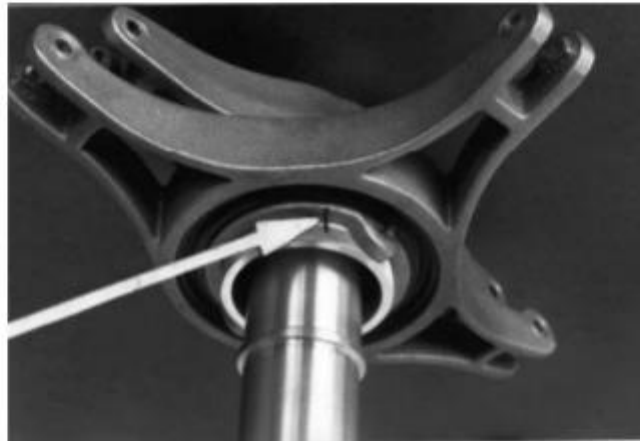
Photo #14: Placing an index mark.

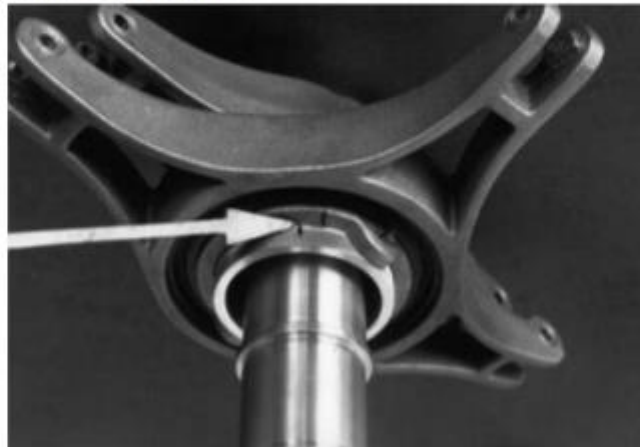
Photo #15: View after the collar has been backed off.

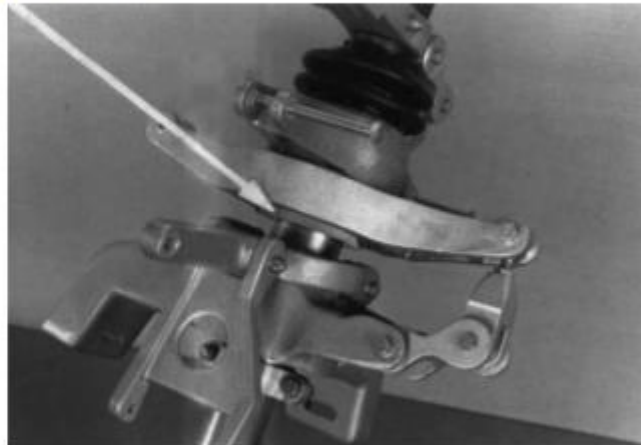
Photo #16: Tighten set screws in collar.

If incorrectly adjusted, the slider ball adjustment collar will produce a feedback through the cyclic controls that feels like the cyclic wants to travel in any one direction independent of any input from the pilot. The amount of feedback felt by the pilot indicates how much the collar is incorrectly adjusted. (Feedback usually means the collar is too tight rather than too loose). If feedback through the cyclic continues, you may back off the adjustment collar another 1/4", for a total 3/4" maximum from the starting index mark. If an undesirable condition still exists, contact the factory.

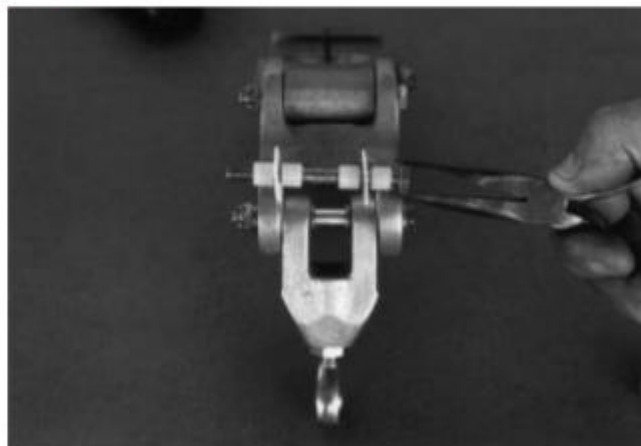
Photo #17 illustrates the positioning of the nylon bushings in the swash plate assembly. To determine if the castings need new bushings, measure the lateral deflection of the parts. If a total of .125 inch or greater is indicated, the nylon bushings should be replaced. The maximum the castellated nut should be tightened is two flats past finger tight. Further tightening may damage the aluminum castings.

Photo #17: Position of bushings.

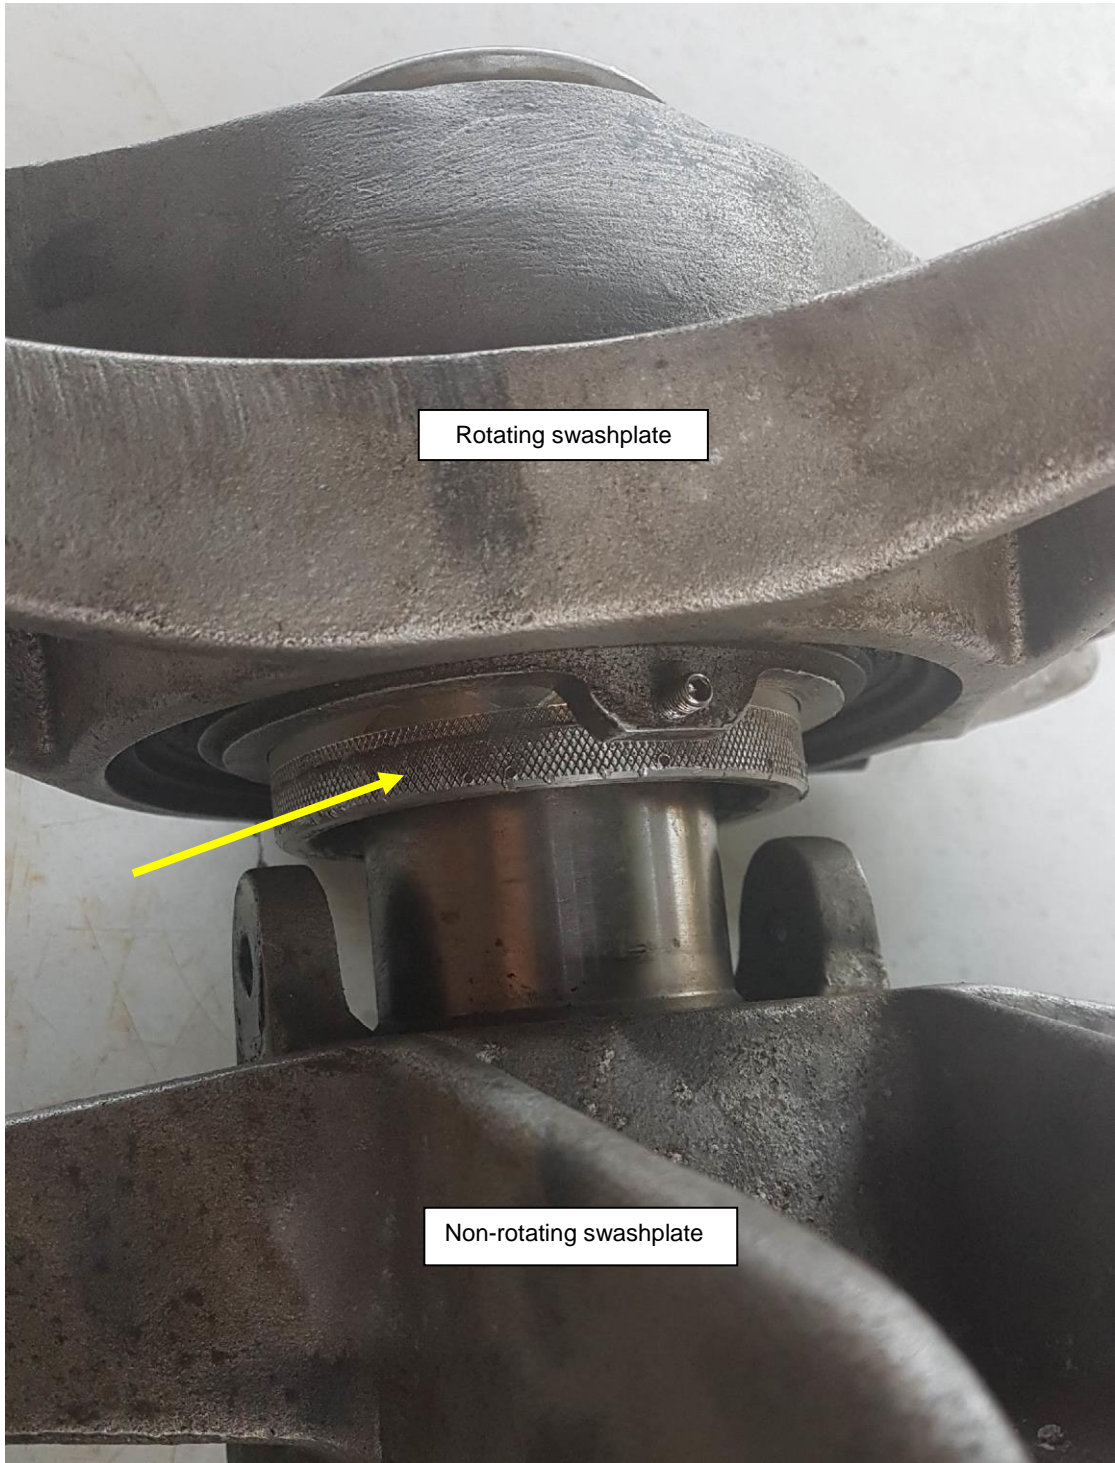
"I have dismantled the whole assembly and examined everything. The collar has a fine thread with about 1mm pitch per turn. Before the accident I found about 0.2 mm play. By turning the collar 35° the play would have been reduced to 0.1mm. I made sure there was some play left and the slider ball did move freely. That seemed to be correct before everything got heated up. Apparently, it was too tight to run under heat and prolonged hovering."

Figure 4: The swashplate assembly with the slider ball adjustment collar prior to disassembly.
(Source: Helicopter pilot/owner)

<p>Probable cause</p> <p>The owner/pilot carried out maintenance on the slider ball adjustment collar which resulted in loss of control of the helicopter during a check flight. The loss of control occurred when the cyclic control stick suddenly pulled to the left (and the helicopter got out of control) during an attempted forced landing; the helicopter rolled over to the left.</p> <p>Contributory factor</p> <p>The pilot performed maintenance on the helicopter without the required qualifications as called for in Part 44.01.4 and Part 66.04.2(1) of CAR 2011 as amended, even though he was the builder.</p>
<p>Safety Action</p> <p>None.</p>
<p>Safety Message</p> <p>Aircraft owners must ensure that only authorised personnel who are licensed or the holder of an Approved Person Certificate that was issued by the Director of Civil Aviation may conduct maintenance on aircraft as per the provisions contained in CAR 2011 as amended.</p>

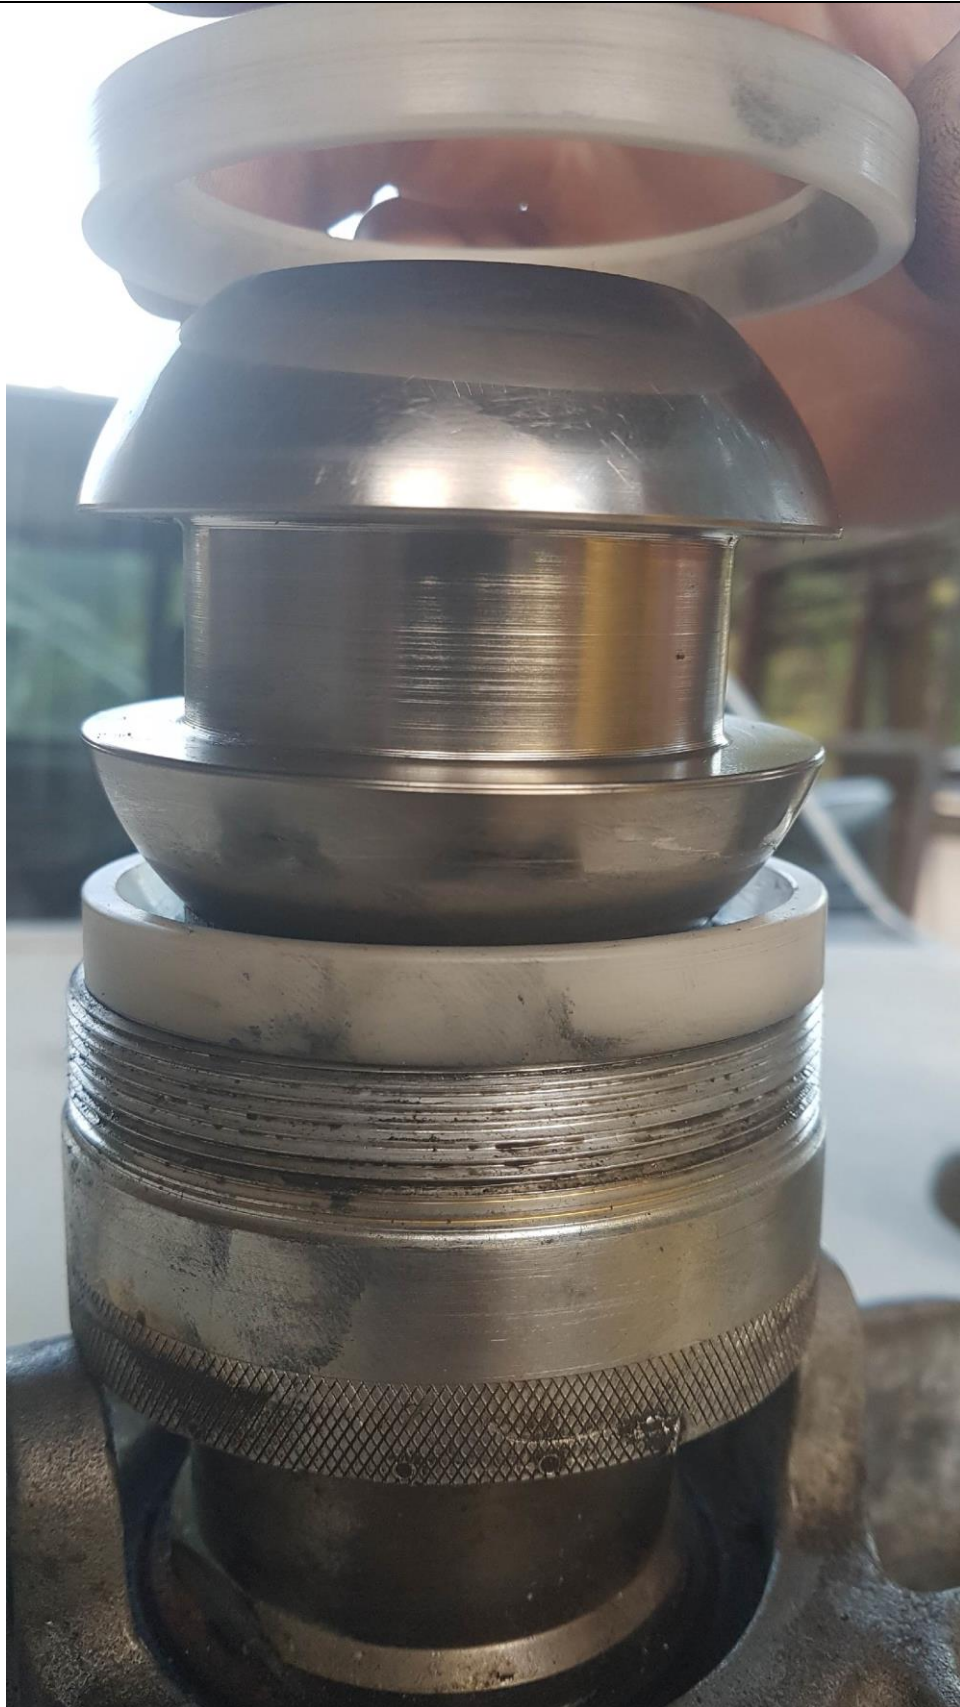
Figure 5: The slider ball adjustment collar assembly. (Source: Helicopter pilot/owner)

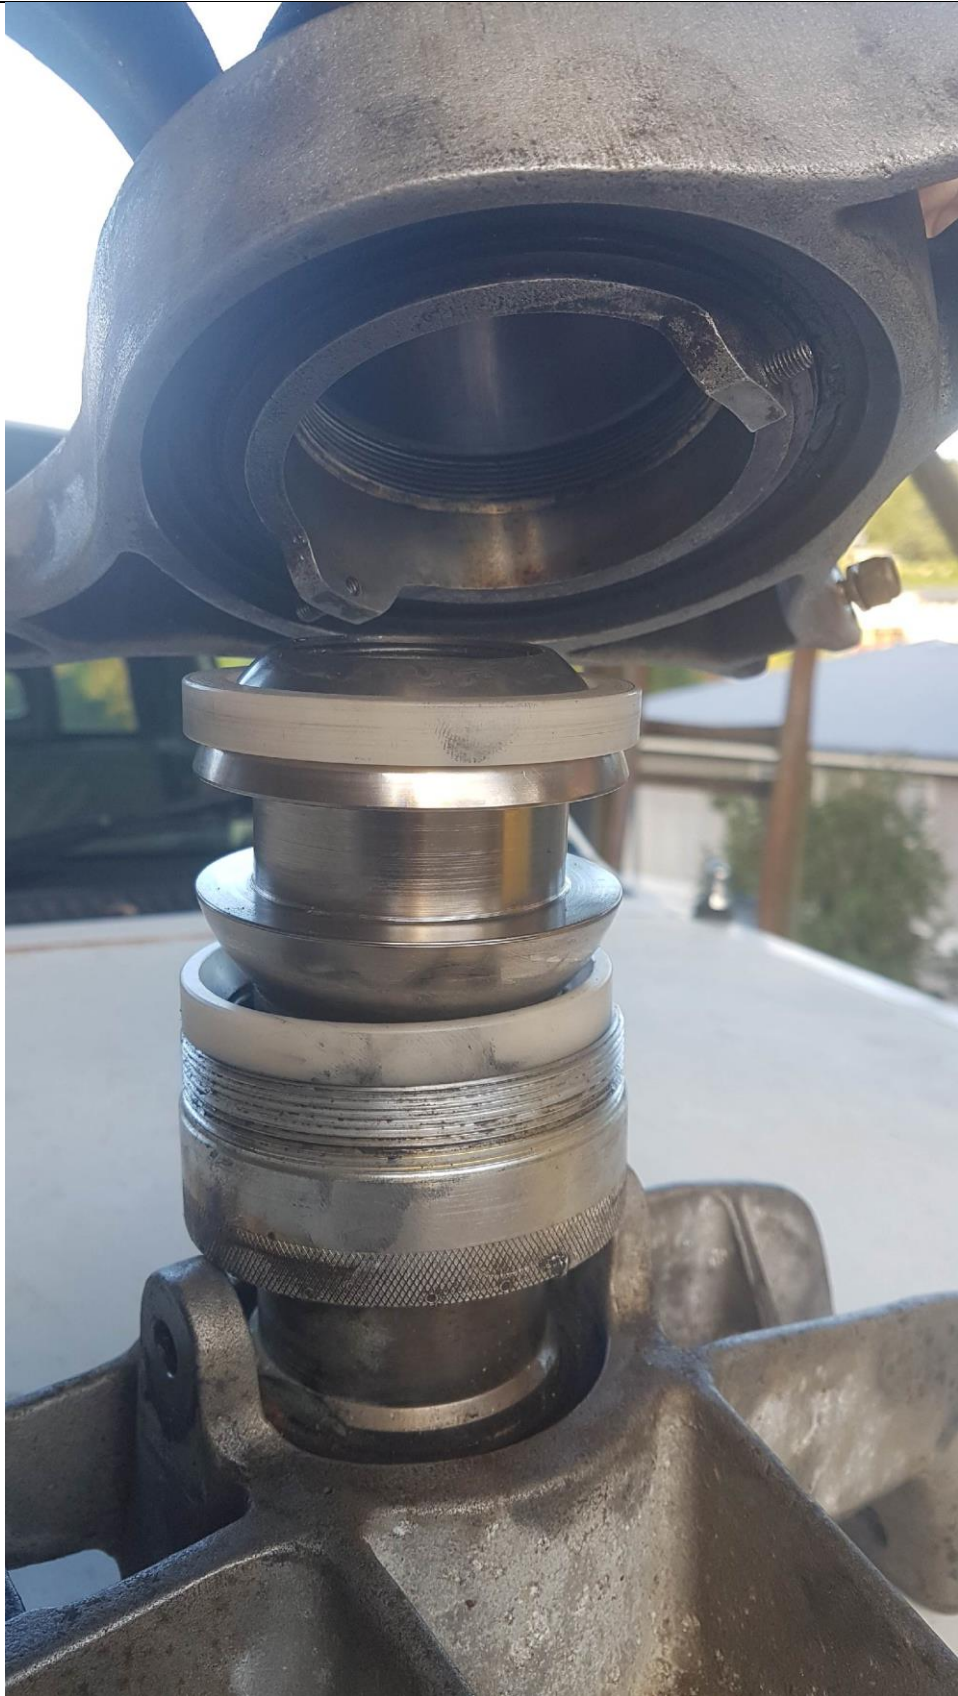
Figure 6: The slider ball adjustment collar assembly with the rotating swashplate at the top.
(Source: Helicopter pilot/owner)
