LIMITED ACCIDENT INVESTIGATION REPORT

Reference Number	CA18/2/3/10117						
Classification	Accident	Date	10 February 2022	Time	1830Z		
Type of Operation	Operation of Non-type Certificated Aircraft (Part 94)						
Location							
Place of Departure	Mossel Bay Aerodrome (FAMO), Western Cape Province		Place of Intended Landing	Mossel Bay Aerodrome (FAMO), Western Cape Province			
Place of Accident	Mossel Bay Aerodrome at GPS S 33° 09' 31.85", E 022° 03' 20.40" and at a field elevation of 545 feet						
GPS Co-ordinates	Longitude	S 33° 09' 31.85"	Latitude	E 022° 03' 20.40"	Elevation	545 ft	
Aircraft Information							
Registration	ZU-DYO						
Model/Make	RAF 2000GTX SE (Serial Number: H2/05/16/645)						
Damage to Aircraft	Substantial		Total Aircraft Hours	1660			
Pilot-in-command							
Licence Type	National Pilot Licence (NPL)		Gender	Male	Age	63	
Licence Valid	Yes						
Total Hours on Type	314		Total Flying Hours	1233.12			
People On-board	1+0	Injuries	0	Fatalities	0	Other (on ground)	0

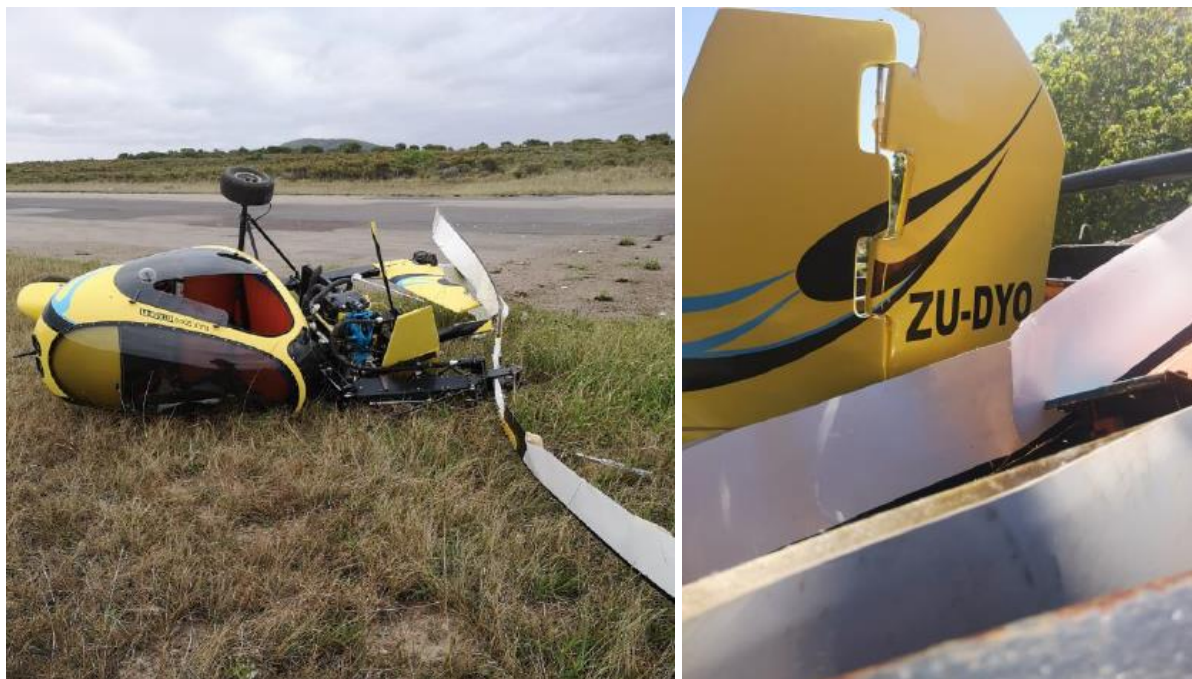
Figures 1 and 2: The damaged aircraft post-accident. (Source: Pilot)

The pilot landed at a high speed and lost control of the Gyrocopter, which veered off towards the left of the runway and subsequently rolled over.

1. Disregard of safe operating procedure limitations for the Gyrocopter.
2. The Gyrocopter was not stable on approach and it landed hard before the pilot lost control.

Safety message: Pilots must adhere to the regulations and manufacturers' limitations at all times during flight in order to attain a safe flight.
