LIMITED ACCIDENT INVESTIGATION REPORT
--

Reference Number		CA18/2/3/10118								
Classification		Accident		Date		11 February 2022	Time		0825Z	
Type of Operation		Training (Part 141)								
Location										
Place of Departure		Wonderboom Aerodrome (FAWB), Gauteng Province			Place of Intended Landing		Wonderboom Aerodrome (FAWB), Gauteng Province			
Place of Occurrence		Runway 11, Wonderboom Aerodrome (FAWB), Gauteng Province								
GPS Co-ordinates		Latitude		25° 39' 13.19" S		Longitude		028° 13' 34.31" E	Elevation	4 085ft
Aircraft Information										
Registration		ZS-SLY								
Model/Make		Cessna 172M (Serial Number: 172-67263)								
Damage to Aircraft		Substantial			Total Aircraft Hours		9 669.1			
Pilot-in-command										
Licence Valid		Yes			Gender		Male	Age	25	
Licence Type		Student Pilot Licence (SPL) Aeroplane								
Total Hours on Type		30.5			Total Flying Hours		30.5			
People On-board		1 + 0	Injuries		0	Fatalities		0	Other (on ground)	0

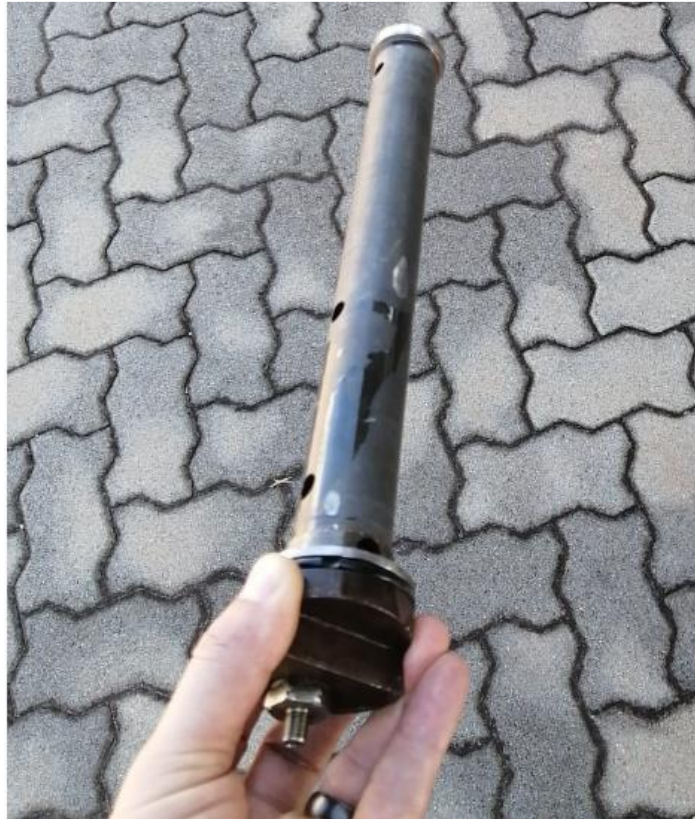
Figure 1: Damage to the nose gear oleo stop bolt.
(Source: Operator)

- The aircraft was recovered to an aircraft maintenance organisation (AMO) for damage analysis. The AMO found that the stop bolt had sheared at the top of the nose gear oleo and the engine firewall had buckled.
- Examination of the ZS-SLY's flight folio indicated no outstanding defects that required rectification relating to the aircraft's steering control and/or braking mechanism prior to the accident.
- Before the SP flew his solo consolidation circuits, he had completed three circuit-and-landing exercises with a flight instructor without incident.

- All damage to the aircraft was attributable to the impact forces exerted to the firewall and nose landing gear because of the hard landing.

The aircraft speed was high on approach, resulting in the aircraft ballooning before it landed with the nose gear first, which subsequently broke off.

Following this accident, the instructor completed a remedial flight with the SP before continuing with solo flights.

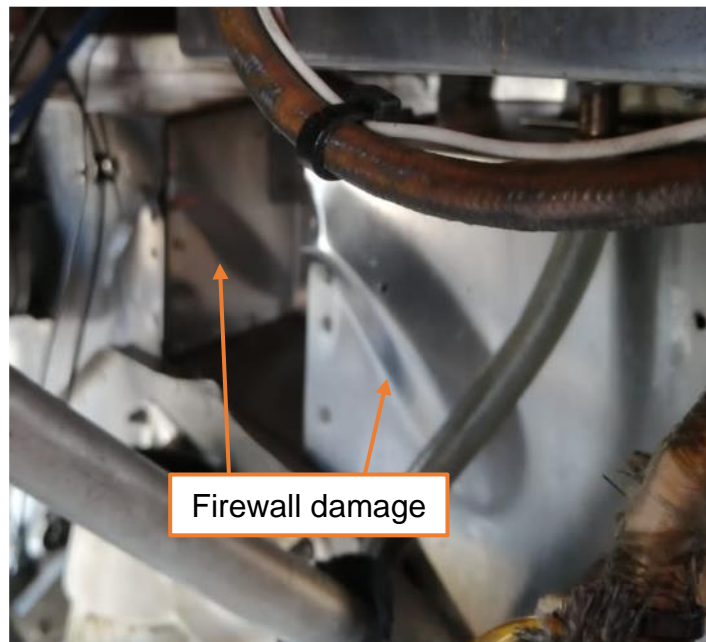
Figure 2: Damage to the firewall. (Source: Operator)
