LIMITED ACCIDENT INVESTIGATION REPORT

Reference Number	CA18/2/3/10120					
Classification	Accident	Date	13 February 2022	Time	1420Z	
Type of Operation	Private (Part 94)					
Location						
Place of Departure	Thabazimbi Aerodrome (FATI), Limpopo Province		Place of Intended Landing	Kitty Hawk Aerodrome (FAKT), Gauteng Province		
Place of Accident	Runway 19 at FAKT, Gauteng Province					
GPS Co-ordinates	Latitude	S25° 51' .25.78"	Longitude	E28°26' .58.37"	Elevation	4573 feet
Aircraft Information						
Registration	ZU-DWF					
Model/Make	Ravin 500 (Serial Number: 0405006)					
Damage to Aircraft	Substantial		Total Aircraft Hours	864		
Pilot-in-command						
Licence Valid	Yes	Gender	Male	Age	47	
Licence Type	Private Pilot Licence (PPL)					
Total Hours on Type	120.31		Total Flying Hours	434.41		
People On-board	1 + 3	Injuries	0	Fatalities	0	Other (On Ground) 0
What Happened						
<p>On Sunday, 13 February 2022, a pilot and three passengers on-board a Ravin 500 aircraft with registration ZU-DWF were on a private flight from Thabazimbi Aerodrome (FATI) in Waterberg District Municipality, Limpopo Province, to Kitty Hawk Aerodrome (FAKT) in south-east Pretoria, Boschkop area, Gauteng Provi

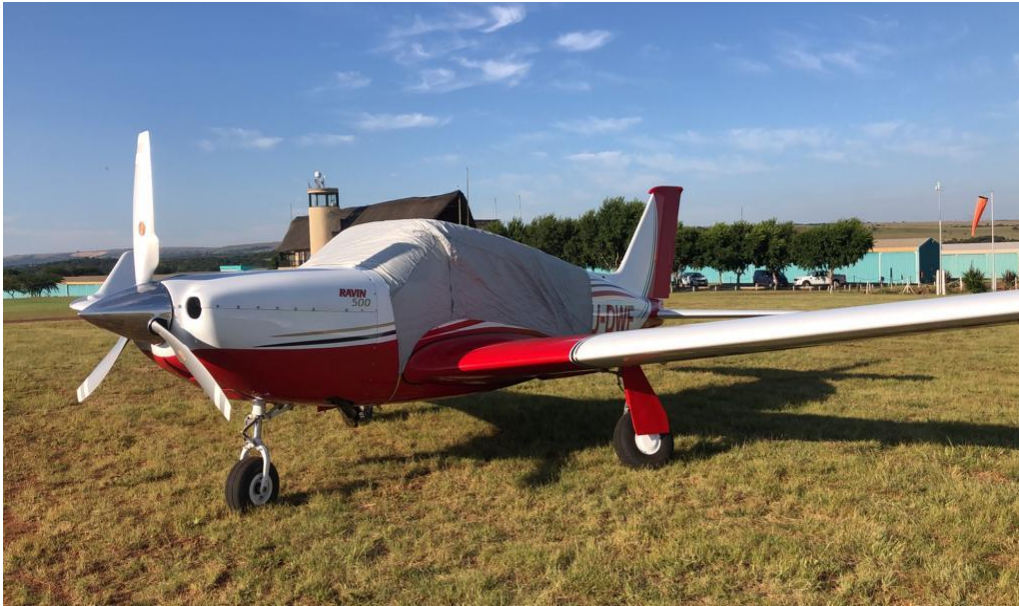
landing hard. The aircraft sustained substantial damages; all four occupants were not injured. The flight lasted 40 minutes.

Figure 1: The aircraft at the accident site. (Source: Pilot)

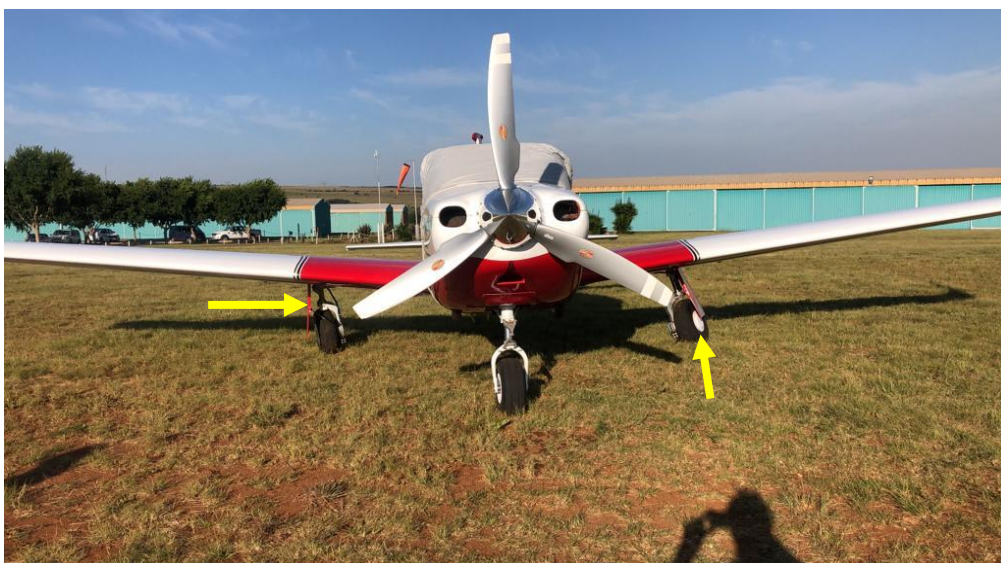
Post-accident examination of the aircraft revealed no defects/malfunctions that would have precluded normal operation. The aircraft sustained substantial damage to the landing gear struts and underwing structures. The calculated landing mass was 1353 kilograms (kg). The aircraft was operated below its maximum take-off weight (MTOW) of 1 622kg prior to landing.

Figure 2: The aircraft with the bent main landing gear.

The aircraft landed hard because the pilot flared too early, resulting in loss of lift and forward speed.
