LIMITED ACCIDENT INVESTIGATION REPORT
--

Reference Number	CA18/2/3/10121						
Classification	Accident	Date	7 February 2022	Time	2000Z		
Type of Operation	Remotely Piloted Aircraft System (Part 101)						
Location							
Place of Departure	Crown Douglas Substation, Mpumalanga Province		Place of Intended Landing	Crown Douglas Substation, Mpumalanga Province			
Place of Accident	Crown Douglas Substation in Mpumalanga Province						
GPS Co-ordinates	Latitude	25°50'34.3" S	Longitude	28°55'10.0" E	Elevation	4737ft	
Aircraft Information							
Registration	ZT-XJY						
Make/Model	DJI Mavic 2 (Serial No. MAV 0075)						
Damage to Aircraft	Destroyed		Total Aircraft Hours	76			
Pilot-in-command							
Licence Type	Remote Pilot Licence (RPL)		Gender	Male		Age: 26	
Licence Valid	Yes						
Total Hours on Type	71.75		Total Flying Hours	71.75			
People On-board	0	Injuries	0	Fatalities	0	Other (on ground)	0
What Happened	<p>On Monday evening, 7 February 2022, a remotely piloted DJI Mavic drone with registration ZT-XJY took off on a surveillance flight from Crown Douglas Railway Station at 1941Z. Fine weather conditions prevailed at the time of flight with a surface wind of 8 knots and temperatur

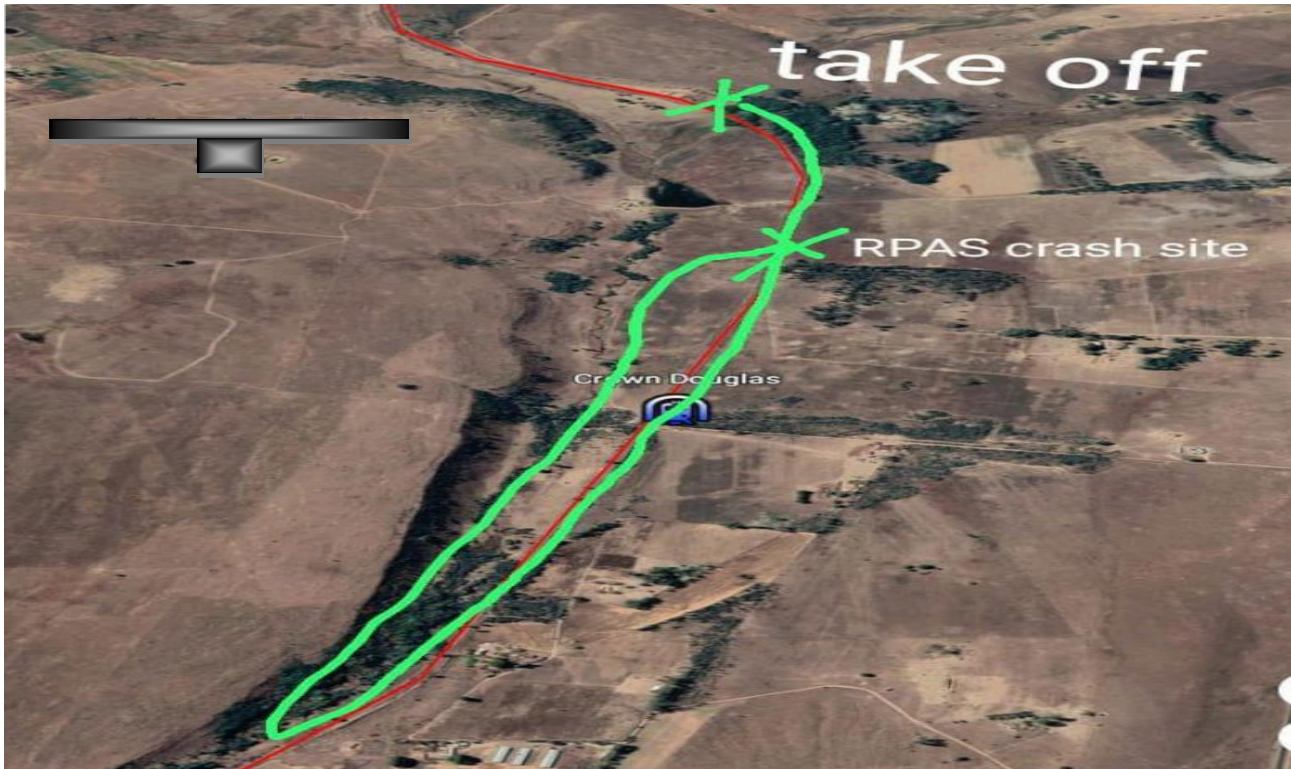
Following the disconnection, the pilot reported that the drone disappeared from his screen while he was driving along the service road next to the railway line. The pilot then requested security officials to assist him in searching for the drone. The search started at 2159Z until 0205Z, and again at 0318Z until day break, without success. As his shift was ending, the pilot asked the colleague who was about to take the next shift to continue with the search. This search was also not successful.

Figure 1: The drone flight path. (Source: Operator)

- The drone was being operated beyond the maximum flight distance.

The drone was operated at night and out of line of sight and may have impacted an object on the return to base flight.

1. Drone operators should ensure that they conduct safety risk assessments in the areas of operation and in operations conducted at night.
2. The DCA is requested to investigate the need to further increase safety drone operations at night and in areas where the drones can cause injuries or damage to property.
