LIMITED ACCIDENT INVESTIGATION REPORT

Reference Number	CA18/2/3/10125					
Classification	Accident	Date	24 February 2022	Time	0605Z	
Type of Operation	Agriculture operations (Part 137)					
Location						
Place of Departure	Groenvlei Private Farm, Standerton, Mpumalanga Province		Place of Intended Landing	Groenvlei Private Farm, Standerton, Mpumalanga Province		
Place of Occurrence	Katdoornkraal Private Farm, Standerton, Mpumalanga Province					
GPS Co-ordinates	Latitude	S27° 05'.02"	Longitude	E029° 20'.52"	Elevation	5300 feet
Aircraft Information						
Registration	ZU-IGM					
Model/Make	Zenith Stol CH750 (Serial Number: 198)					
Damage to Aircraft	Substantial		Total Aircraft Hours	150		
Pilot-in-command						
Licence Valid	Yes	Gender	Male	Age	63	
Licence Type	Private Pilot Licence (PPL)					
Total Hours on Type	47.6		Total Flying Hours	194.6		
People On-board	1 + 0	Injuries	0	Fatalities	0	Other (On Ground) 0
What Happened						
<p>On Thursday morning, 24 February 2022, the pilot on-board a Zenith Stol CH750 aircraft with registration ZU-IGM took off on a crop-spraying flight from Groenvlei private farm airstrip located in Standerton, Mpumalanga province, with the intention to r

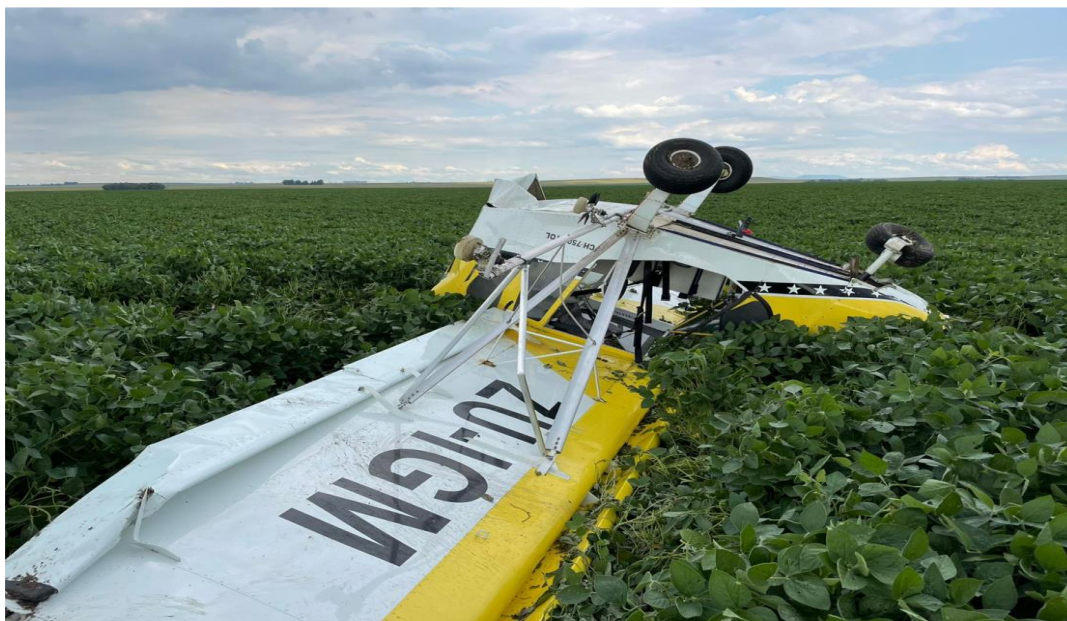
The weather in the area at the time of the flight was described by the pilot as fine and clear with some high clouds and no wind; the outside air temperature was about 16° Celsius (C). During the crop-spray application run, the soybean plant branches got entangled on the spray-boom (structure that supports spray nozzles along the wingspan of the aircraft) and the aircraft flipped over, coming to rest in an upside-down position. The aircraft sustained substantial damages during the accident sequence and the pilot was not injured. Third party damage was limited to the crops in proximity to the site of the accident.

Figure 1: The aircraft at the accident site (Source: Operator)

- i. No mechanical malfunction with the aircraft or its engine was noted that could have contributed or have caused the accident.
- ii. The weather condition was favourable for the flight and did not contribute to the accident.
- iii. The pilot did not have an agricultural pilot rating which was in contravention of Part 61.25.1 of the South African Civil Aviation Regulations 2011 as amended.
