LIMITED ACCIDENT INVESTIGATION REPORT
--

Reference Number	CA18/2/3/10126					
Classification	Accident	Date	26 February 2022	Time	0740Z	
Type of Operation	Training Flight (Part 141)					
Location						
Place of Departure	Rhino Park Aerodrome, Gauteng Province		Place of Intended Landing	Rhino Park Aerodrome, Gauteng Province		
Place of Accident	On the edge of Runway 27 at Rhino Park Aerodrome, Gauteng Province					
GPS Co-ordinates	Latitude	S 25°49'57.24"	Longitude	E 028°32'39.25"	Elevation	4 760 feet
Aircraft Information						
Registration	ZU-IKG					
Model/Make	Jabiru J430 (Serial Number: 913)					
Damage to Aircraft	Substantial		Total Aircraft Hours	1 498.6		
Pilot-in-command						
Licence Type	Commercial Pilot Licence (CPL) Aeroplane	Gender	Male		Age: 26	
Licence Valid	Yes					
Total Hours on Type	10.7		Total Flying Hours	609.3		
People On-board	2 + 0	Injuries	0	Fatalities	0	Other (on ground) 0
What Happened						
<p>On 26 February 2022 at approximately 0645Z, an instructor and a student pilot on-board a Jabiru J430 aircraft with registration ZU-IKG took off from Runway 27 at Rhino Park Aerodrome with the intention to land back at the same aerodrome. The purpose of the flight wa

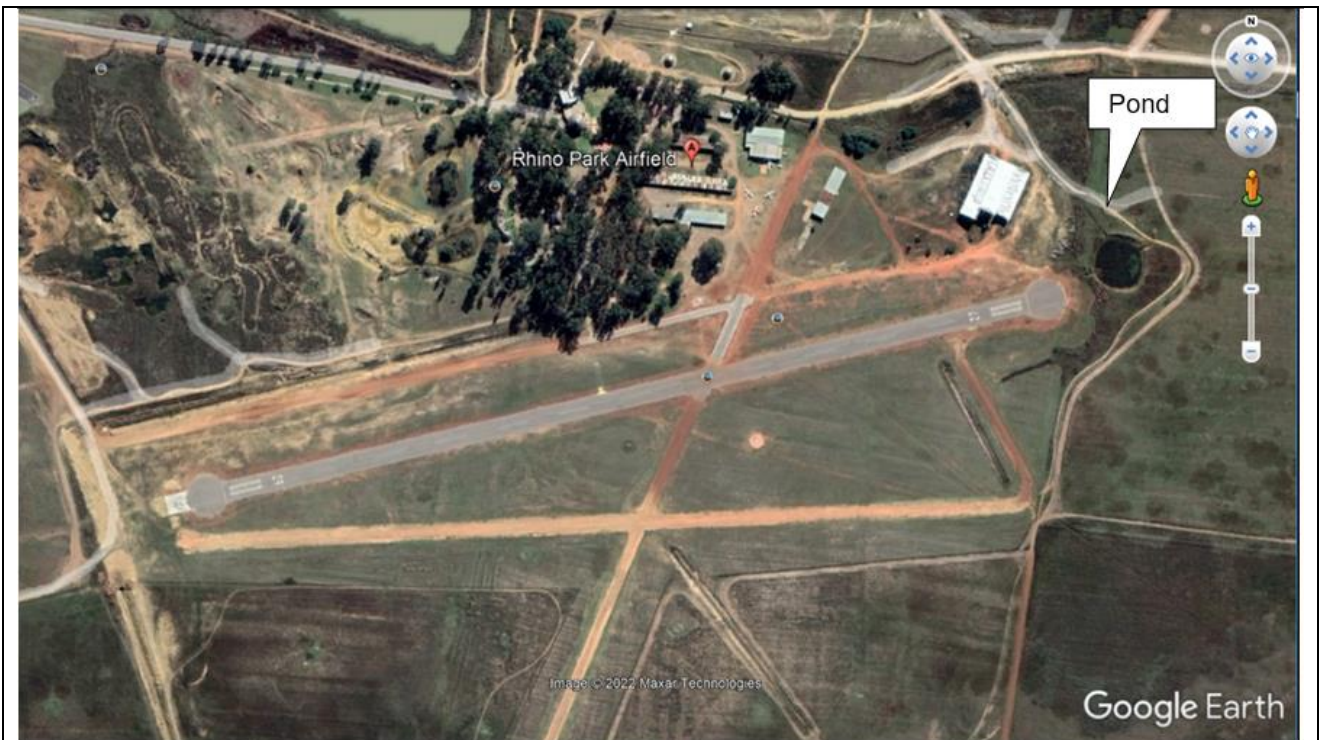
Figure 1: The pond at the threshold of Runway 27. (Source: Google Earth)

During an interview with the instructor, he mentioned that the pond near the threshold of Runway 27 gives a 'sinking' sensation whenever pilots fly over it before touchdown.

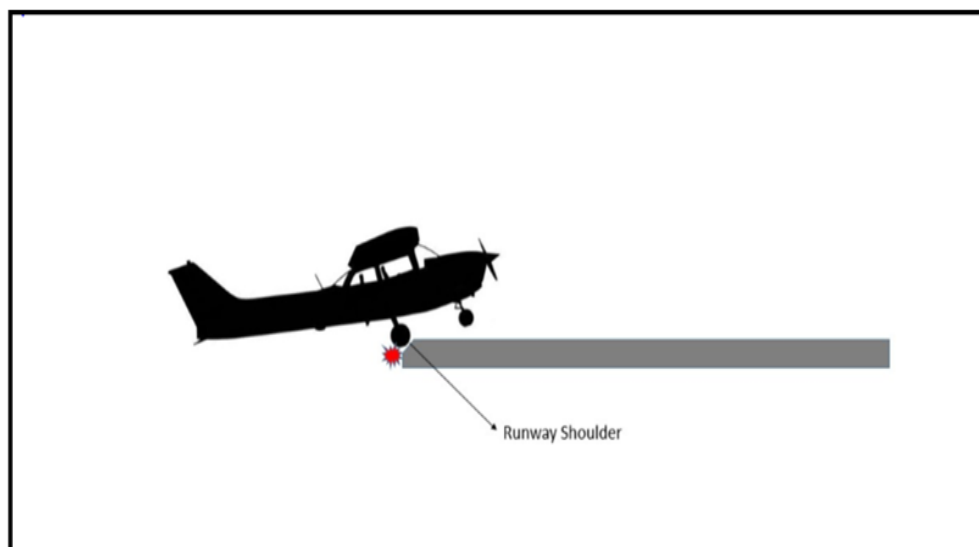
On the third circuit whilst on final approach, the student pilot stated that he felt the aircraft sink, which was more pronounced than usual; as a result, the instructor took over the control of the aircraft and tried to increase throttle, but it was a little late. The aircraft's main landing gear impacted the edge of the runway hard, causing damage to the left main landing gear. The instructor and the student pilot were not injured during the accident sequence. The student pilot stated that the flight lasted approximately 54 minutes.

Illustration 1: A representation of the accident aircraft's main landing gear impacting the beginning of the runway. (Source: Pilot)

Probable cause	
<ul style="list-style-type: none"> The aircraft was shallow on approach just before landing, which resulted in the main landing gear impacting the edge of the runway. 	
Safety Action/s	
None.	
Safety Message and/or Safety Recommendation/s	
None.	
Purpose of the Investigation	
<p><i>In terms of Regulation 12.03.1 of the Civil Aviation Regulations (CAR) 2011, this report was compiled in the interest of the promotion of aviation safety and the reduction of the risk of aviation accidents or incidents and not to apportion blame or liability.</i></p>	
About this Report	
<p><i>Decisions regarding whether to investigate, and the scope of an investigation are based on many factors, including the level of safety benefit likely to be obtained from an investigation. For this occurrence, no investigation has been conducted, and the Accident and Incident Investigations Division (AIID) has relied on the information submitted by the affected person/s and organisation/s to compile this brief report. The report has been compiled using information supplied in the initial notification, as well as follow-up information to bring awareness of potential safety issues to the industry in respect of this occurrence, as well as possible safety action/s that the industry might want to consider in preventing a recurrence of a similar accident.</i></p> <p><i>This report provides an opportunity to share safety message/s in the absence of an investigation.</i></p> <p><i>All times given in this report are Co-ordinated Universal Time (UTC) and will be denoted by (Z). South African Standard Time is UTC plus 2 hours.</i></p>

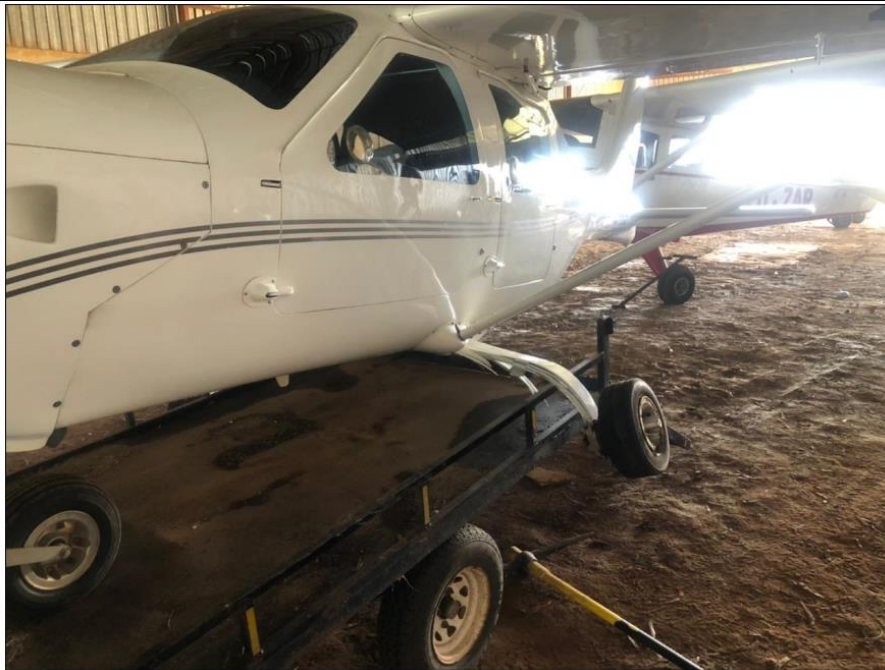
Figure 2: Damage on the left main landing gear strut. (Source: Pilot)
