<b>LIMITED ACCIDENT INVESTIGATION REPORT</b>
--

<b>Reference Number</b>	CA18/2/3/10128						
<b>Classification</b>	Accident		<b>Date</b>	26 February 2022		<b>Time</b>	1500Z
<b>Type of Operation</b>	Private (Part 94)						
<b>Location</b>							
Place of Departure	New Tempe Aerodrome (FATP), Free State Province			Place of Intended Landing	Lindbergh Lodge, North West Province		
Place of Occurrence	18 nautical miles from Lindbergh Lodge, North West Province						
GPS Co-ordinates	Latitude	27° 29' 14.81" S	Longitude	025° 27' 15.61" E	Elevation	4 250ft	
<b>Aircraft Information</b>							
Registration	ZU-ECY						
Model/Make	Thunderbird MKVI (Serial Number: TDE 85)						
Damage to Aircraft	Substantial			Total Aircraft Hours	272.0		
<b>Pilot-in-command</b>							
Licence Valid	Yes			Gender	Male	Age	52
Licence Type	National Pilot Licence (NPL)						
Total Hours on Type	140			Total Flying Hours	140		
People On-board	1 + 1	Injuries	0	Fatalities	0	Other (on ground)	0

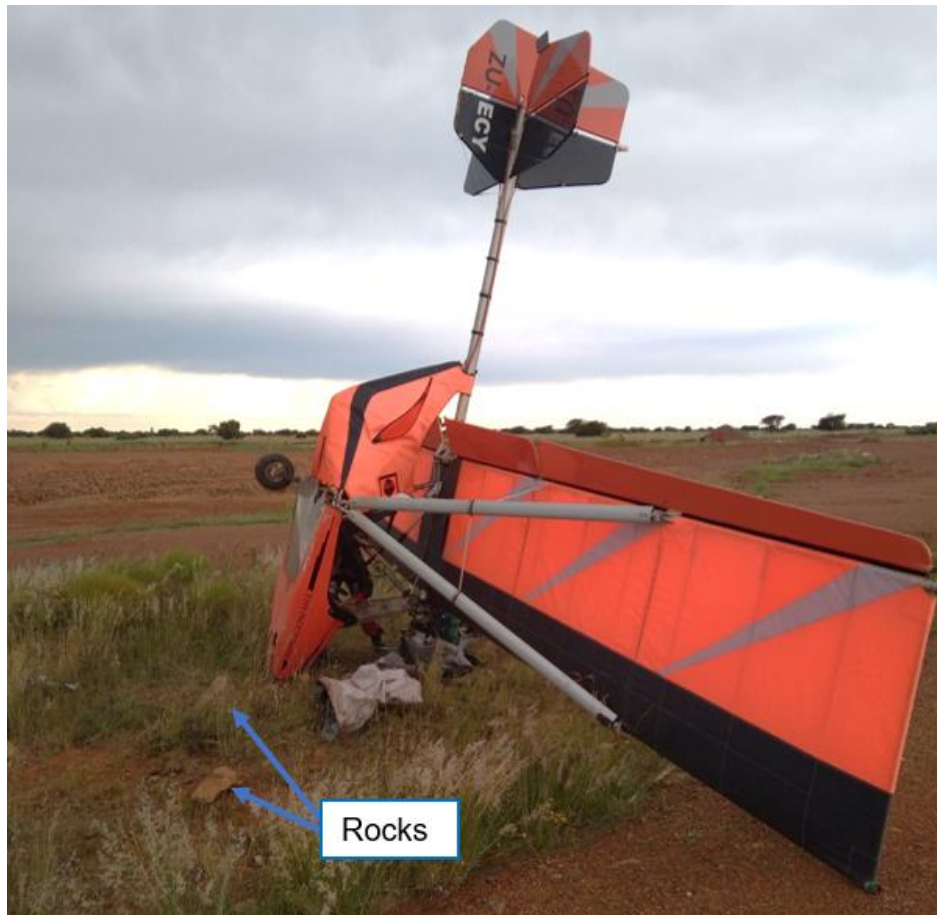
**Figure 1:** The aircraft as it came to rest after colliding with a rock. (Source: Owner)

- Based on the information recorded in the aircraft's flight folio following the completion of the annual inspection, the aircraft was ground-run by the AP and was found to be satisfactory in all respect.
- All damage to the aircraft was attributable to impact forces exerted to the undercarriage due to the rough terrain. Damage to the propeller was caused when the aircraft nosed over after colliding with the rock on its path.
