LIMITED ACCIDENT INVESTIGATION REPORT
--

Reference Number	CA18/2/3/10129						
Classification	Accident	Date	25 February 2022	Time	0735Z		
Type of Operation	Training (Part 141)						
Location							
Place of Departure	Lanseria International Aerodrome (FALA), Gauteng Province		Place of Intended Landing	Lanseria International Aerodrome (FALA), Gauteng Province			
Place of Accident	Open field, approximately 1.1 nautical miles (nm) from the threshold of Runway 07 at FALA						
GPS Co-ordinates	Latitude	25°57'26.80" S	Longitude	027°53'47.40" E	Elevation	4411ft	
Aircraft Information							
Registration	ZS-FIF						
Make/Model	Cessna 172I (Serial Number: 172-56705)						
Damage to Aircraft	Substantial		Total Aircraft Hours	12 657.8			
Pilot-in-command							
Licence Type	Student Pilot Licence		Gender	Male		Age: 21	
Licence Valid	Yes						
Total Hours on Type	58.5		Total Flying Hours	58.5			
People On-board	1 + 0	Injuries	1	Fatalities	0	Other (On ground)	0

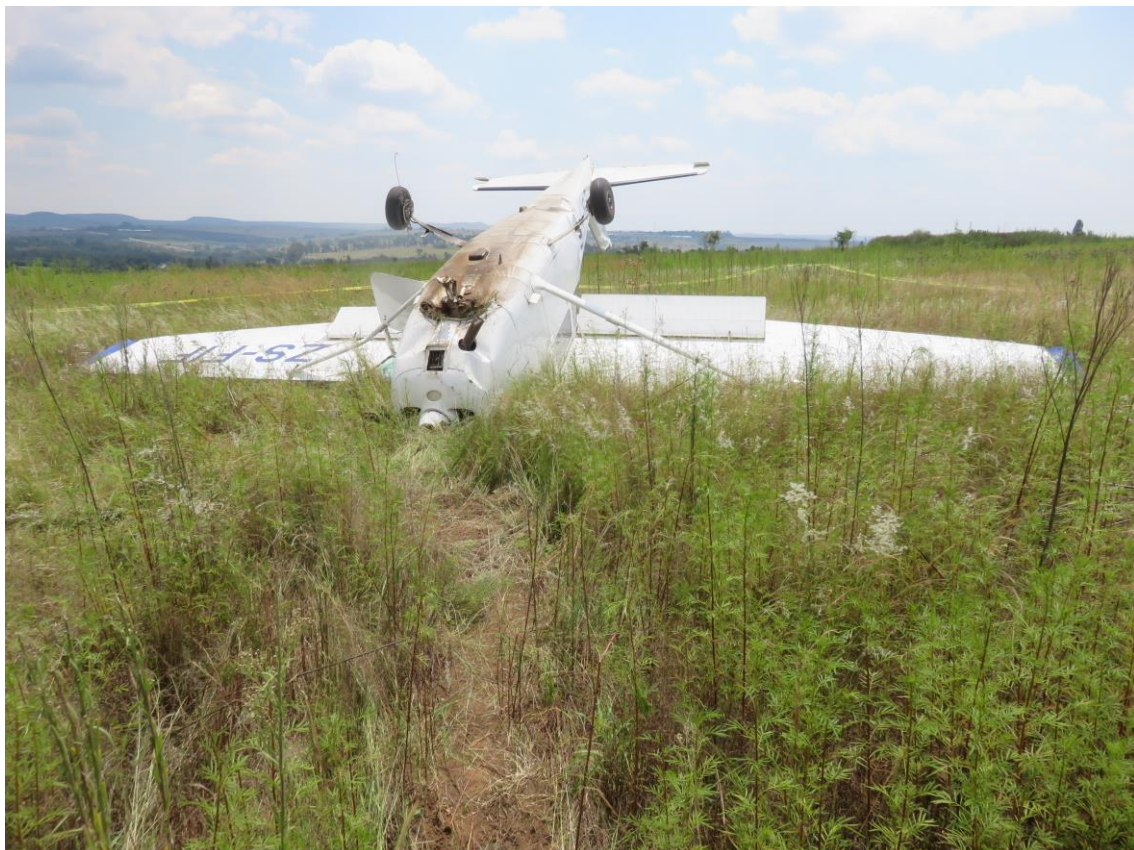
During the forced landing, approximately 50m after touchdown on the open field, the aircraft collided with a concealed embankment of about 40 centimetre (cm) in height. The aircraft’s nose wheel broke off and the aircraft nosed over and came to rest in an inverted attitude approximately 1.1 nautical miles (nm) from the threshold of Runway 07.

Figure 2: The aircraft as it came to rest.

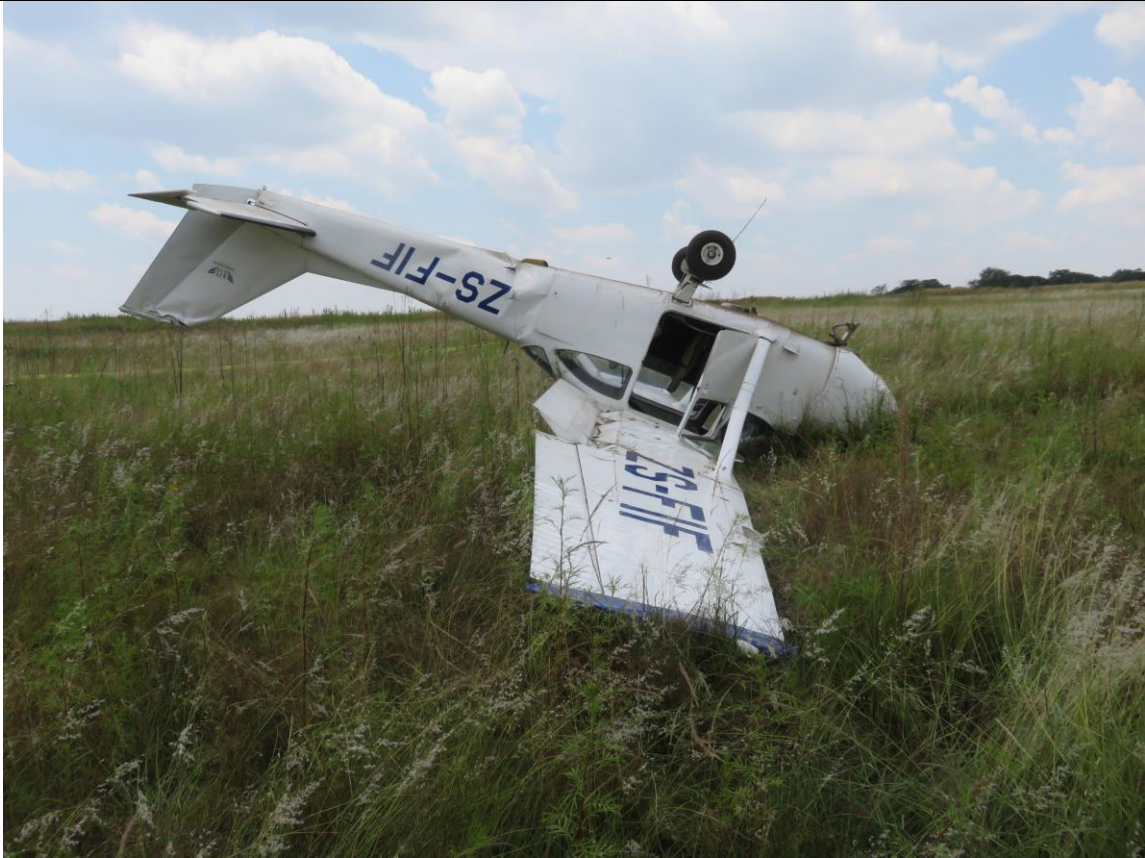
Figure 3: A side view of the aircraft in its resting position post-accident.

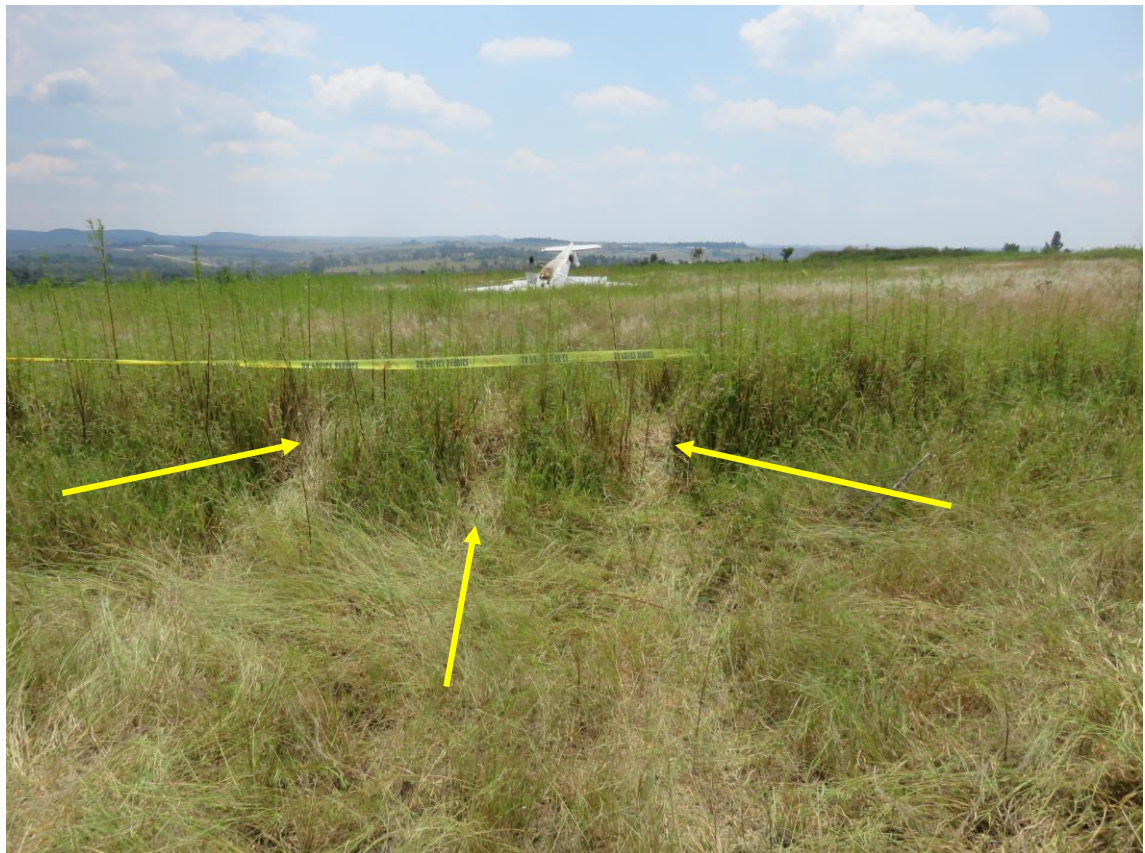
Figure 4: The wheel tracks of the aircraft and the embankment, indicated by the yellow arrows.

The aircraft collided with a concealed embankment during a forced landing on an open field following an engine stoppage in-flight that was attributed to carburettor icing.

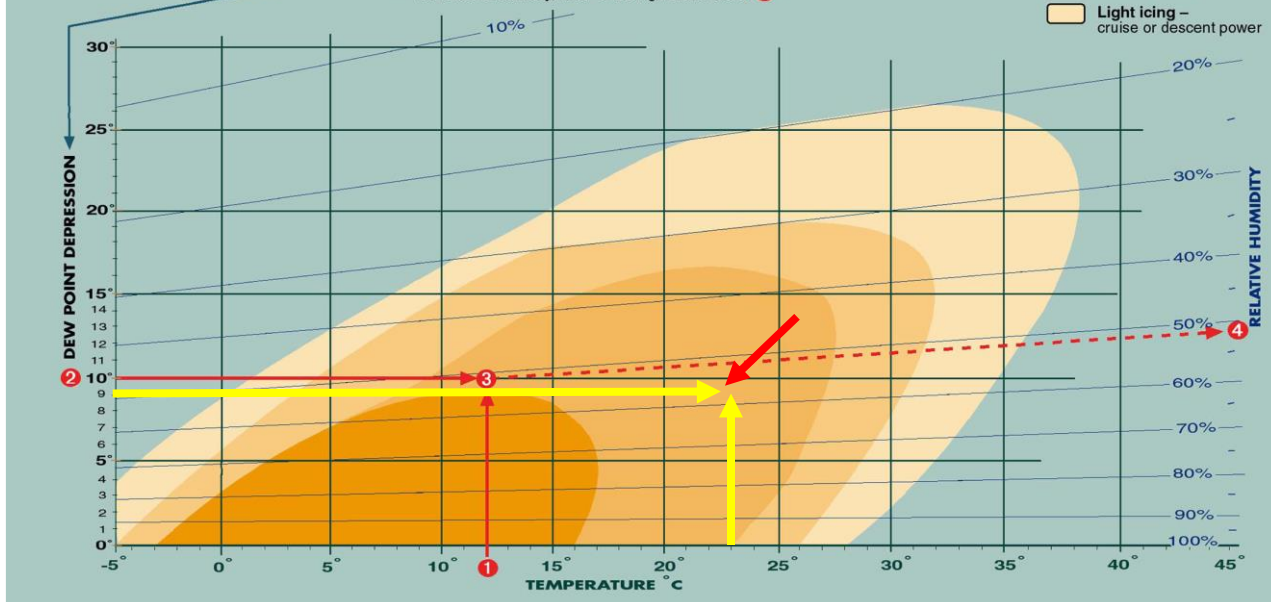
According to the carburettor icing-probability chart, serious icing conditions could have been encountered during descent with the prevailing weather conditions at the time.

Figure 5: The yellow and red arrows indicate the probability of icing.

- (xi) According to the carburettor icing-probability chart, serious icing conditions prevailed during the descent phase of the aircraft. The carburettor heat lever was found in the forward position (COLD), it is highly probable that the engine stoppage was due to carburettor icing.

Pilots should be alert and know that carburettor ice could occur at any stage during flight, even in the hottest months of the year.

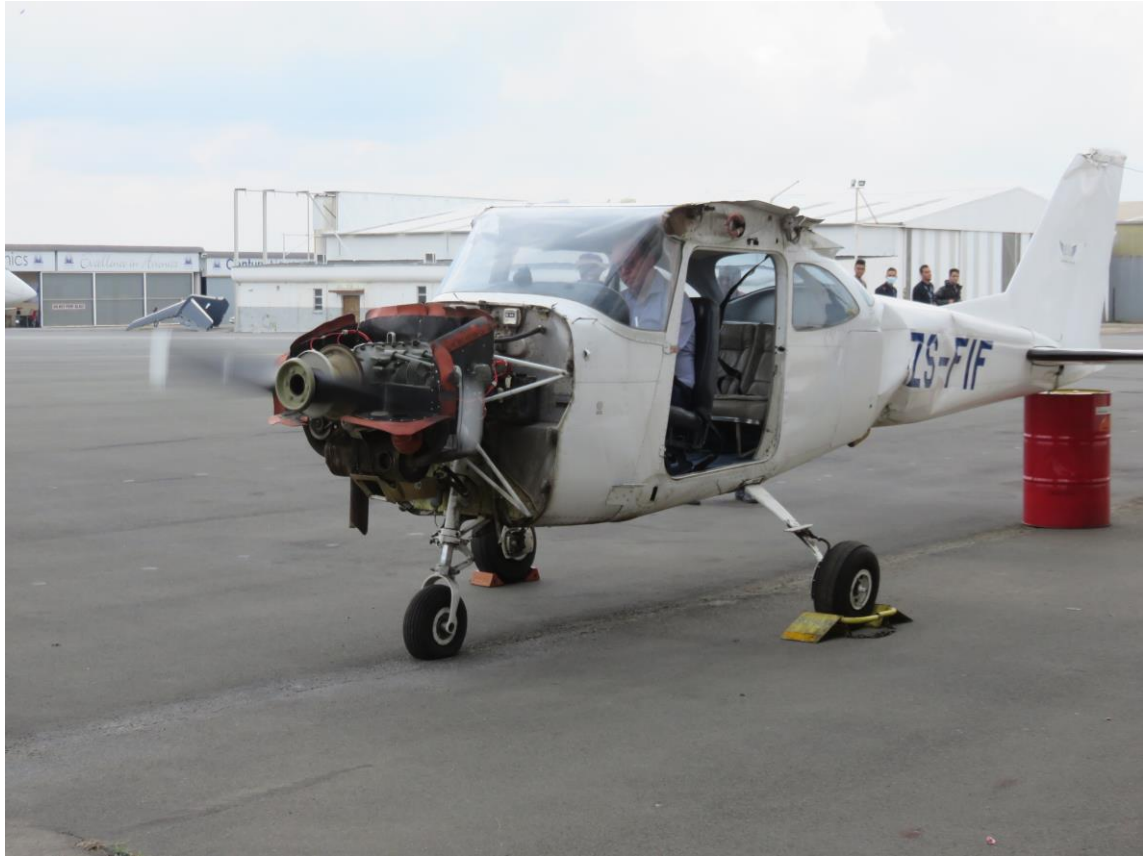
Figure 7: An engine ground run was performed, and the engine ran without a problem.

- (xii) An engine ground test run was performed following recovery of the aircraft and no mechanical anomalies were noted that could have caused the engine to stop in operation during flight.

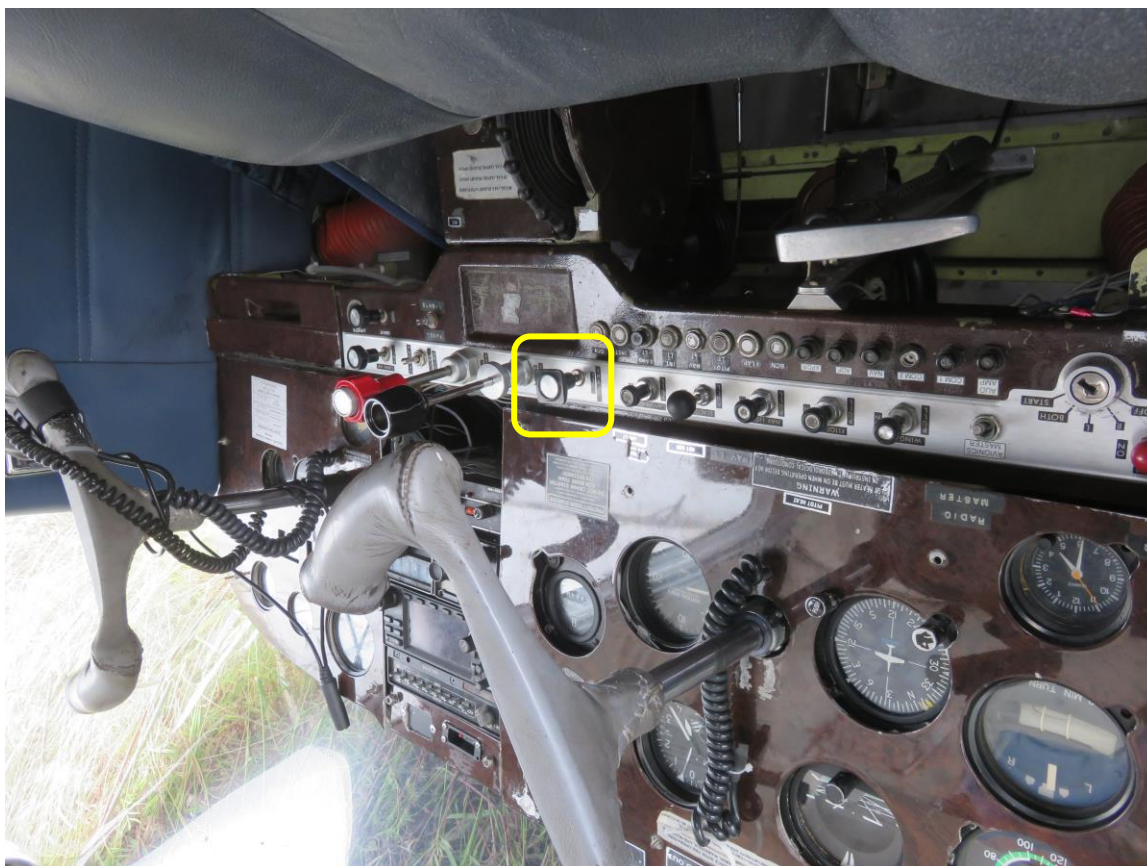
During the on-site investigation, it was noted that the carburettor heat lever was in the forward position (COLD) as seen in Figure 8.

Figure 8: The position of the carburettor heat lever (in the yellow window) taken on-site.
