LIMITED ACCIDENT INVESTIGATION REPORT
--

Reference Number		CA18/2/3/10131					
Classification	Accident	Date	28 February 2022	Time	16:30Z		
Type of Operation		Private (Part 94)					
Location							
Place of Departure		Private Airstrip Near Coligny, North West Province		Place of Intended Landing		Private Airstrip Near Coligny, North West Province	
Place of Accident		Private Airstrip Near Coligny					
GPS Co-ordinates		Latitude	S 26°22'20.27"	Longitude	E 26°11'43.62"	Elevation	4970ft
Aircraft Information							
Registration		ZU-SVA					
Model/Make		Savanna S (Serial Number: 12-10-54-0213)					
Damage to Aircraft		Substantial		Total Aircraft Hours		200.38	
Pilot-in-command							
Licence Valid		Yes		Gender		Male	
						Age 51	
Licence Type		National Pilot Licence (Aeroplane)					
Total Hours on Type		200		Total Flying Hours		220	
People On-board		1+0		Injuries		0	
				Fatalities		0	
				Other (On ground)		0	
What Happened							
<p>On Monday, 28 February 2022, a pilot on-board a Savanna S aircraft with registration ZU-SVA took off on a local flight from Oppaslaagte Farm private airstrip from Runway 15 in Coligny, North West province, with the intention to land back at the same take-of

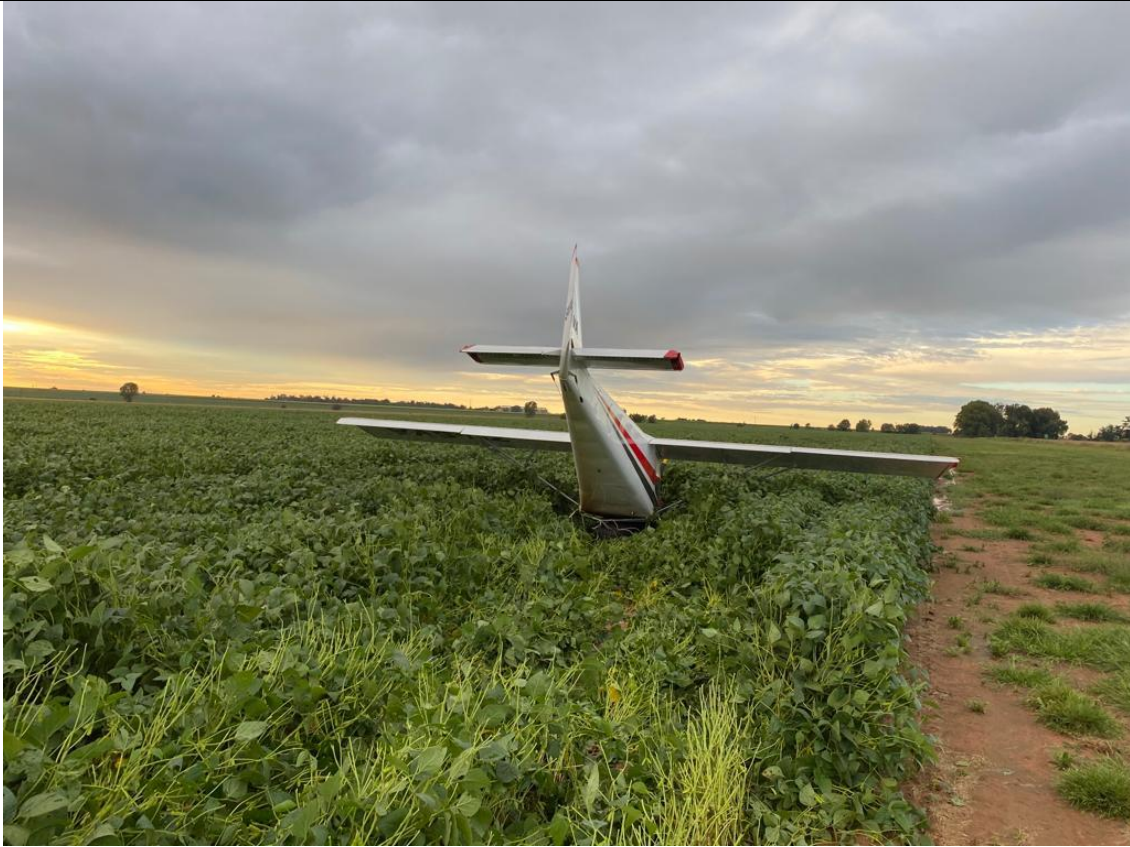
Figure 2: The aircraft at its resting position post-accident. (Source: Pilot)

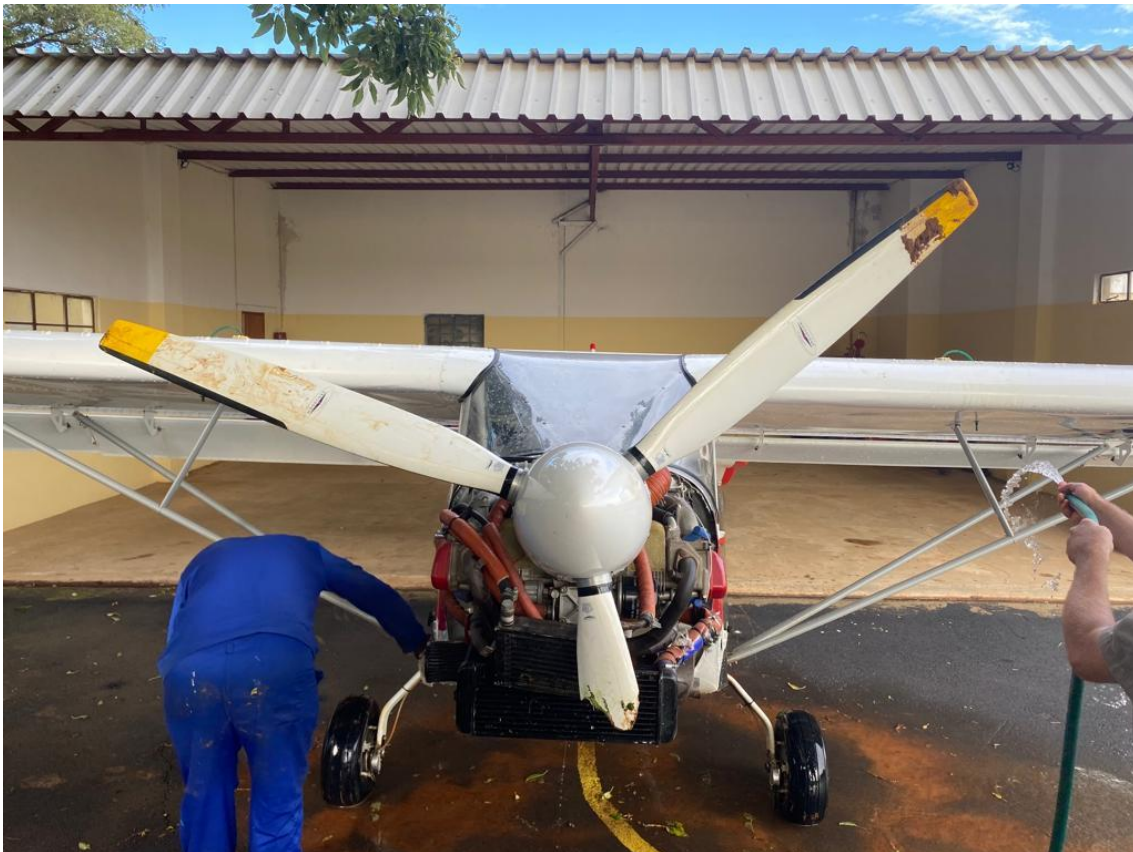
Figure 3: Damage to the propeller and engine bay. (Source: Pilot)

It is likely that the pilot's approach for landing was unstable, which led to the pilot's loss of directional control. This resulted in a hard landing and the subsequent nose gear failure.

Pilots flying in gusty winds and crosswind conditions are advised to use the crab manoeuvre during approach by pointing the nose slightly into wind to stabilise the approach as recommended in standard practise.

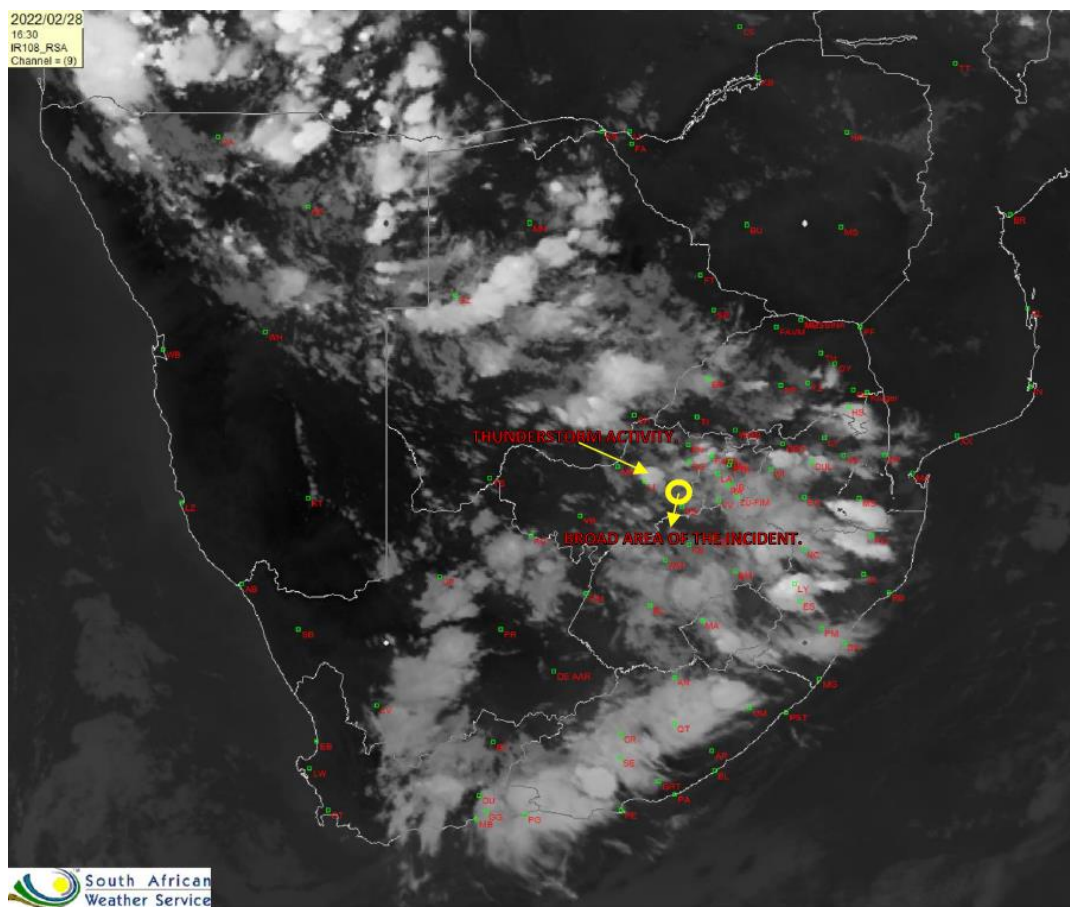
It is likely that the gust of wind experienced by the pilot was one of many rapid “burst of winds” from an outflow boundary of a thunderstorm. In Figure 4, a thunderstorm is circled; the thunderstorm was moving towards Oppaslaagte Farm area. The gusts of wind from the recorded data does not show strong winds. Unexpected rapid strong gusts of wind at intervals not readily recorded as well as thunderstorm activities could affect aircraft as far as 100km away. It is likely that the wind gust experienced by the aircraft was from the approaching storm from the north-west direction.

Figure 4: Infrared satellite imagery of the weather conditions around the time of accident. (Source: South African Weather Service)

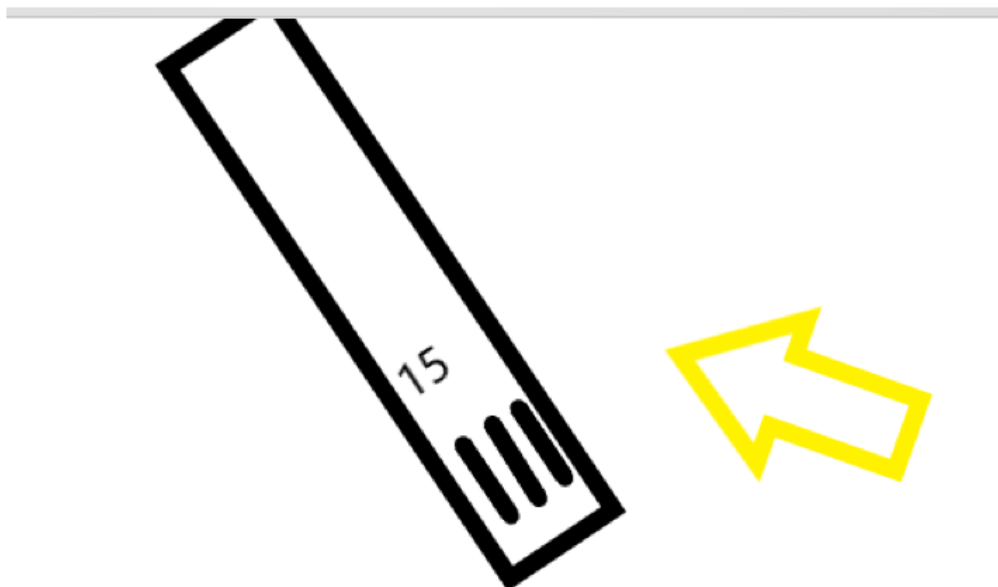
Figure 5: Wind component around the time of the accident.

According to the Pilot's Operating Handbook, the aircraft is rated for a 26-knot crosswind.
