LIMITED ACCIDENT INVESTIGATION REPORT
--

Reference Number		CA18/2/3/10133					
Classification	Accident	Date	10 March 2022	Time	0900Z		
Type of Operation	Game Capturing (Part 137)						
Location							
Place of Departure	Paul Roux Game Farm, Free State Province		Place of Intended Landing	Paul Roux Game Farm, Free State Province			
Place of Occurrence	Open field in Paul Roux game farm, Free State Province						
GPS Co-ordinates	Latitude	S28° 12'.10. 2"	Longitude	E027°53'.05.9"	Elevation	5000 feet	
Aircraft Information							
Registration	ZS-HED						
Model/Make	Schweizer 269C (Serial Number: 111020)						
Damage to Aircraft	Destroyed		Total Aircraft Hours	1672.5			
Pilot-in-command							
Licence Valid	Yes	Gender	Male	Age	30		
Licence Type	Commercial Pilot Licence (CPL) Helicopter						
Total Hours on Type	700		Total Flying Hours	2572.50			
People On-board	1 + 0	Injuries	1	Fatalities	0	Other (On Ground) 0	
What Happened							
<p>On Thursday morning, 10 March 2022, a pilot on a Schweizer 269C helicopter with registration ZS-HED took off on a game capturing mission from Paul Roux game farm near Bethlehem, Free State province, with the intention to return to the same farm. Visual mete

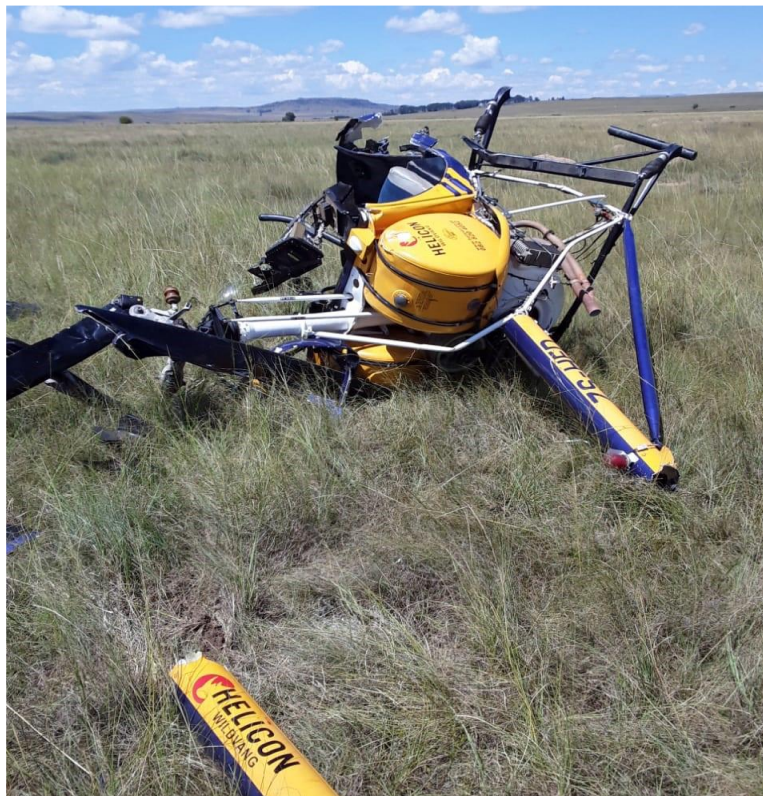
He then pulled the collective pitch lever with the intention to climb, but without success. The helicopter entered a spin that the pilot could not recover from and the helicopter impacted the ground very hard on an open piece of farm land. The pilot switched off the master before disembarking the wreckage unassisted. The helicopter was destroyed during the accident sequence. There was no pre- or post-impact fire. The pilot called the owner of the aircraft on his mobile phone. The emergency response plan was activated following the accident notification and a Robinson R44 helicopter was dispatched to the accident scene. The pilot sustained serious injuries; he was later transported to Bethlehem Mediclinic in Bloemfontein for medical attention. According to the pilot, the duration of the flight was about 30 minutes.

Figure 1: The helicopter at the accident site. (Source: Operator)

Post-accident examination of the wreckage indicated that the cockpit area, including the instrument panel, was destroyed on impact. The collective pitch lever was found in the full-up position, and the twist grip was on maximum power setting. The fuel tanks were intact with no fuel leakages noted. The cycle control stick remained intact and the anti-torque pedals displayed distortion associated with ground impact. Examination of the main rotor blades showed that the engine was producing a substantial amount of power at the time of the accident. The transmission drive clutch assembly was found in the engaged position and all the transmission drive belts were found intact with no signs of having slipped/snapped during operation.

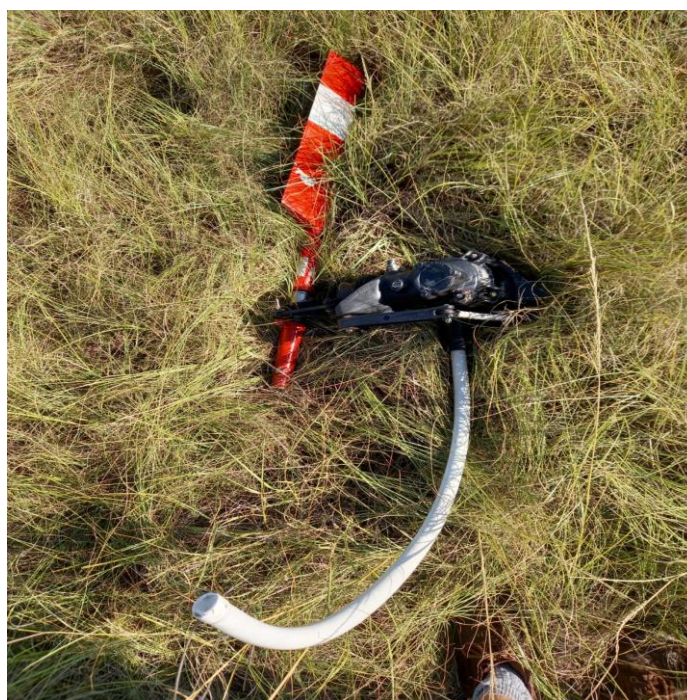
The tail rotor driveshaft had failed in torsional overload. The tail rotor assembly had separated from the tail-cone. One tail rotor blade remained attached to the rotor hub and was intact. No evidence was found of any possible defect or malfunction on the flight control system.

A search around the accident site was initiated and a dead antelope with a large wound on its head was found. The other tail rotor blade that separated from the rotor hub was found next to the antelope. There were signs that the antelope had just been killed; the injury on the head was attributed to the tail rotor strike.

Figure 2: The tail rotor and gearbox with one blade missing. (Source: Operator)

The helicopter's tail rotor impacted an antelope while flying close to the ground during a game capture operation; the helicopter spun out of control, rendering ground impact inevitable.
