LIMITED ACCIDENT INVESTIGATION REPORT

| Reference Number | CA18/2/3/10134 | | | | | |
| Registration | ZS-PJD | | | | | |
| Make/Model | Cessna 170A (Serial Number: 18743) | | | | | |

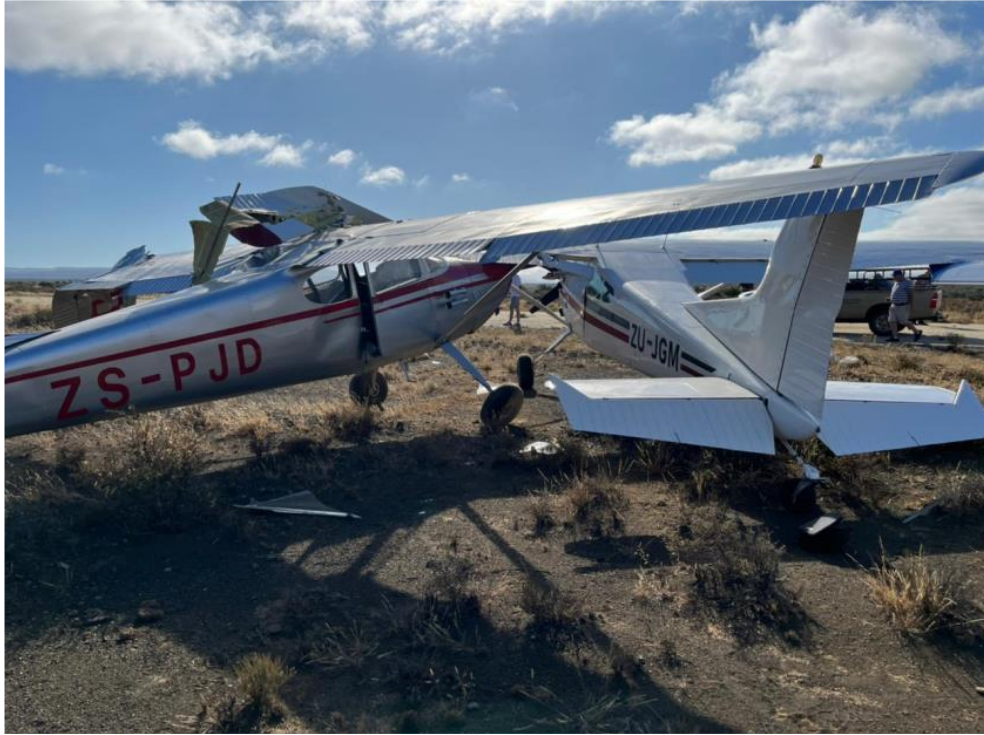
the right and colliding with a parked aircraft with registration mark ZU-JGM. Both aircraft sustained substantial damage to the wings, fuselage and propellers. The pilot and the passengers were not injured.

Figure 1: The ZS-PJD and the ZU-JGM aircraft post-impact. (Source: Pilot)

It is likely that the aircraft's approach for landing was unstable, resulting in the aircraft bouncing and losing directional control before colliding with a parked aircraft on the right-side of the runway.

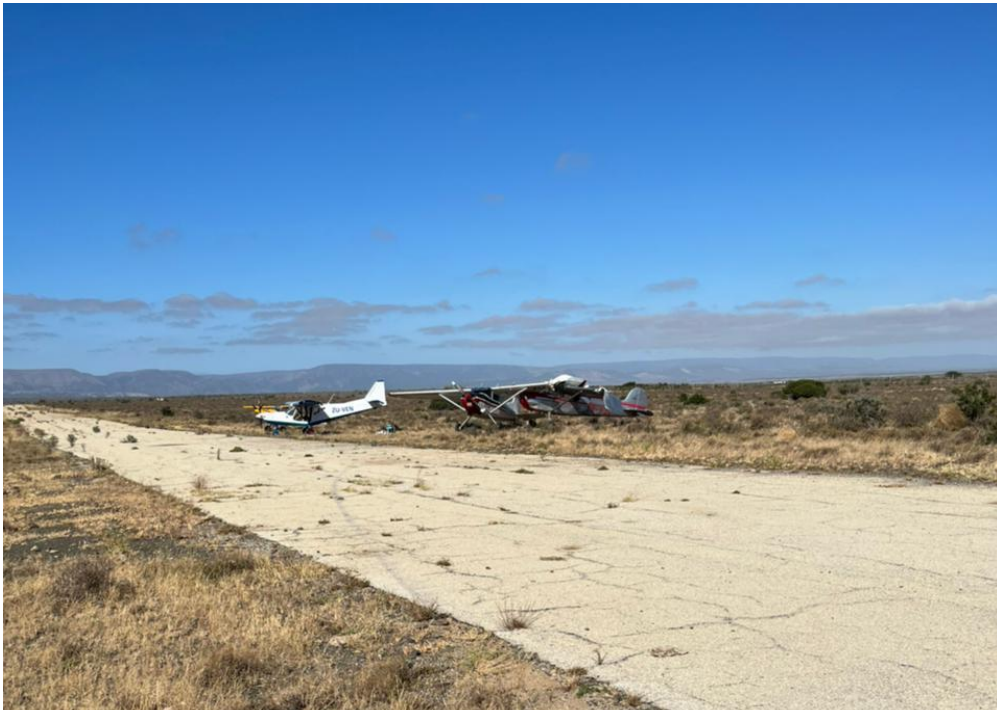
Figure 2: Proximity of the parked aircraft to the runway. (Source: Pilot)

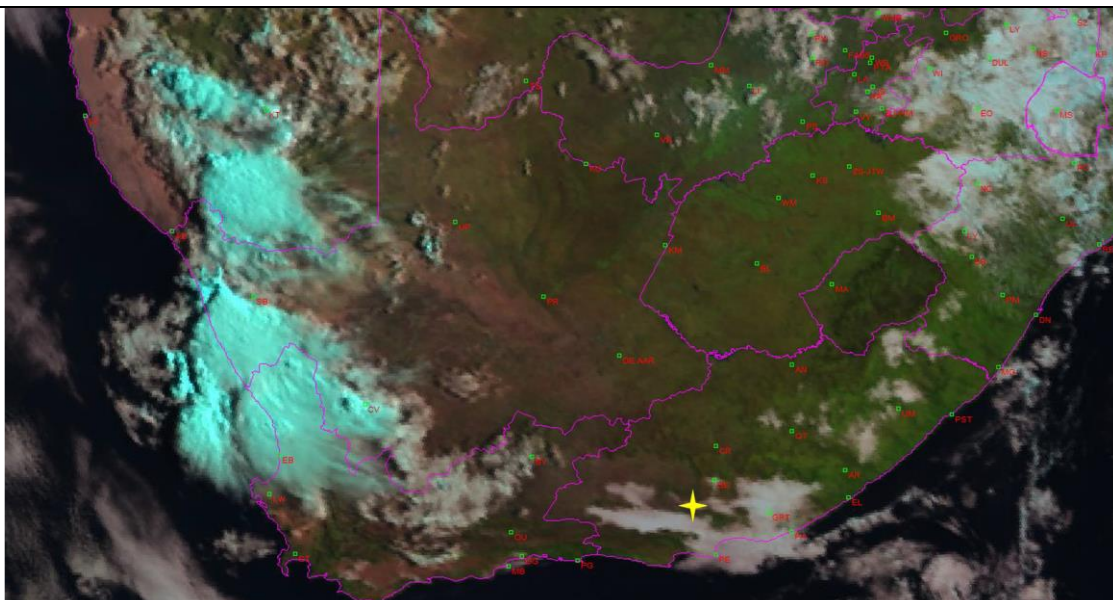
Satellite Imagery (Source: South African Weather Services/MeteoSat)

The Day Natural Colours (Figure below) satellite image of the MeteoSat Second Generation (MSG) represents image taken at 06h30Z. On the satellite image, low clouds are seen as indicated by the white/light pink area of clouds between Port Alfred and Gqeberha (FAPE), extending into the interior from approximately Fort Beaufort to Willowmore. The yellow star indicates the approximate area of Darlington Dam Lodge Airport (FADP), where patches of low cloud can also be seen.

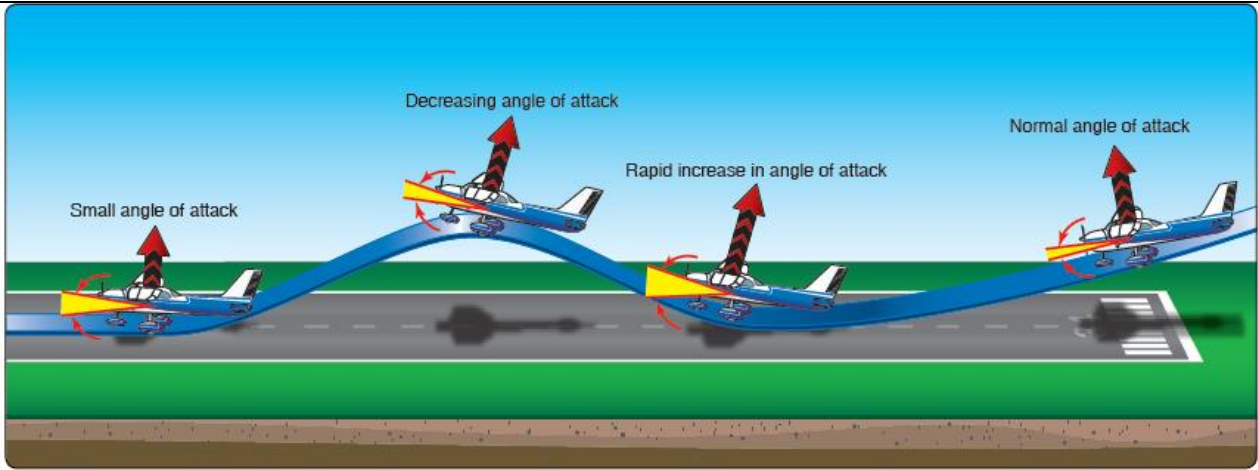
Figure 8-36. Bouncing during touchdown.

When the airplane contacts the ground with a sharp impact as the result of an improper attitude or an excessive rate of sink, it tends to bounce back into the air. Though the airplane's tires and shock struts provide some springing action, the airplane does not bounce like a rubber ball. Instead, it rebounds into the air because the wing's angle of attack (AOA) was abruptly increased, producing a sudden addition of lift. [Figure 8-36]

The abrupt change in AOA is the result of inertia instantly forcing the airplane's tail downward when the main wheels contact the ground sharply. The severity of the bounce depends on the airspeed at the moment of contact and the degree to which the AOA or pitch attitude was increased. Since a bounce occurs when the airplane makes contact with the ground before the proper touchdown attitude is attained, it is almost invariably accompanied by the application of excessive back-elevator pressure. This is usually the result of the pilot realizing too late that the airplane is not in the proper attitude and attempting to establish it just as the second touchdown occurs.

The corrective action for a bounce is the same as for ballooning and similarly depends on its severity. When it is very slight and there is no extreme change in the airplane's pitch attitude, a follow-up landing may be executed by applying sufficient power to cushion the subsequent touchdown and smoothly adjusting the pitch to the proper touchdown attitude. In the event a very slight bounce is encountered while landing with a crosswind, crosswind correction must be maintained while the next touchdown is made. Remember that since the subsequent touchdown is made at a slower airspeed, the upwind wing has to be lowered even further to compensate for drift. Extreme caution and alertness must be exercised any time a bounce occurs.
