LIMITED ACCIDENT INVESTIGATION REPORT
--

Reference Number		CA18/2/3/10136					
Classification	Accident	Date	19 March 2022	Time	1000Z		
Type of Operation	Private (Part 91)						
Location							
Place of Departure	Brits Airfield (FABS), North West Province		Place of Intended Landing	Sterkfontein Airfield (Brits), North West Province			
Place of Accident	Runway (RWY) 02 at Sterkfontein Airfield						
GPS Co-ordinates	Latitude	26° 2' 50.81"S	Longitude	27° 42' 7.66"E	Elevation	5 040 feet	
Aircraft Information							
Registration	ZS-FSH						
Make/Model	Oscar Partenavia P64B (Serial Number: 39)						
Damage to Aircraft	Substantial		Total Aircraft Hours	1904.8			
Pilot-in-command							
Licence Type	Private Pilot Licence	Gender	Male	Age	83		
Licence Valid	Yes						
Total Hours on Type	74.1		Total Flying Hours	1288.8			
People On-board	1 + 0	Injuries	0	Fatalities	0	Other (on ground)	0
What Happened							
<p>On 19 March 2022, a pilot on-board a P64B Oscar Partenavia aircraft with registration ZS-FSH was on a private flight from Brits Airfield (FABS) in the North West province, to Sterkfontein Airfield in the same province. The flight was conducted under visual flight rules (VFR) by day an

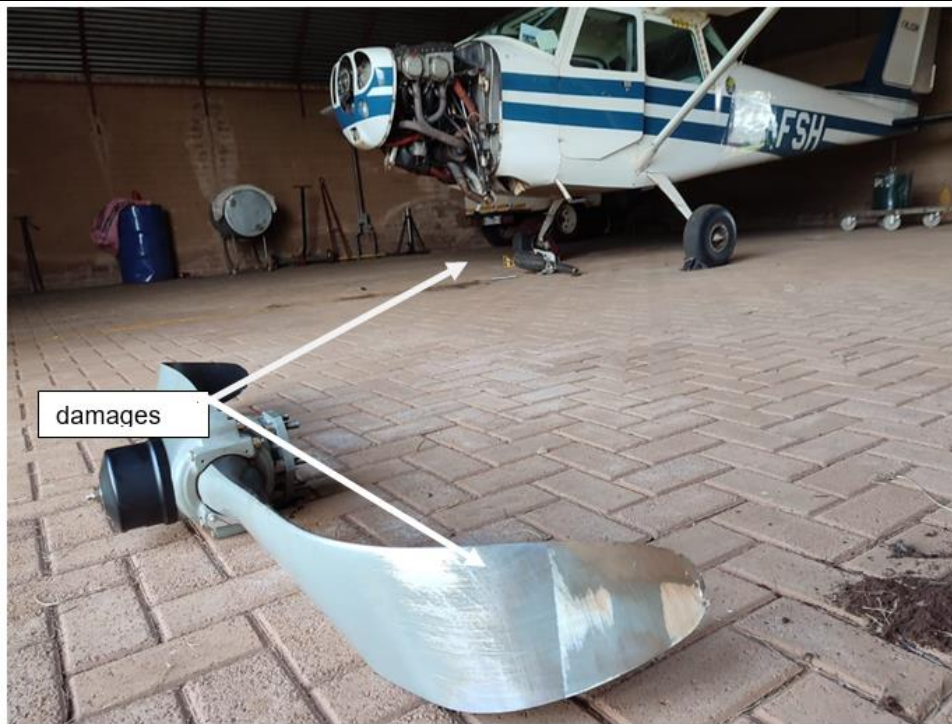
Figure 1: The damaged propeller and nose landing gear.

The nose landing gear (NLG) got caught in a mongoose burrow, resulting in a propeller striking the ground.

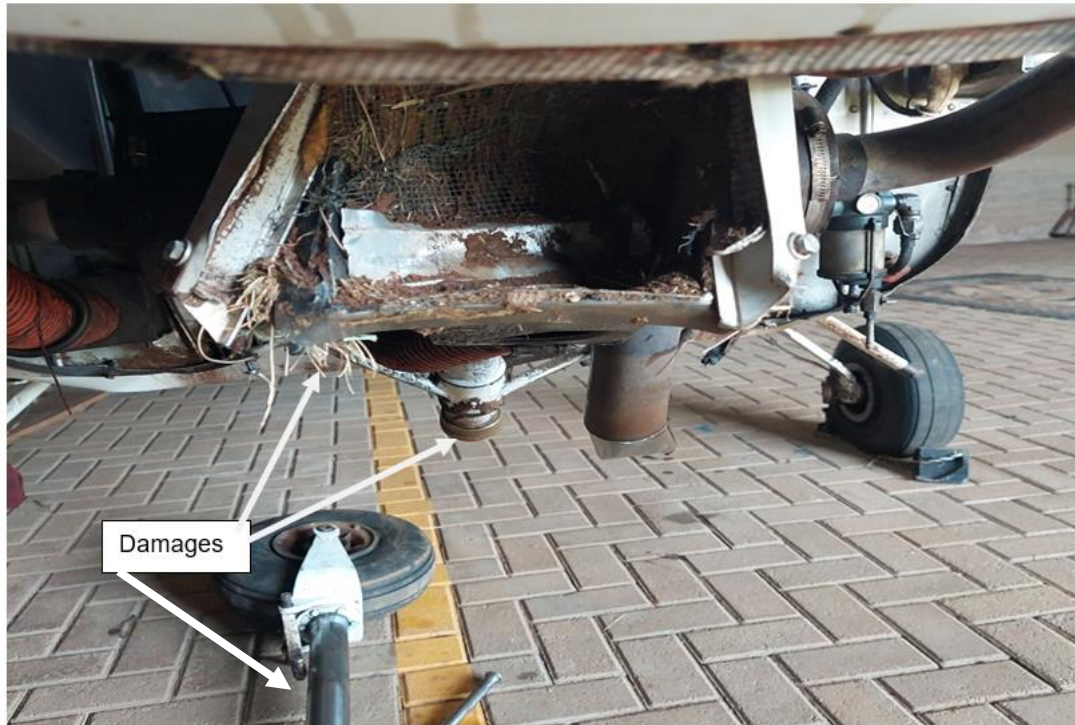
Figure 2: Damage on the nose landing gear.

- Figure 2 shows grass in the scoop located under the aircraft's nose section, which indicates that the nose wheel must have sunk into the mongoose burrow.
- The pilot further reported that he inspected the airfield on a regular basis for mongoose burrows. He stated that in instances where he found the mongoose burrows, he would close them before undertaking the flight. However, on his return, he would find that the mongoose have dug up the burrows again.

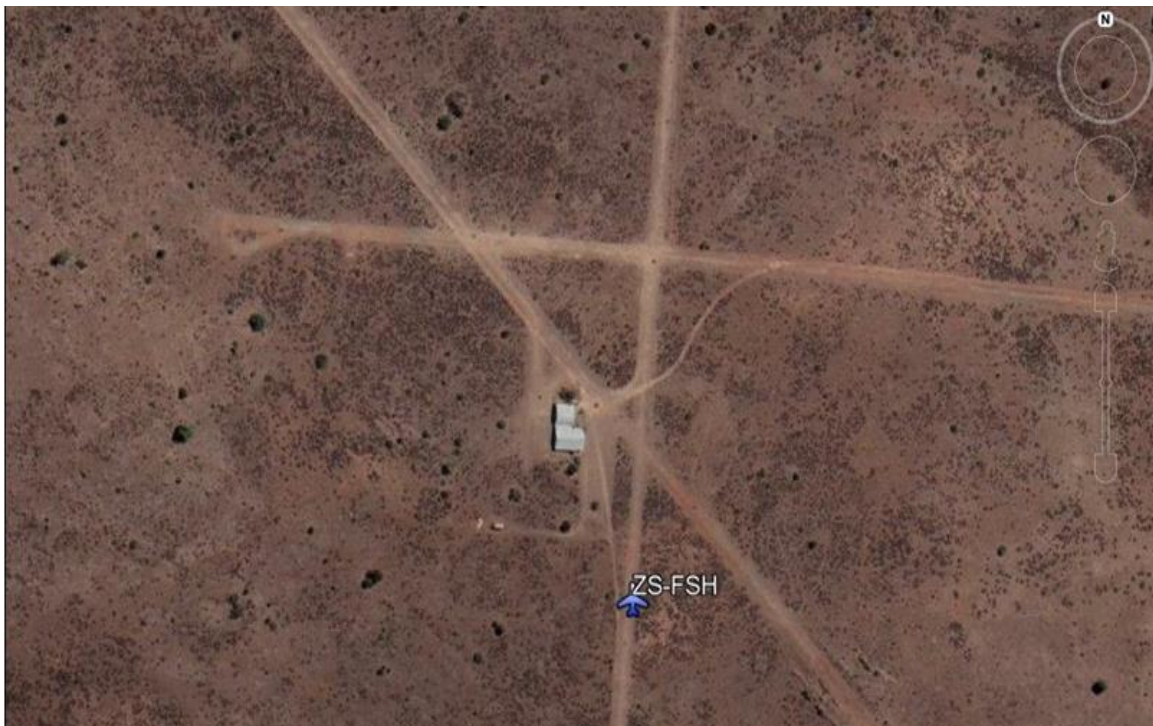
Figure 3: Position of the aircraft on the runway. (Source: Google Earth)

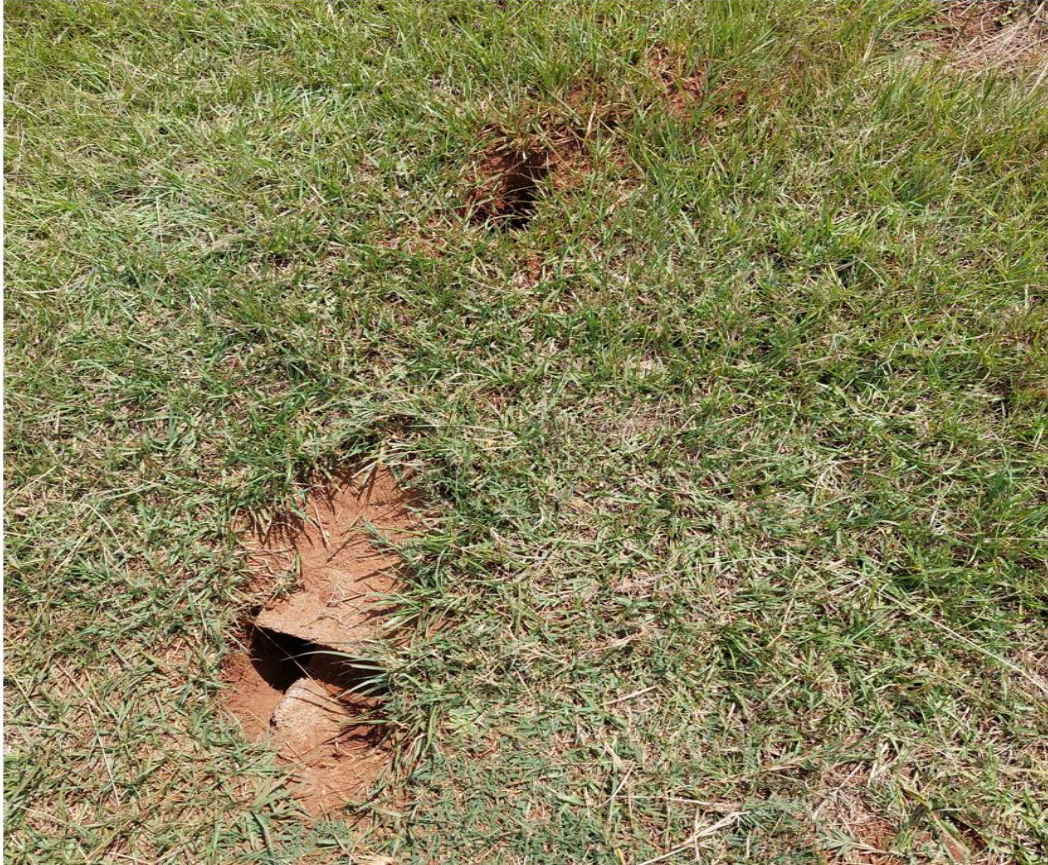
length and 11m (36 ft) in width each. The airfield is not fenced or walled, and mongoose burrows are scattered on all the runways (farm).

Figure 4: Mongoose burrows on one of the runways.

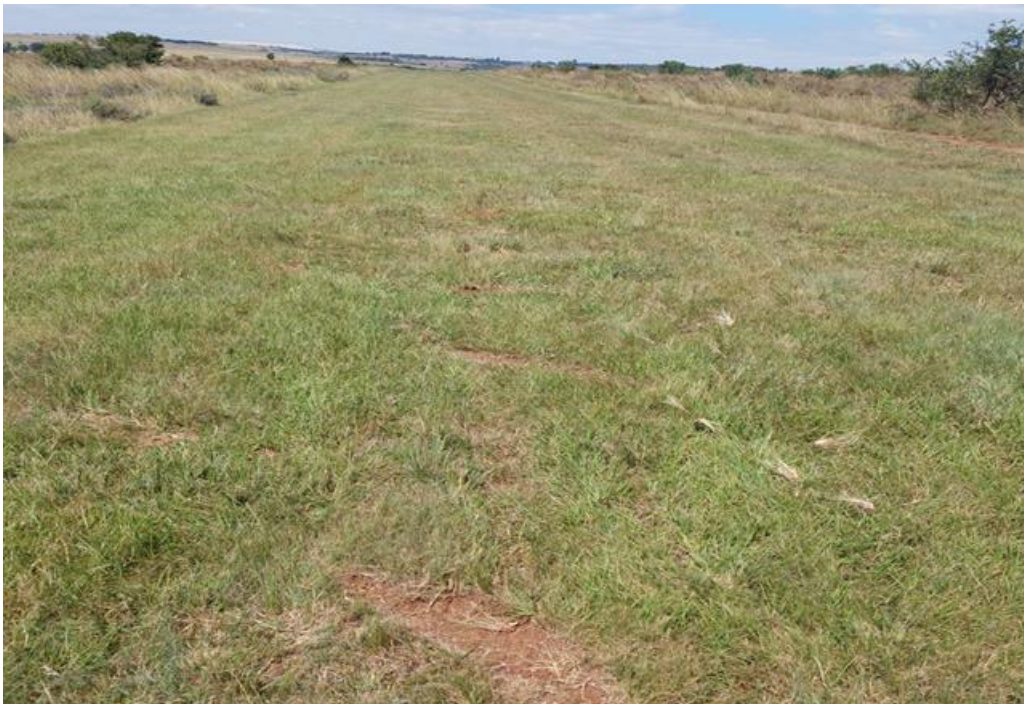
Figure 5: Propeller marks on the ground.
