<b>LIMITED ACCIDENT INVESTIGATION REPORT</b>
--

<b>Reference Number</b>	CA18/2/3/10137						
<b>Classification</b>	Accident	<b>Date</b>	18 March 2022	<b>Time</b>	1220Z		
<b>Type of Operation</b>	Private (Part 91)						
<b>Location</b>							
Place of Departure	Lumarie Game Farm Airstrip, North West Province		Place of Intended Landing	Lumarie Game Farm Airstrip, North West Province			
Place of Accident	Koedoeskop Farm, North West province						
GPS Co-ordinates	Latitude	S 24° 54' 84"	Longitude	E 27° 32' 06"	Elevation	4 257ft	
<b>Aircraft Information</b>							
Registration	ZS-HJJ						
Make/Model	Bell 206B (Serial Number: 3152)						
Damage to Aircraft	Substantial		Total Aircraft Hours	5656.5			
<b>Pilot-in-command</b>							
Licence Valid	Yes	Gender	Male	Age	26		
Licence Type	Private Pilot Licence (PPL) Helicopter						
Total Hours on Type	299.3		Total Flying Hours	351.9			
People On-board	1 + 1	Injuries	0	Fatalities	0	Other (On Ground)	0
<b>What Happened</b>

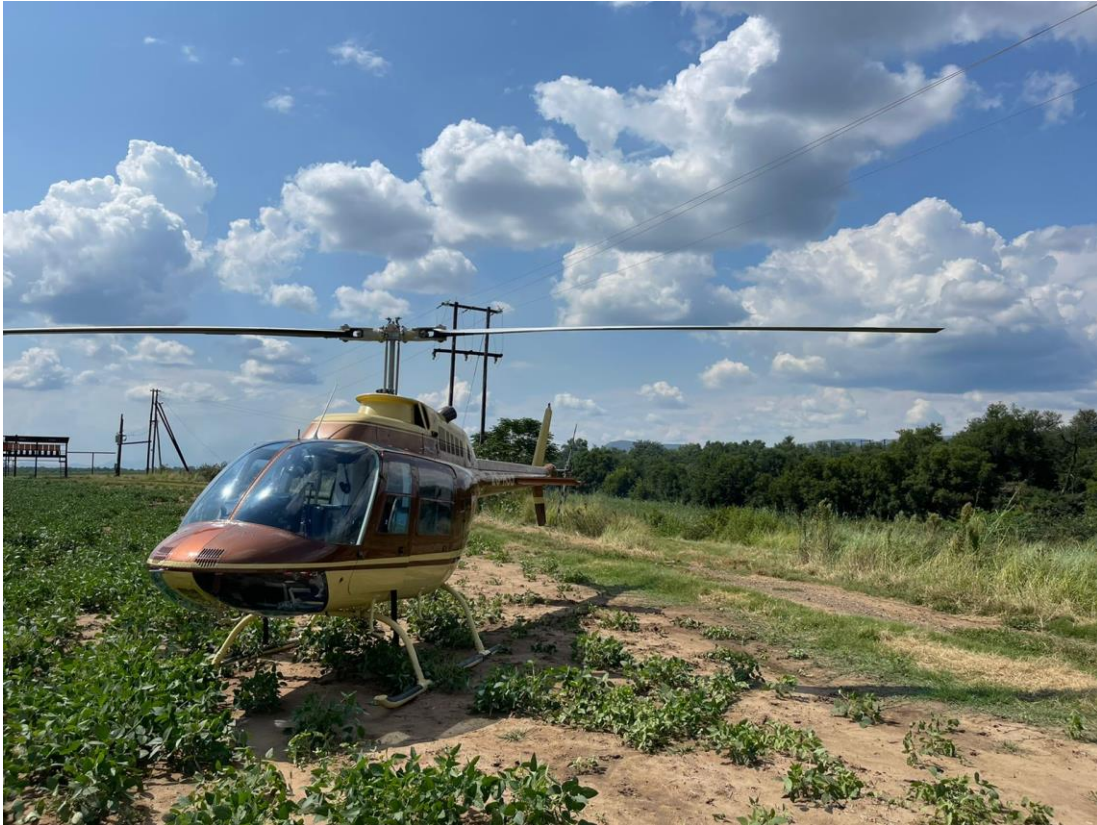
The helicopter sustained damage to one of the main rotor blades and its pitch link. Both occupants were not injured during the accident.

**Figure 1:** The aircraft as found on site. (Source: Pilot)

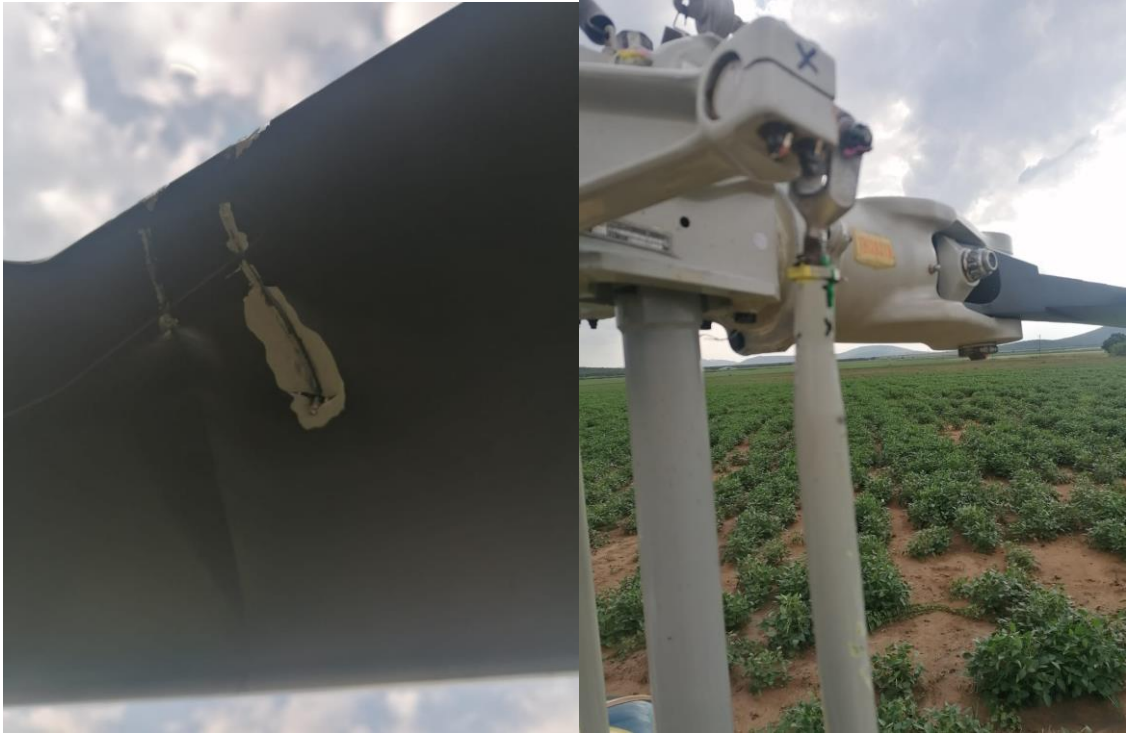
- The aircraft maintenance engineer (AME) who assessed the helicopter found that one of the main rotor blades was damaged and the accompanying pitch link was bent during impact with the power line.

**Figure 2:** Damage to the main rotor blade and the bent pitch link. (Source: AME)

<p><b>Probable cause:</b></p> <p>The pilot was flying low level and the helicopter's main rotor blade impacted a power line. The pilot performed a precautionary landing without any further damage.</p>	
<p><b>Contributory Factor:</b></p> <p>Lack of situational awareness.</p>	
<p><b>Safety Action</b></p>	
<p>None.</p>	
<p><b>Safety Message</b></p>	
<p>All pilots operating aerial work are encouraged to always observe the requirements as stated in the CAR 2011 as amended.</p>	
<p><b>Purpose of the Investigation</b></p>	
<p><i>In terms of Regulation 12.03.1 of the Civil Aviation Regulations (CAR) 2011, this report was compiled in the interest of the promotion of aviation safety and the reduction of the risk of aviation accidents or incidents and <b>not to apportion blame or liability.</b></i></p>	
<p><b>About this Report</b></p>	
<p><i>Decisions regarding whether to investigate, and the scope of an investigation are based on many factors, including the level of safety benefit likely to be obtained from an investigation. For this occurrence, no investigation has been conducted, and the Accident and Incident Investigations Division (AIID) has relied on the information submitted by the affected person/s and organisation/s to compile this brief report. The report has been compiled using information supplied in the initial notification, as well as follow-up information to bring awareness of potential safety issues to the industry in respect of this occurrence, as well as possible safety action/s that the industry might want to consider in preventing a recurrence of a similar accident.</i></p> <p><i>This report provides an opportunity to share safety message/s in the absence of an investigation.</i></p> <p><i>All times given in this report are Co-ordinated Universal Time (UTC) and will be denoted by (Z). South African Standard Time is UTC plus 2 hours.</i></p>

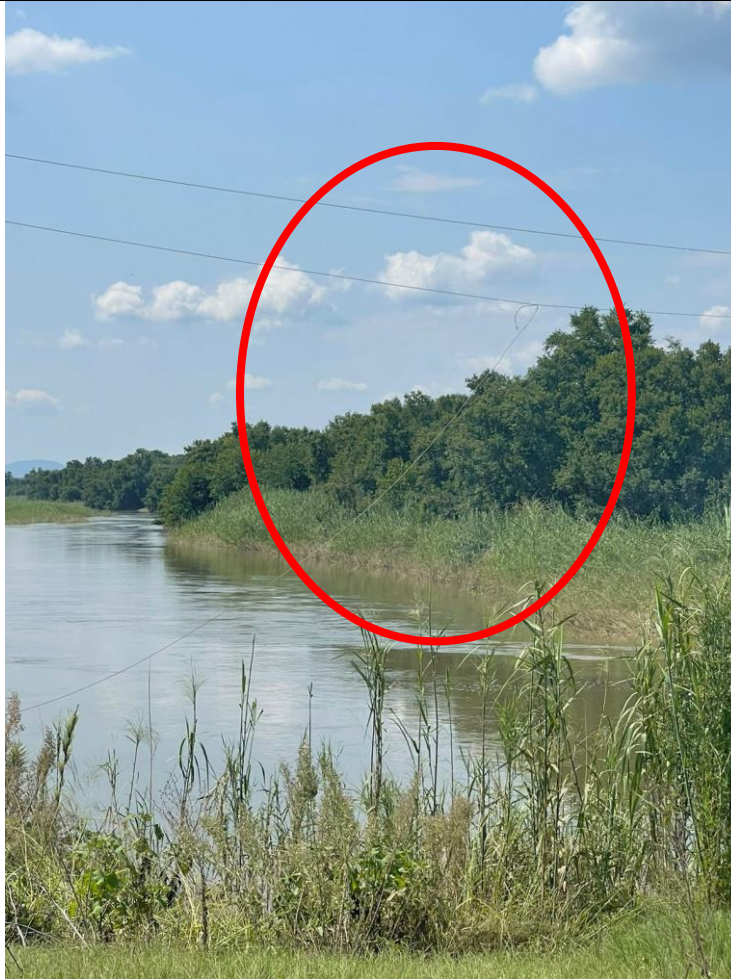
- The power line was severed during the accident sequence.

**Figure 3:** The power line that the main rotor blade impacted. (Source: Pilot)
