LIMITED OCCURRENCE INVESTIGATION REPORT – FINAL

Reference Number	CA18/2/3/10138						
Classification	Accident	Date	27 March 2022	Time	1030Z		
Type of Operation	Training (Part 141)						
Location							
Place of Departure	Lanseria International Aerodrome (FALA)		Place of Intended Landing	Lanseria International Aerodrome (FALA)			
Place of Occurrence	Open field near Hartbeespoort, North West Province						
GPS Co-ordinates	Latitude	25° 50' 22.31" S	Longitude	27° 49' 20.31" E	Elevation	4 612 ft	
Aircraft Information							
Registration	ZS-PFC						
Make; Model; S/N	Cessna 172H Skyhawk (Serial Number: 172-55742)						
Damage to Aircraft	Substantial			Total Aircraft Hours	10 080.93		
Pilot-in-command							
Licence Type	Commercial Pilot Licence (CPL) Aeroplane		Gender	Male	Age	31	
Licence Valid	Yes	Total Hours on Type	179.4		Total Flying Hours	495	
People On-board	2 + 0	Injuries	2	Fatalities	0	Other (on ground)	0
What Happened							
<p>On 27 March 2022, a flight instructor (FI) and a student pilot (SP) on-board a Cessna 172H (Skyhawk) aircraft with registration ZS-PFC departed Lanseria International Aerodrome (FALA) in Gauteng province on a training flight to practise stall exercises

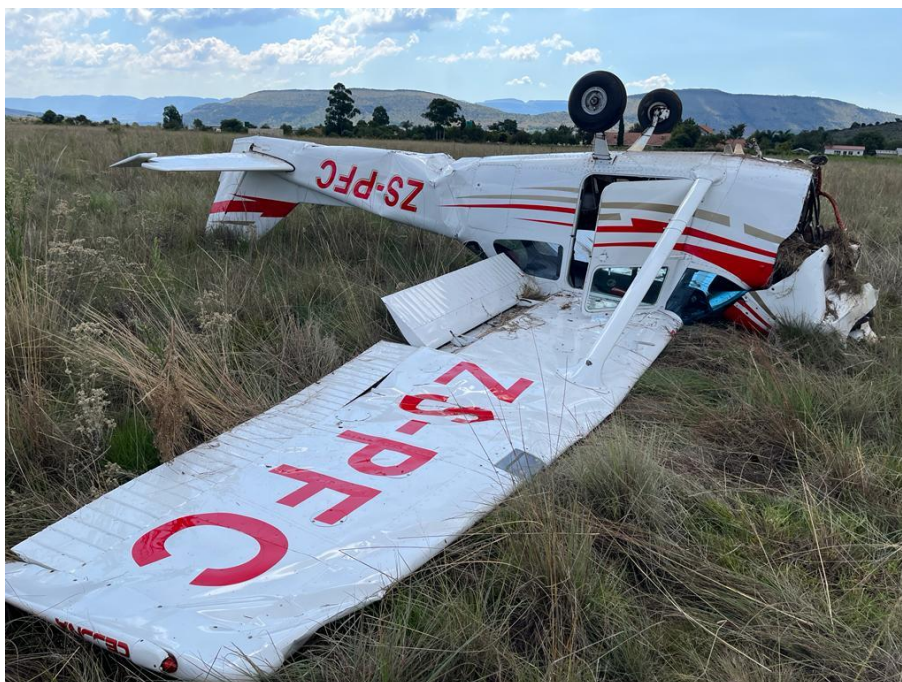
The aircraft was substantially damaged, and both pilots sustained minor injuries during the accident sequence.

Figure 1: The aircraft post-accident.

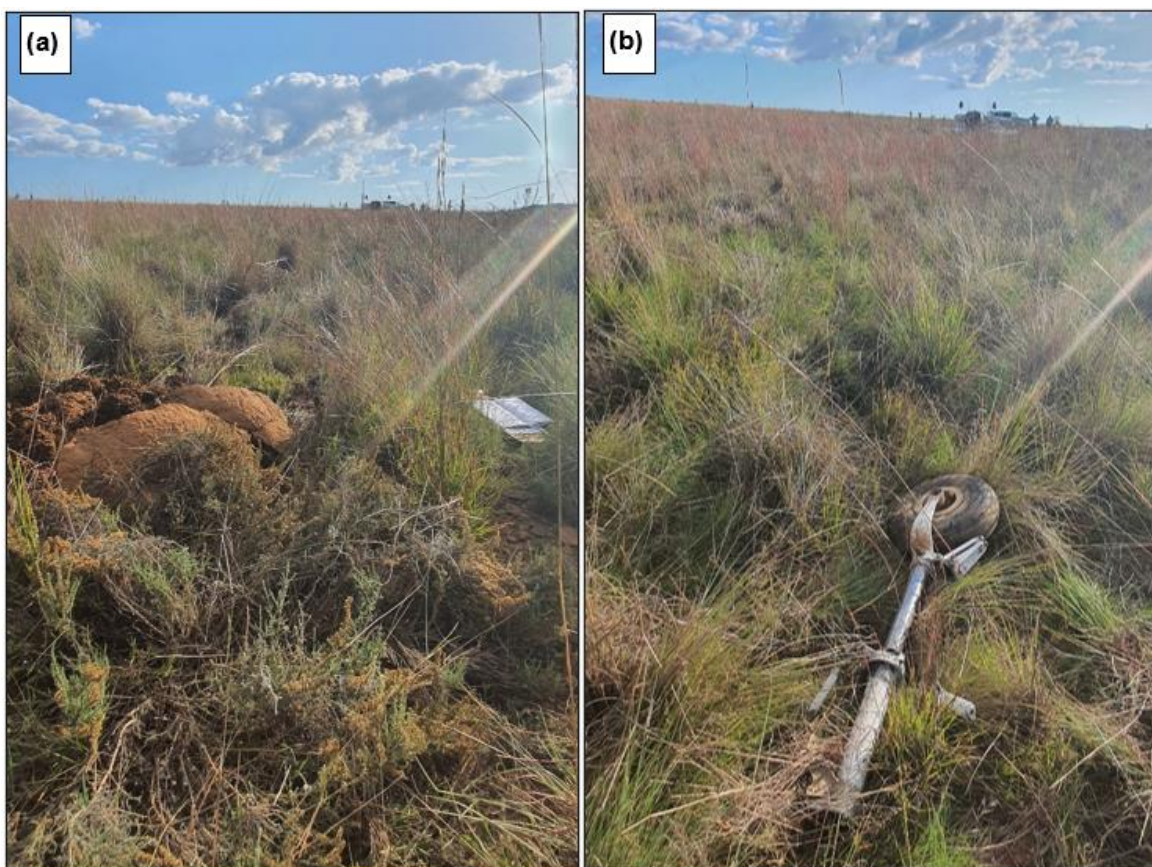
Figure 2: (a) The anthill with which the nose gear collided. (b) Location of the nose landing gear strut in relation to the main wreckage.

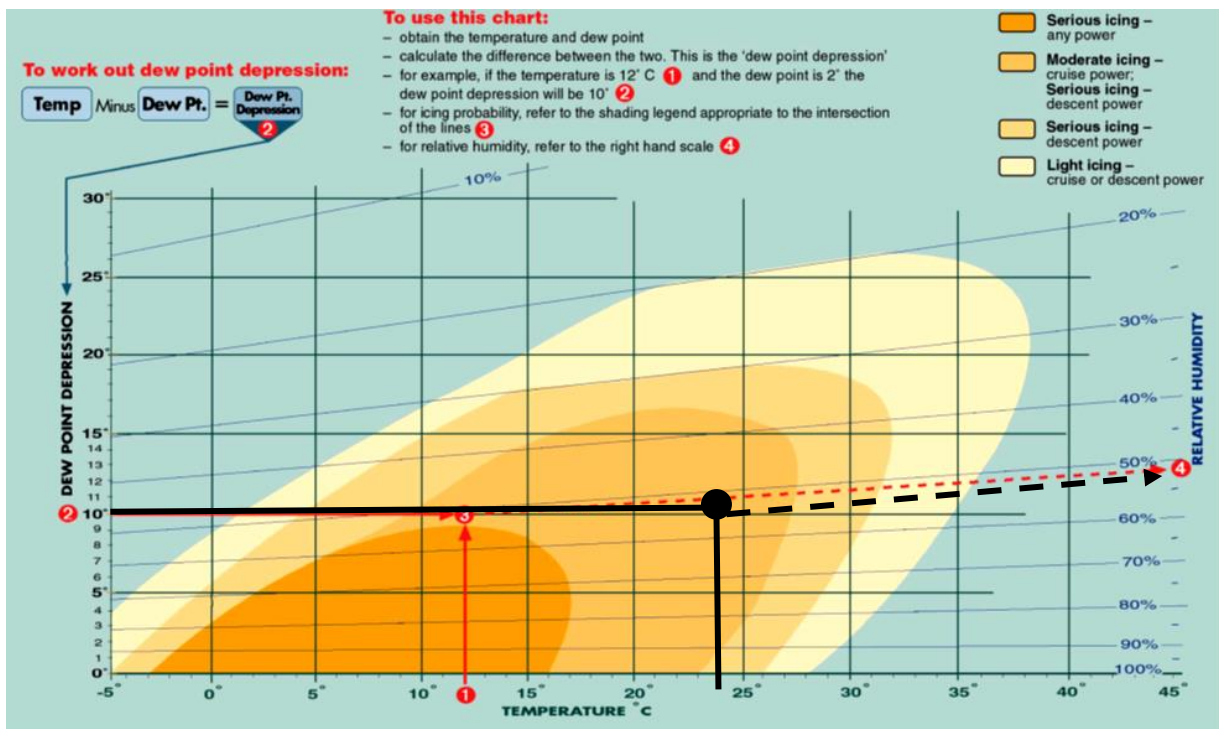
Figure 3: The Carburettor Icing-probability Chart.

The carburettor (carb) icing chart shows that the weather conditions were conducive for moderate icing at cruise power or serious icing at descent power with 50% relative humidity (refer to the black solid and dotted lines, as well as the round spot on the graph below).

Temperature	24 °C
Dewpoint	13 °C
Dewpoint depression	11 °C

Ice formation in the carburettor occurred during the climb at a cruise altitude of 5 500ft AMSL, which led to the reduction in engine power. This resulted in loss of altitude and a subsequent unsuccessful forced landing.
