LIMITED ACCIDENT INVESTIGATION REPORT

Reference Number	CA18/2/3/10140						
Classification	Accident	Date	4 April 2022		Time	0740Z	
Type of Operation	Private Flight (Part 91)						
Location							
Place of Departure	Riverside Aerodrome, Mpumalanga Province		Place of Intended Landing		Hoedspruit Civil Aerodrome (FAHT), Limpopo Province		
Place of Accident	Hangar No. 28 on the right-side of Runway 35 at FAHT						
GPS Co-ordinates	Latitude	24°21'02.87" S	Longitude	030°56'53.40" E	Elevation	1 800ft	
Aircraft Information							
Registration	ZS-MSB						
Make/Model	Cessna T210N (Serial No. 210-64663)						
Damage to Aircraft	Substantial		Total Aircraft Hours		3 440.1		
Pilot-in-command							
Licence Type	Private Pilot Licence		Gender	Male		Age: 47	
Licence Valid	Yes						
Total Hours on Type	150.1		Total Flying Hours		754.7		
People On-board	1 + 0	Injuries	0	Fatalities	0	Other (On ground)	0
What Happened							
<p>On Monday morning, 4 April 2022 at 0700Z, a private pilot flying solo on-board a Cessna T210N aircraft with registration ZS-MSB took off from Riverside Aerodrome near Malelane with the intention to land at Hoedspruit Civil Aerodrome (FAHT). The flight was conducted under the

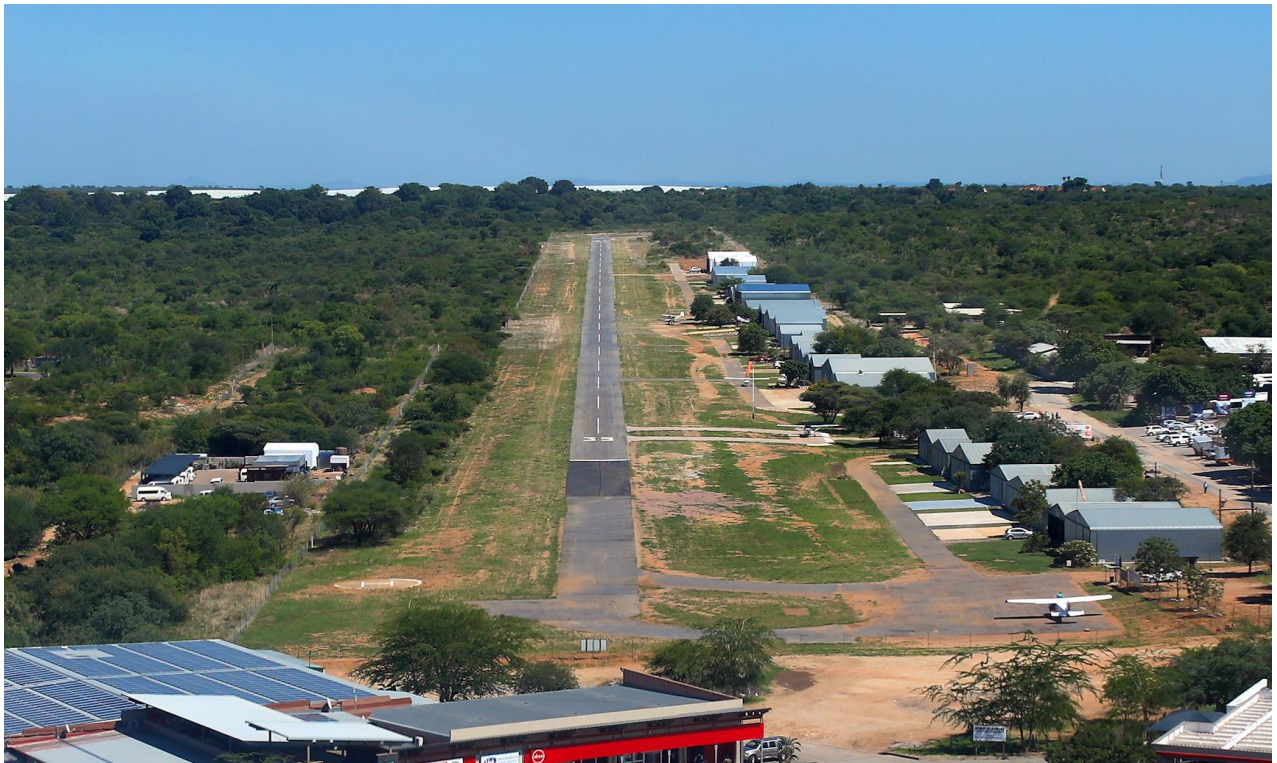
Figure 1: Aerial view, final approach for Runway 35 at FAHT. (Source: Mr Wynand Uys)

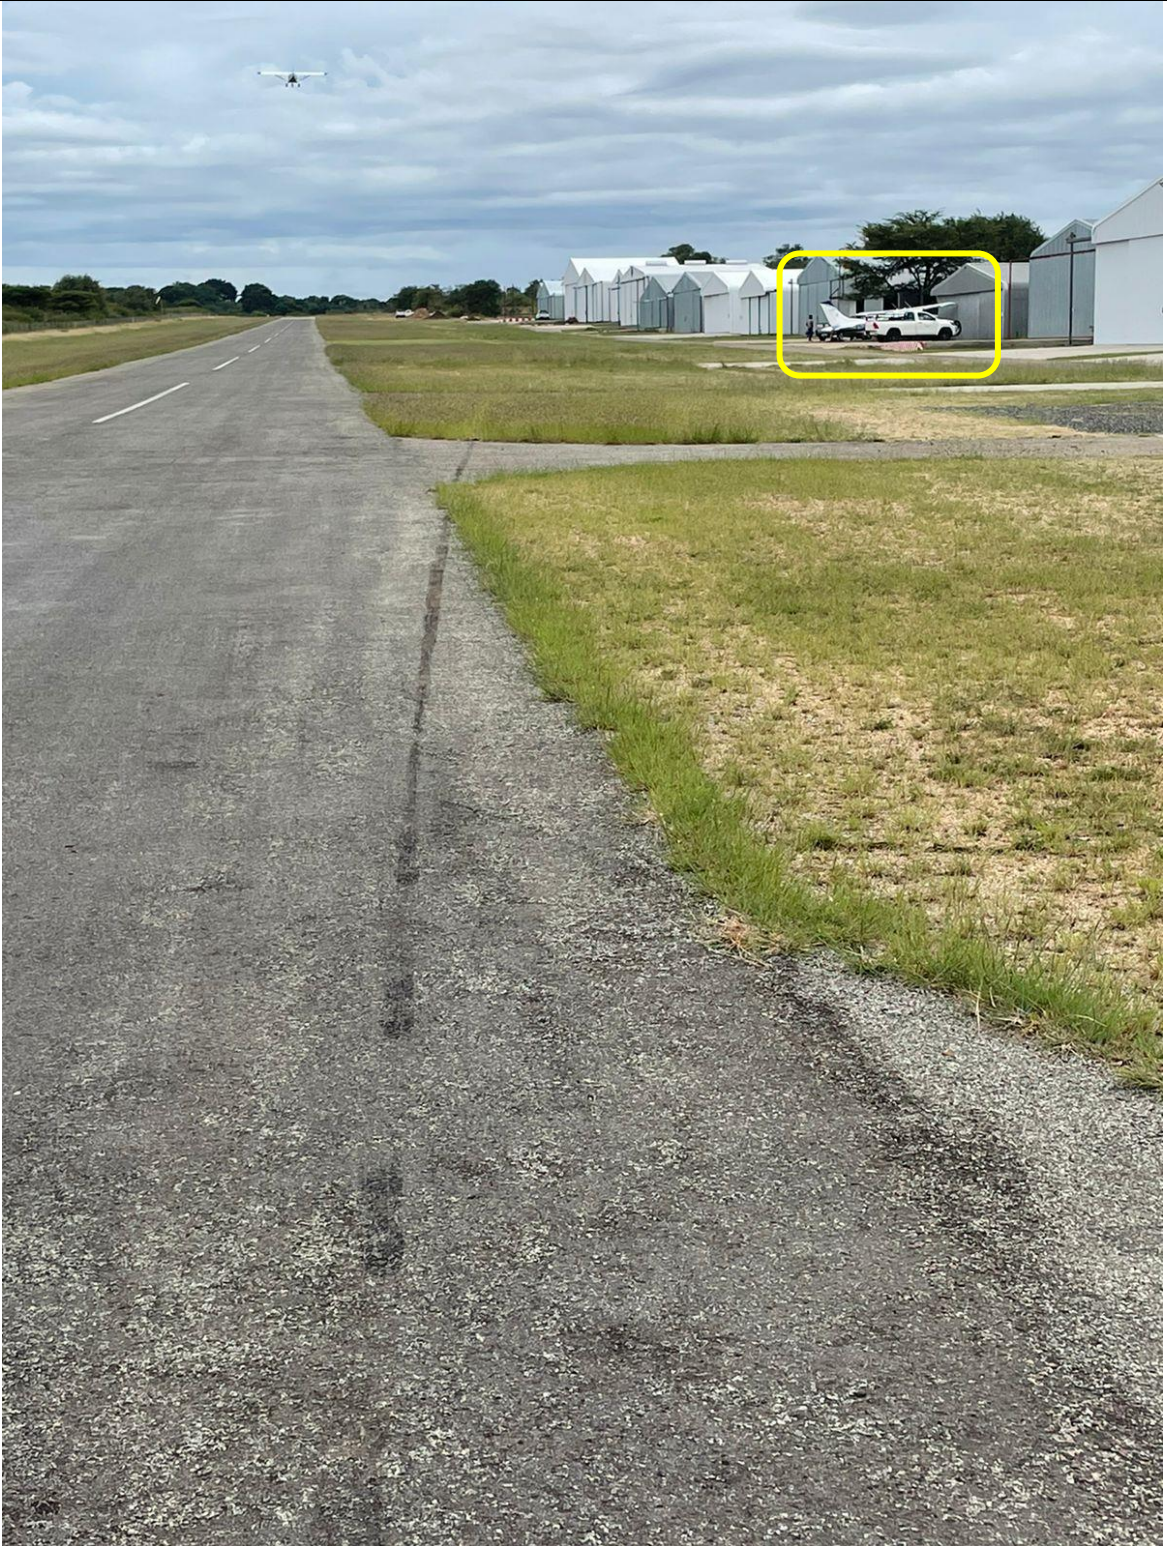
Figure 2: Tyre markings of the right main wheel and the accident aircraft in the yellow window.

The tyre/brake marking of the right wheel from the first touch (on the runway's surface) until impact with the hangar was approximately 260m; a section of the marking could be seen in Figure 2. Figures 3 and 4 show that the pilot had applied brakes until the aircraft impacted the hangar.

- (viii) Fine weather conditions prevailed with a light northerly wind at the time of the flight.
- (ix) No mechanical defect was found that could have contributed or have caused the accident. Both the main wheels turned freely, and the brakes were fully functional after the accident.
- (x) According to the tyre markings, it appeared as if the aircraft contacted the runway surface with its right wheel first.

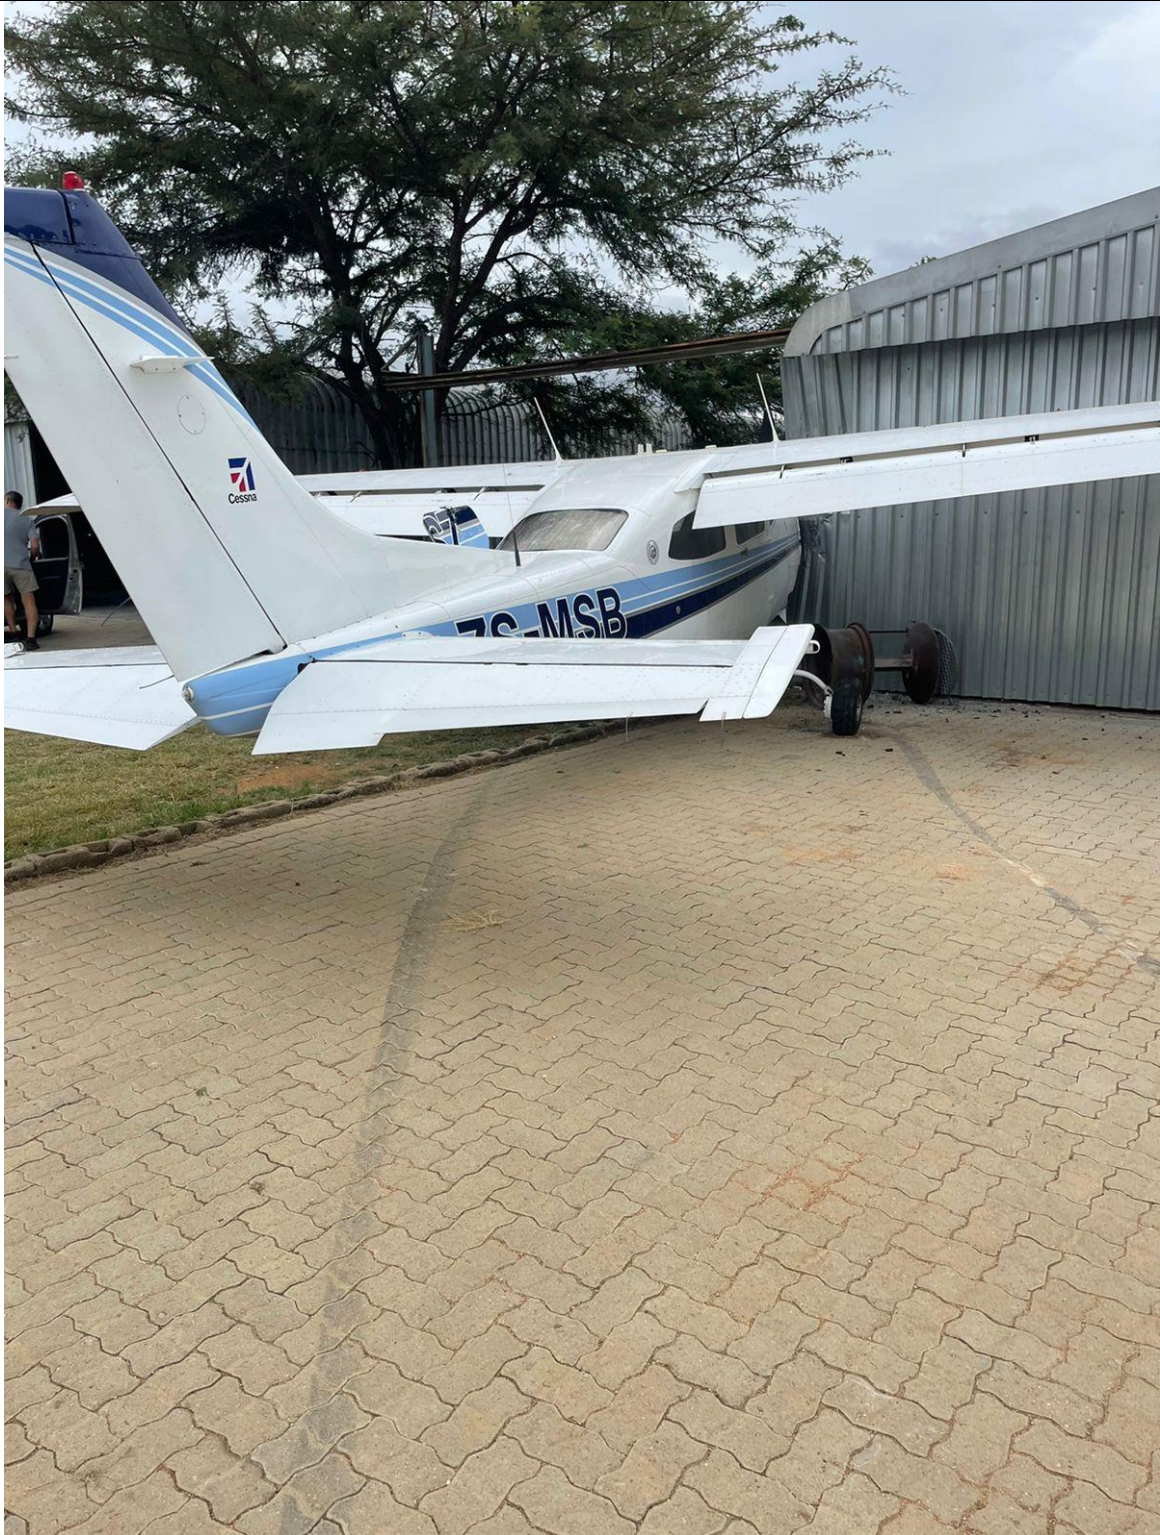
Figure 3: Tyre/brake markings from the left and the right wheels following excessive braking.

The pilot landed with the right brake applied (depressed toe brake) on the rudder pedals; as he applied the left rudder to counteract the right yaw, he most probably applied additional pressure on the right brake, which caused the aircraft to yaw to the right. The pilot was unable to bring the aircraft to a stop and it collided with a hangar.

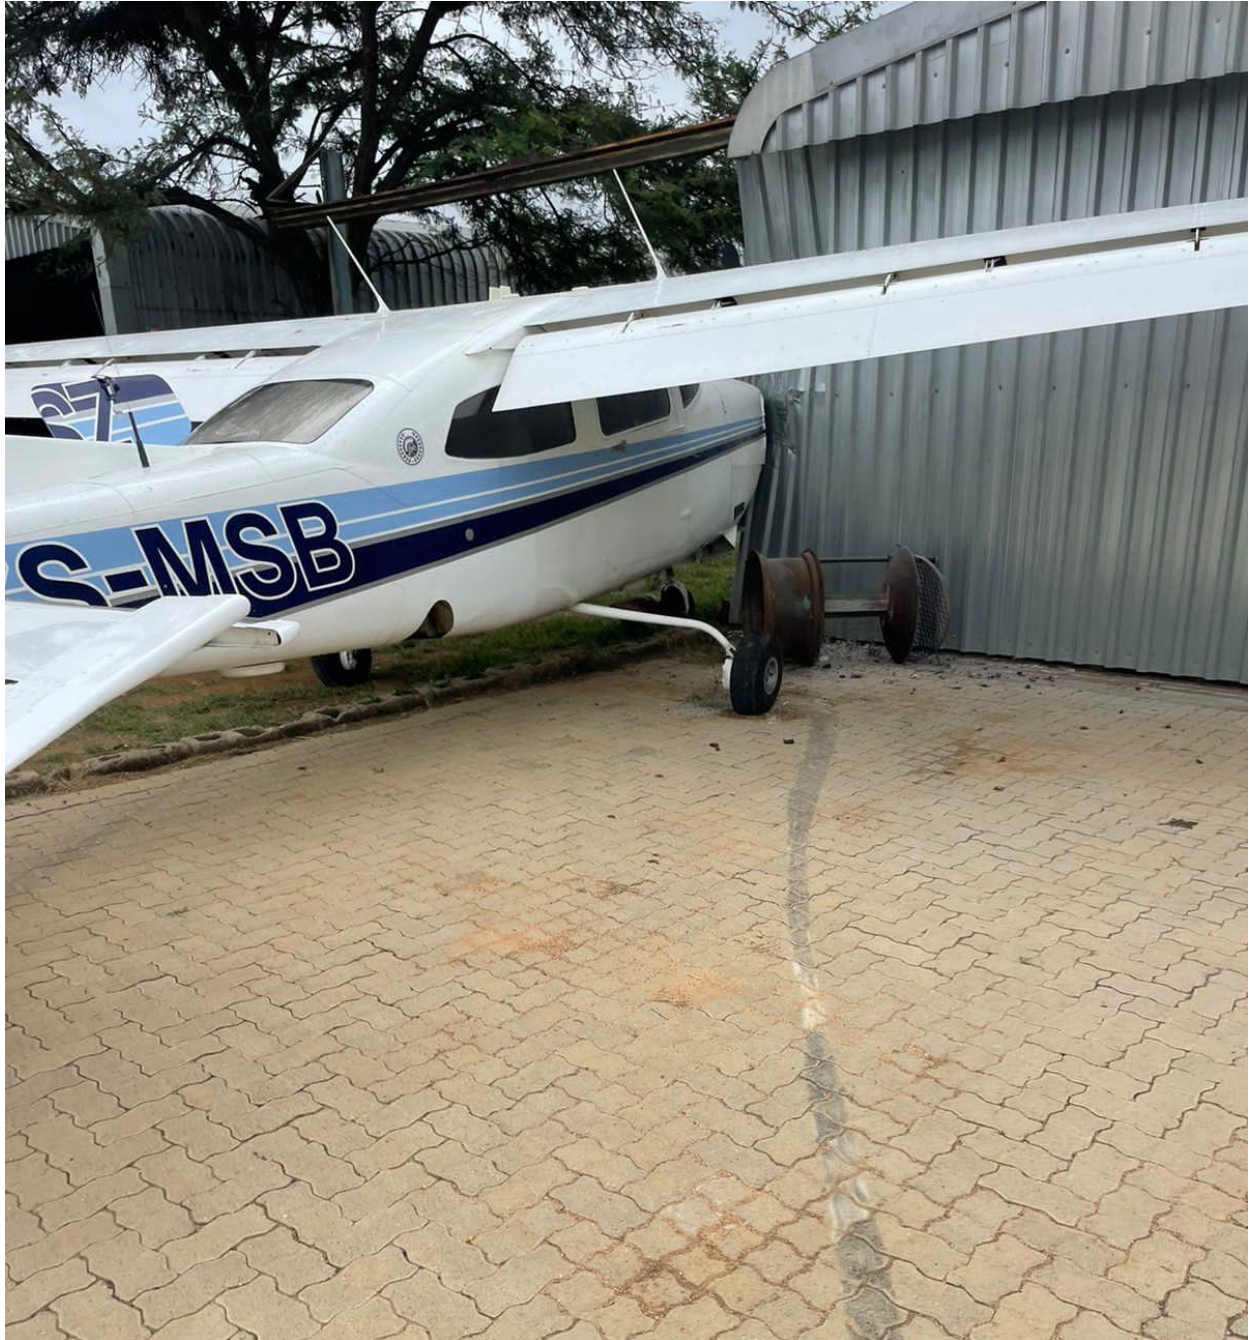
Figure 4: Tyre markings on the paving from the right wheel whilst brakes were applied.

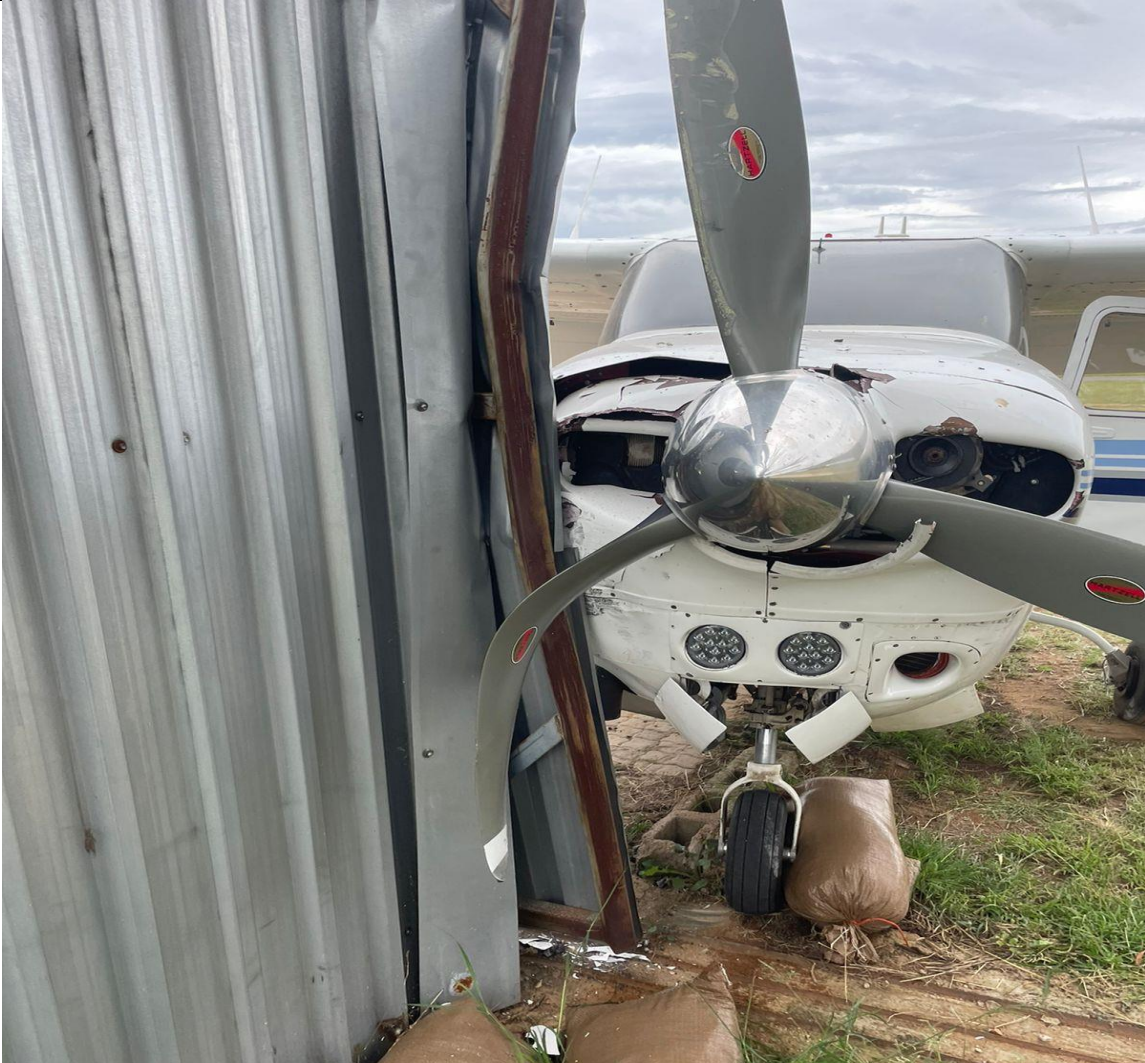
The pilot stated that he was familiar with FAHT as he regularly landed and took off from the aerodrome. The pilot stated that he had selected full wing flaps for landing and shortly after touchdown, the aircraft veered off to the right-side of the runway. He then applied the left rudder, but it had no effect. The pilot was unable to bring the aircraft to a stop and, thus, collided with Hangar Number 28 on the right-side of the runway. The pilot was not injured during the accident sequence; he secured the aircraft post-crash before he disembarked unassisted. The aircraft sustained substantial damage.

Figure 5: A front view of the aircraft after it came to rest.
