LIMITED ACCIDENT INVESTIGATION REPORT

Reference Number	CA18/2/3/10141					
Classification	Accident	Date	15 February 2022	Time	0900Z	
Type of Operation	Training (Part 141)					
Location						
Place of Departure	Wonderboom Airport (FAWB), Gauteng Province		Place of Intended Landing	Wonderboom Airport (FAWB), Gauteng Province		
Place of Accident	Runway 11 FAWB, Gauteng Province					
GPS Co-ordinates	Latitude	S 25° 39' 11"	Longitude	E 28° 12' 52"	Elevation	4045 ft
Aircraft Information						
Registration	ZS-SNS					
Make/Model	Cessna 172M (Serial Number: 17261620)					
Damage to Aircraft	Substantial		Total Aircraft Hours	8740.0		
Pilot-in-command						
Licence Valid	Yes	Gender	Female	Age	20	
Licence Type	Student Pilot Licence (SPL) Aeroplane					
Total Hours on Type	29.8		Total Flying Hours	29.8		
People On-board	1 + 0	Injuries	0	Fatalities	0	Other (On Ground) 0
What Happened

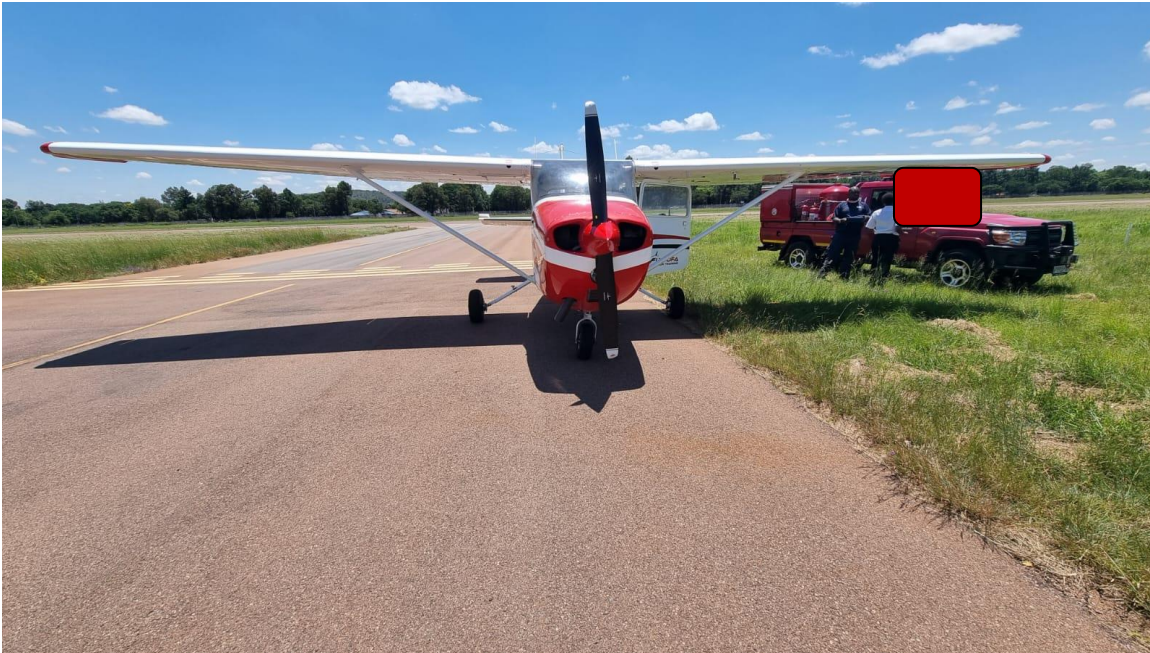
to the nose landing gear, firewall and both propeller blade tips was observed after inspection of the aircraft. The pilot was not injured during the accident.

Figure 1: The damaged propeller tips and the bent nose undercarriage. (Source: Operator)

The aircraft was unstable on approach for landing and it ballooned on touch down before landing on the nose gear first, damaging the nose gear, fire wall and propeller.

The ATO instructed the student pilot to complete a remedial flight with a Grade 2 instructor before continuing with solo flights.

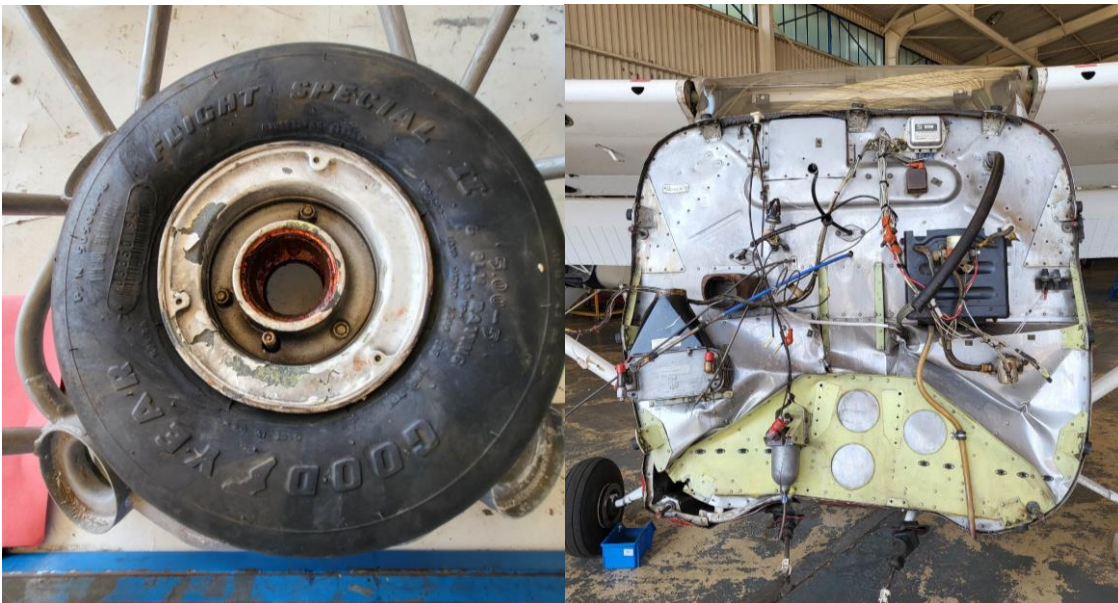
Figure 2: Damage to the nose wheel hub and the firewall.
