**LIMITED ACCIDENT INVESTIGATION REPORT**

<b>Reference Number</b>	CA18/2/3/10142						
<b>Classification</b>	Accident	<b>Date</b>	4 April 2022		<b>Time</b>	0911Z	
<b>Type of Operation</b>	Private (Part 91)						
<b>Location</b>							
Place of Departure	Kromhoek Farm in Odendaalsrus, Free State Province			Place of Intended Landing	Rockridge Farm in Parys, Free State Province		
Place of Accident	Rockridge Farm in Parys						
GPS Co-ordinates	Latitude	26°49'32.5" S	Longitude	27°35'29.4" E	Elevation	4721 feet	
<b>Aircraft Information</b>							
Registration	ZT-RDS						
Make/Model	Schweizer (Hughes) 269C (Serial Number: 460487)						
Damage to Aircraft	Destroyed		Total Aircraft Hours	4 554			
<b>Pilot-in-command</b>							
Licence Type	Private Pilot Licence (PPL) H		Gender	Male		Age	72
Licence Valid	Yes						
Total Hours on Type	536.2		Total Flying Hours	1536.2			
People On-board	1+ 0	Injuries	0	Fatalities	1	Other (on ground)	0
<b>What Happened</b>

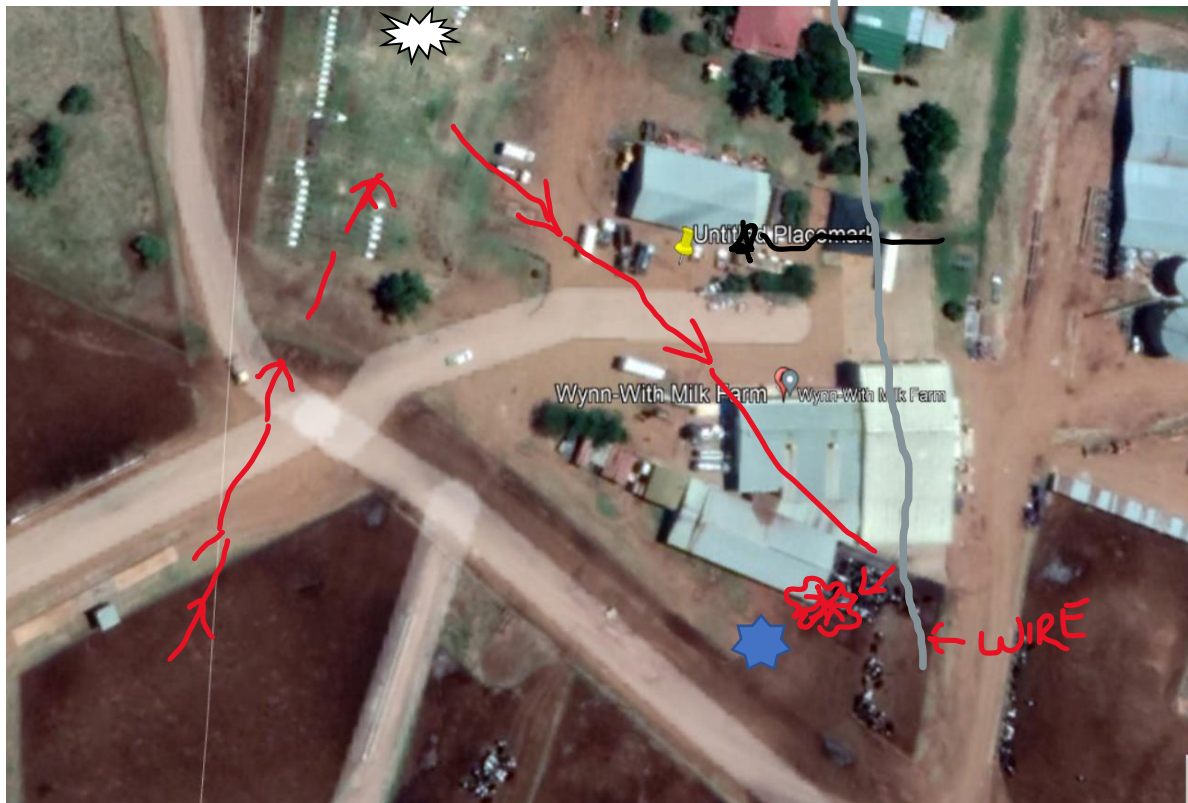
**Figure 1:** The white spot indicates the helicopter's first attempted landing spot. The blue spot indicates the crash site. (Source: Google Earth)

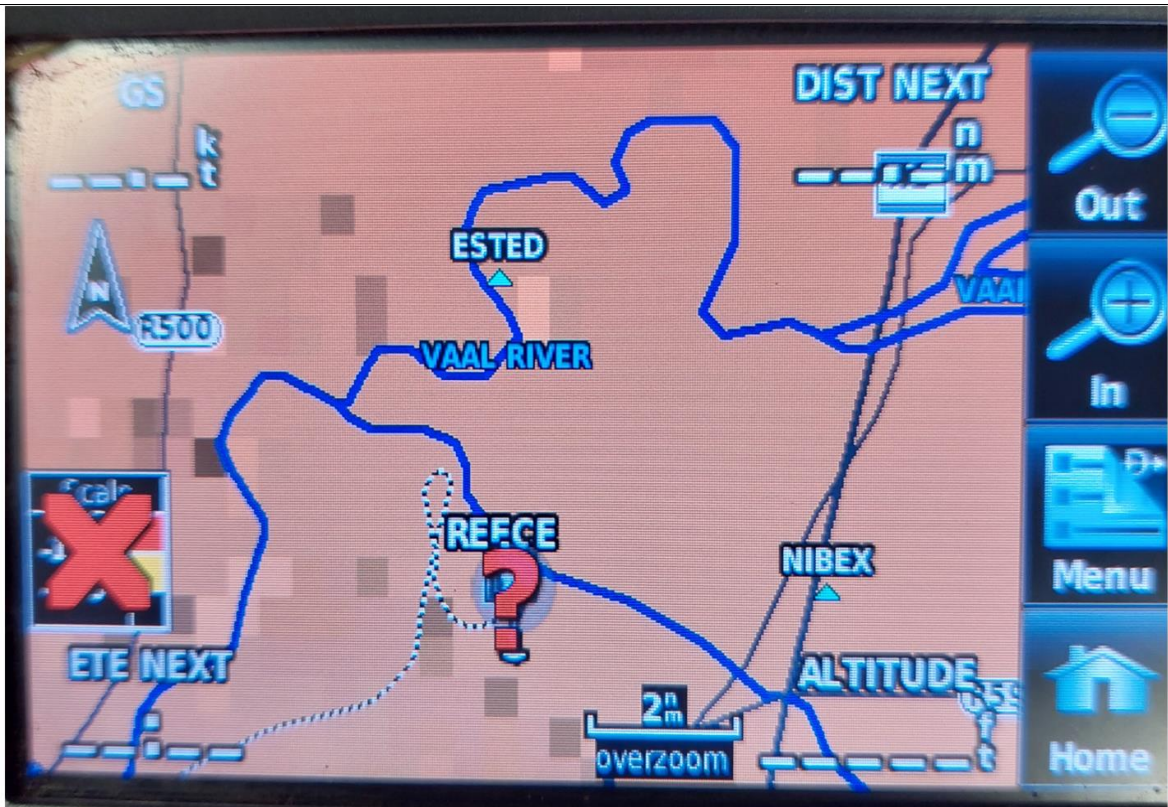
**Figure 2:** The dotted lines indicate the flight path. (Source: Gamini from the cockpit)

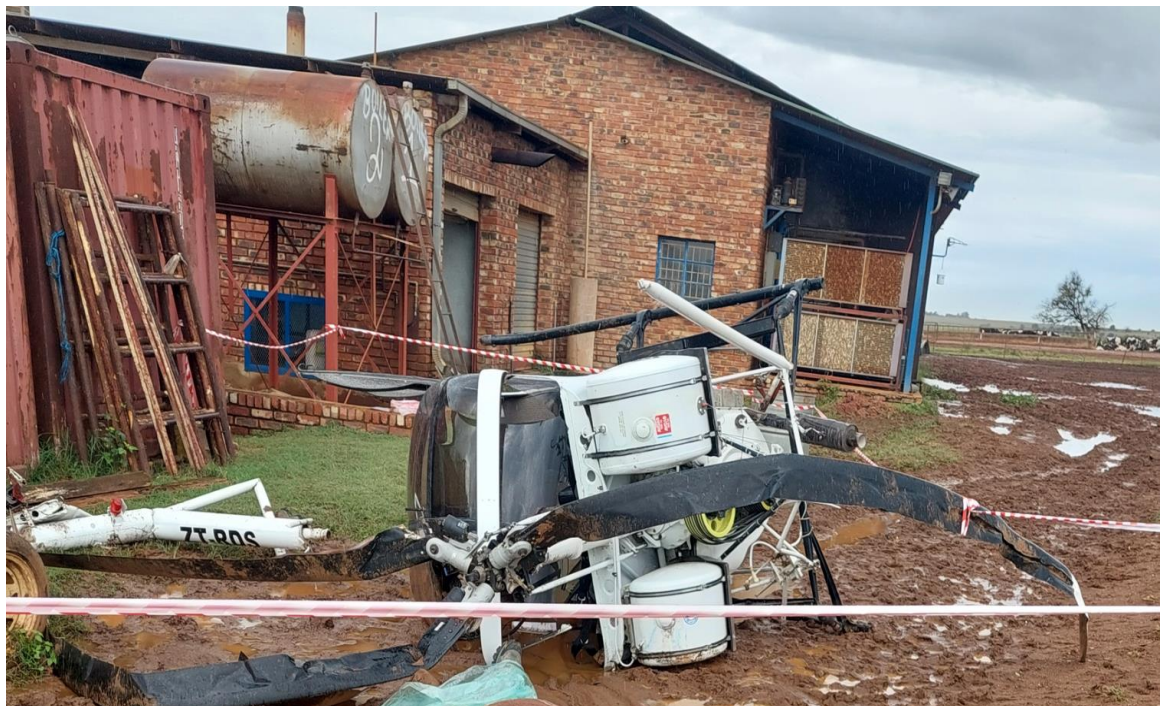
**Figure 3:** The helicopter at the accident site. (Source: Operator)

- During inspection of the accident site, the helicopter was found lying on its left-side with the glass cockpit damaged and the main rotor still attached, but also damaged. The electrical

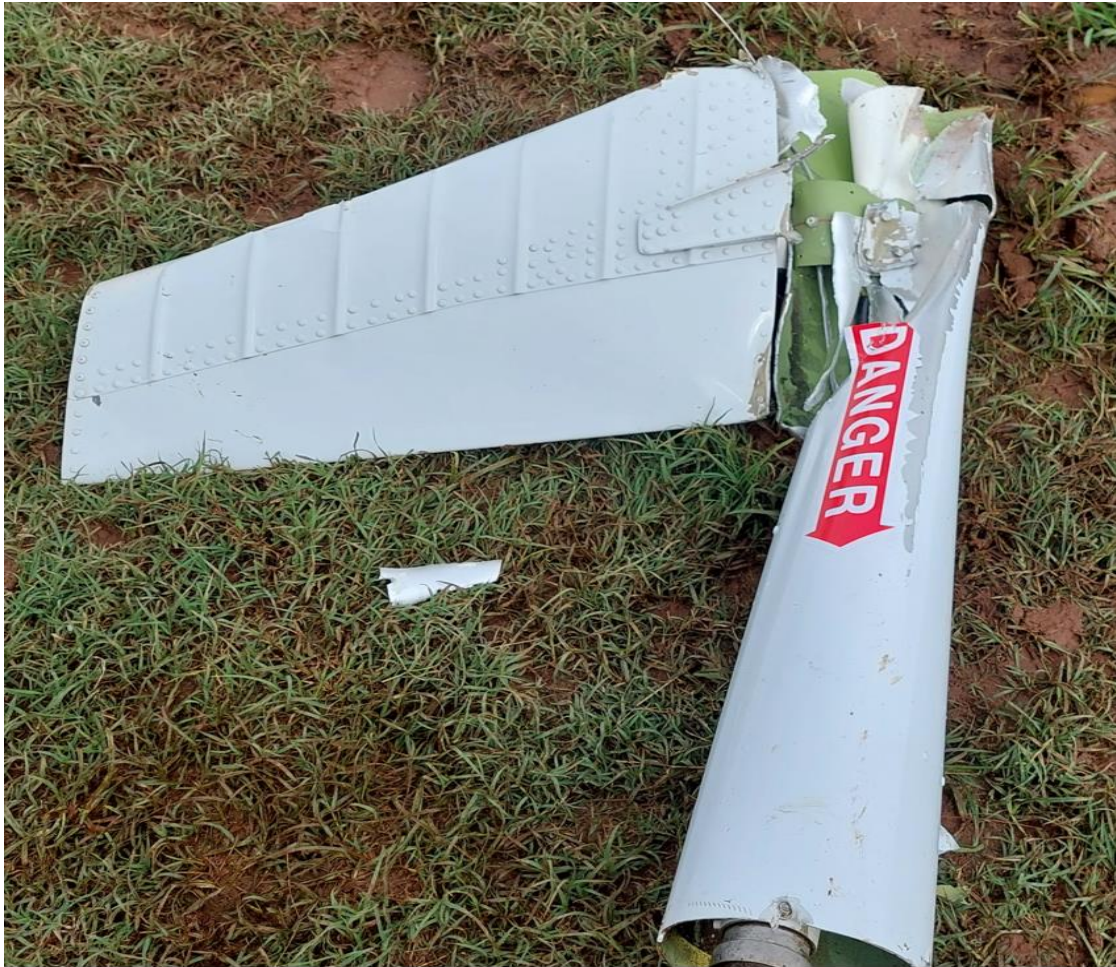
cable severed the tail section from the fuselage, and it was found on the roof of the factory (Figure 4). The height of the cable pole was approximately 12 metres (m); and the severed cable was found nearby.

**Figure 4:** The tail section of the helicopter.

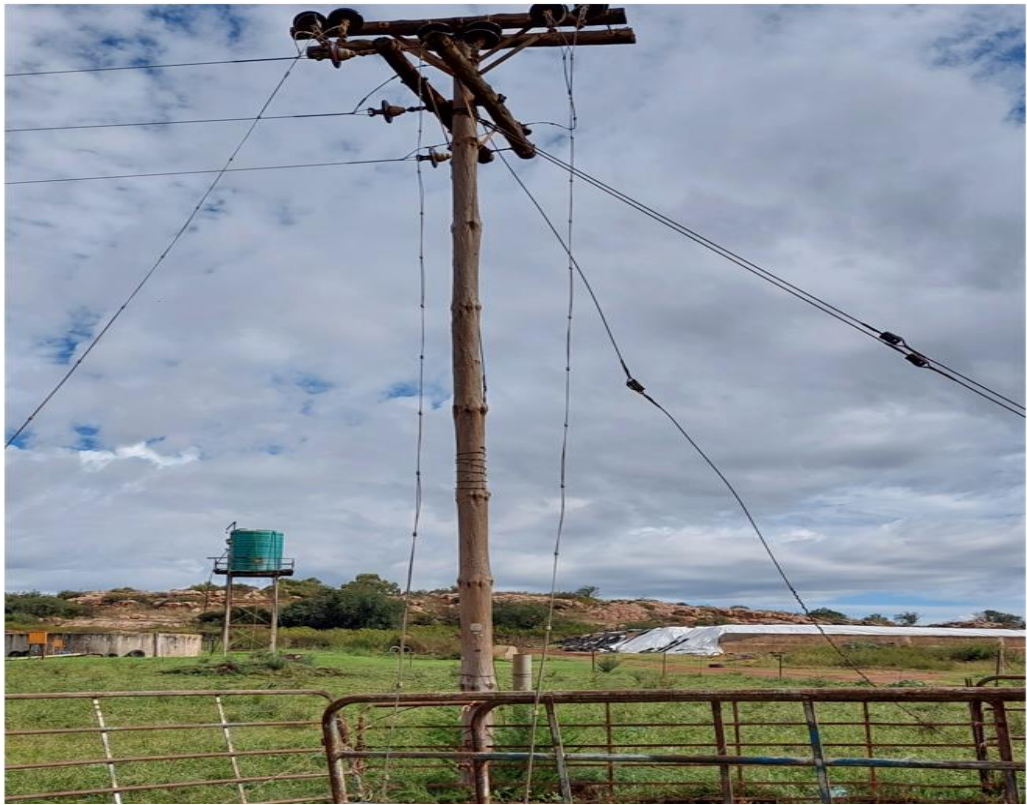
**Figure 5:** The electric cable pole.

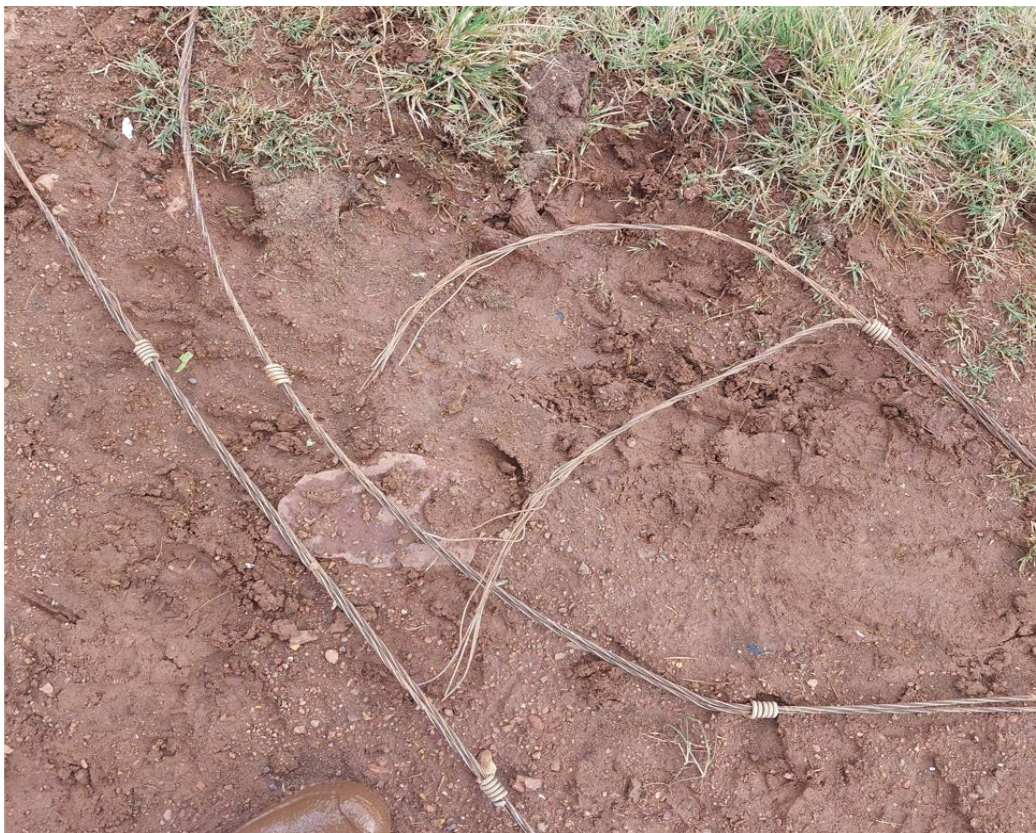
**Figure 6:** The severed cables.
