LIMITED ACCIDENT INVESTIGATION REPORT
--

Reference Number		CA18/2/3/10143					
Classification	Accident	Date	26 March 2022	Time	1400Z		
Type of Operation	Private (Part 94)						
Location							
Place of Departure	Groutville Airfield, KwaZulu-Natal Province		Place of Intended Landing	Groutville Airfield, KwaZulu-Natal Province			
Place of Occurrence	About 300 metres from Umvoti River Mouth, KwaZulu-Natal Province						
GPS Co-ordinates	Latitude	29° 23' 36.38" S	Longitude	31° 20' 10.65" E	Elevation	16 ft	
Aircraft Information							
Registration	ZU-FCN						
Make/Model	Solo Wings CC, Windlass Aquilla Trike (Serial Number: WA1189)						
Damage to Trike	Substantial		Total Aircraft Hours	176 hours			
Pilot-in-command							
Licence Valid	Yes		Gender	Male	Age	48	
Licence Type	National Pilot Licence (NPL)						
Total Hours on Type	1 300 hours		Total Flying Hours	1 300 hours			
People On-board	1 + 1	Injuries	0	Fatalities	0	Other (on ground)	0
What Happened

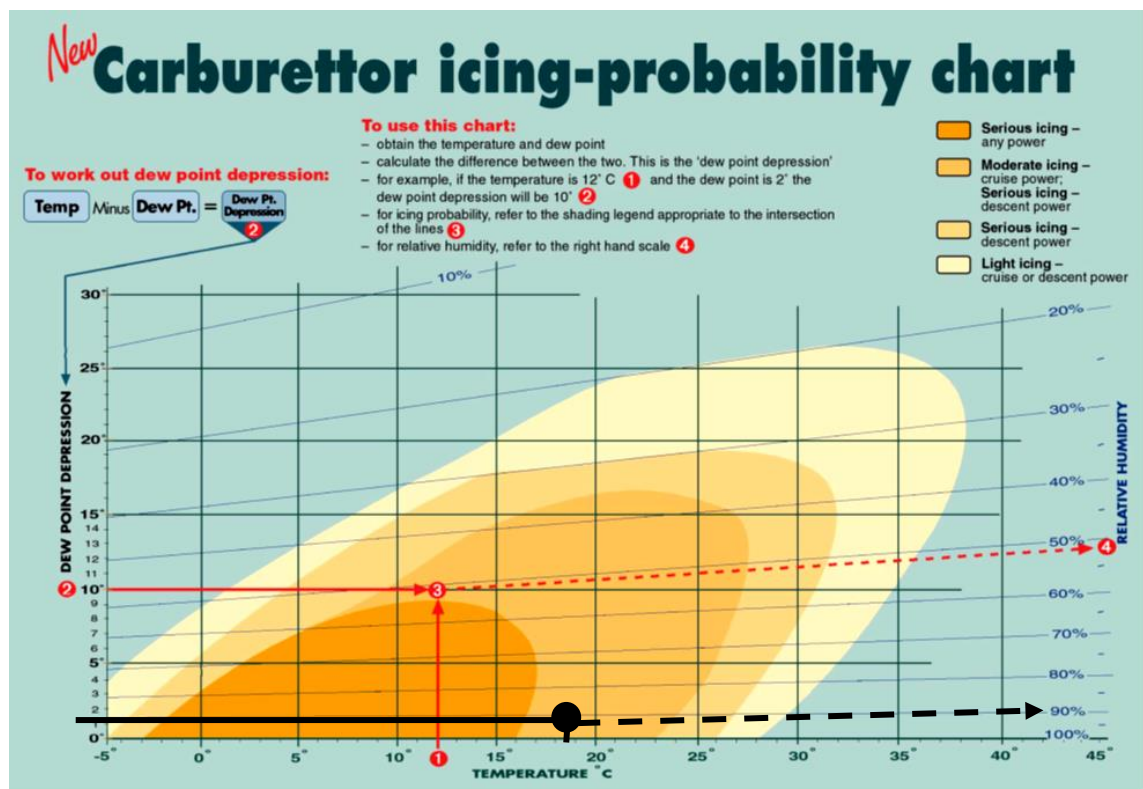
The carburettor icing chart showed that the weather conditions were conducive for moderate icing at cruise power or serious icing at descent power (refer to the black solid and dotted lines, as well as the round spot on the graph below).

Temperature	20 °C
Dewpoint	19 °C
Dewpoint depression	1 °C

Figure 1: The Carburettor Icing-probability Chart.

Engine stoppage whilst in cruise was due to carburettor icing, which led to an unsuccessful forced landing on an open field next to the beach.
