**AIRCRAFT ACCIDENT REPORT AND EXECUTIVE SUMMARY**

<b>Reference:</b>		<b>CA18/2/3/10144</b>	
<b>Aircraft Registration</b>	ZS-AXE	<b>Date of Accident</b>	8 April 2022		<b>Time of Accident</b>	1050Z	
<b>Type of Aircraft</b>	Piper PA-38-112 (Tomahawk)		<b>Type of Operation</b>		Training (Part 141)		
<b>Pilot-in-command Licence Type</b>	Commercial Pilot Licence (CPL)		<b>Age</b>	27	<b>Licence Valid</b>	Yes	
<b>Pilot-in-command Flying Experience</b>	<b>Total Flying Hours</b>		316.7	<b>Hours on Type</b>	137		
<b>Last Point of Departure</b>	Cape Town International Airport (FACT), Western Cape Province						
<b>Next Point of Intended Landing</b>	Cape Town International Airport (FACT), Western Cape Province						
<b>Damage to Aircraft</b>	Substantial						
<b>Location of the accident site with reference to easily defined geographical points (GPS readings if possible)</b>							
Private farm near Diemerskraal Aerodrome at Global Positioning System (GPS) determined to be 33°35'0.10" South 018°54'47.45" East, at 300ft above mean sea level (AMSL)

**Synopsis**

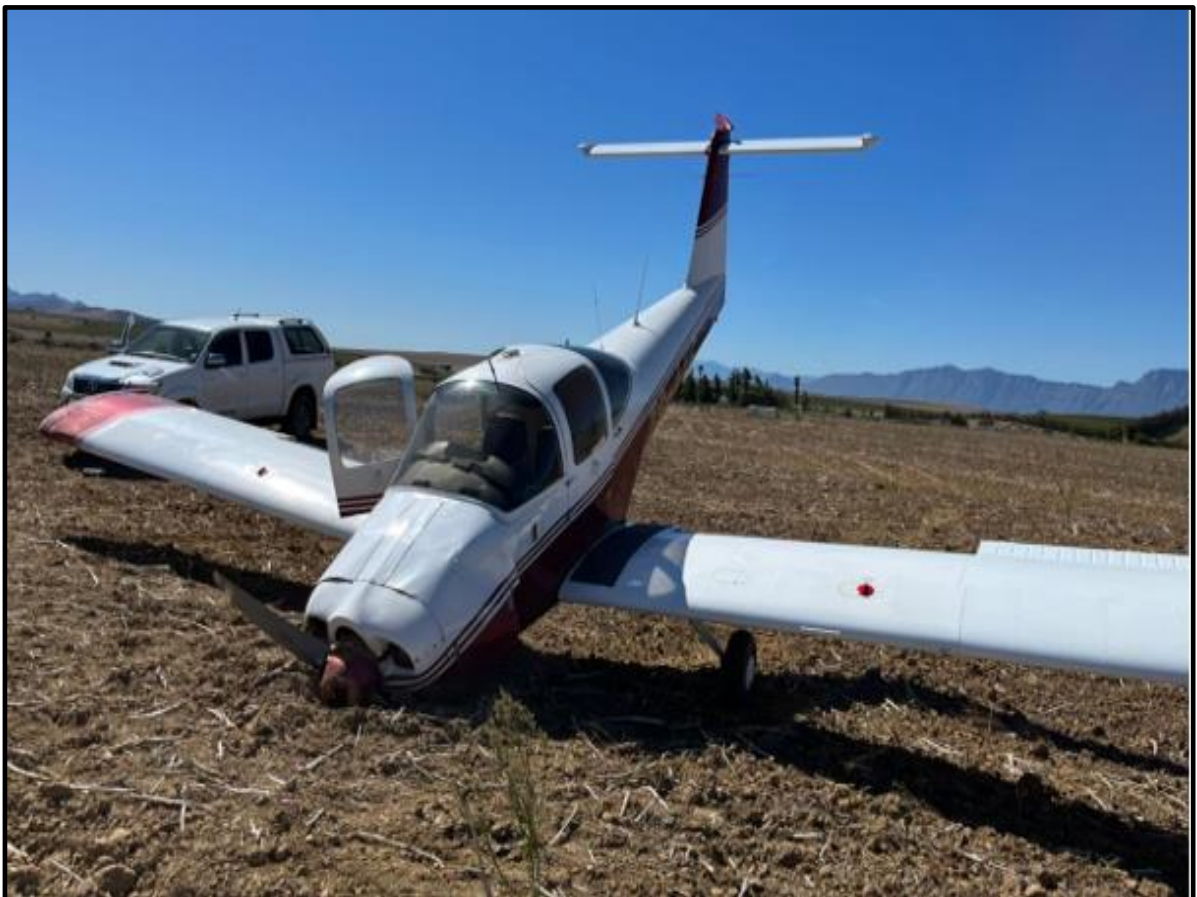
- 1.3.1. The aircraft sustained substantial damage to the nose landing gear and nose section, as well as the propeller hub.

**Figure 2:** The aircraft as it came to rest. (Source: ATO)

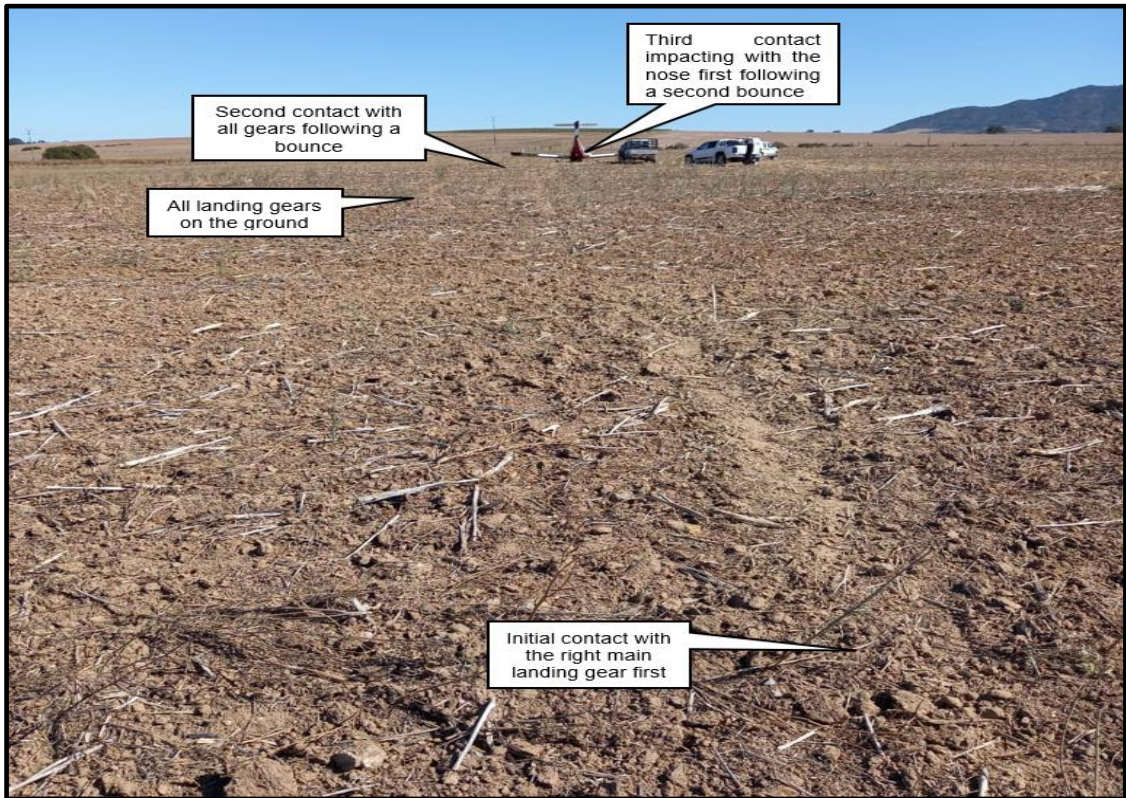
The aircraft accident occurred on an open field in a private farm with an uneven surface. The ground surface had plough lanes which were perpendicular at 90° (degree) to the aircraft's landing path.

**Figure 4:** The aircraft's ground markings during the accident. (Source: Operator)

- Initially, the aircraft contacted the ground with its right main landing gear first and rolled for 17 metres (m) before both the left gear and the nose gear hit the ground and continued to roll for approximately 7m; then the aircraft bounced. The second contact was with all three landing gears, and the aircraft continue to roll for approximately 5m before it bounced again. On the third contact with the ground, the aircraft impacted the ground with the nose first, which caused the nose landing gear to bend backwards. The aircraft came to a stop in a nose-down attitude.

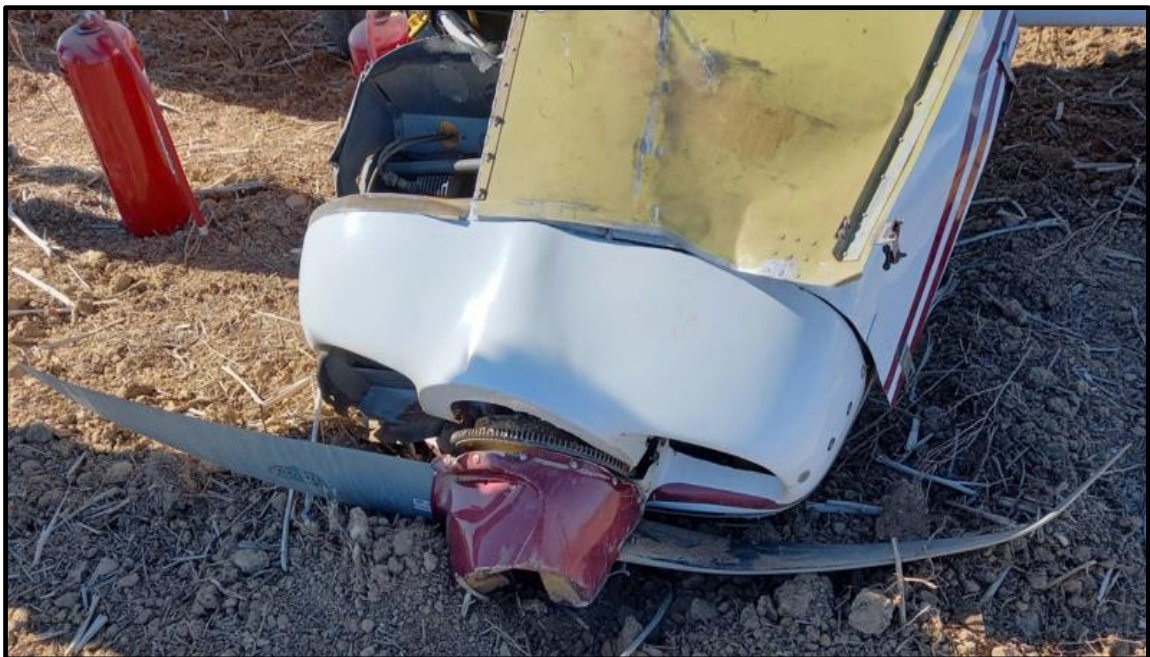
**Figure 5:** The damaged propeller hub and propeller blades.

- The propeller hub and the nose section sustained substantial damage due to impact with the ground during the accident sequence. One of the propeller blades was bent. The damage on the propeller blade was consistent with the propeller that was not turning or windmilling at the time of impact with the ground.

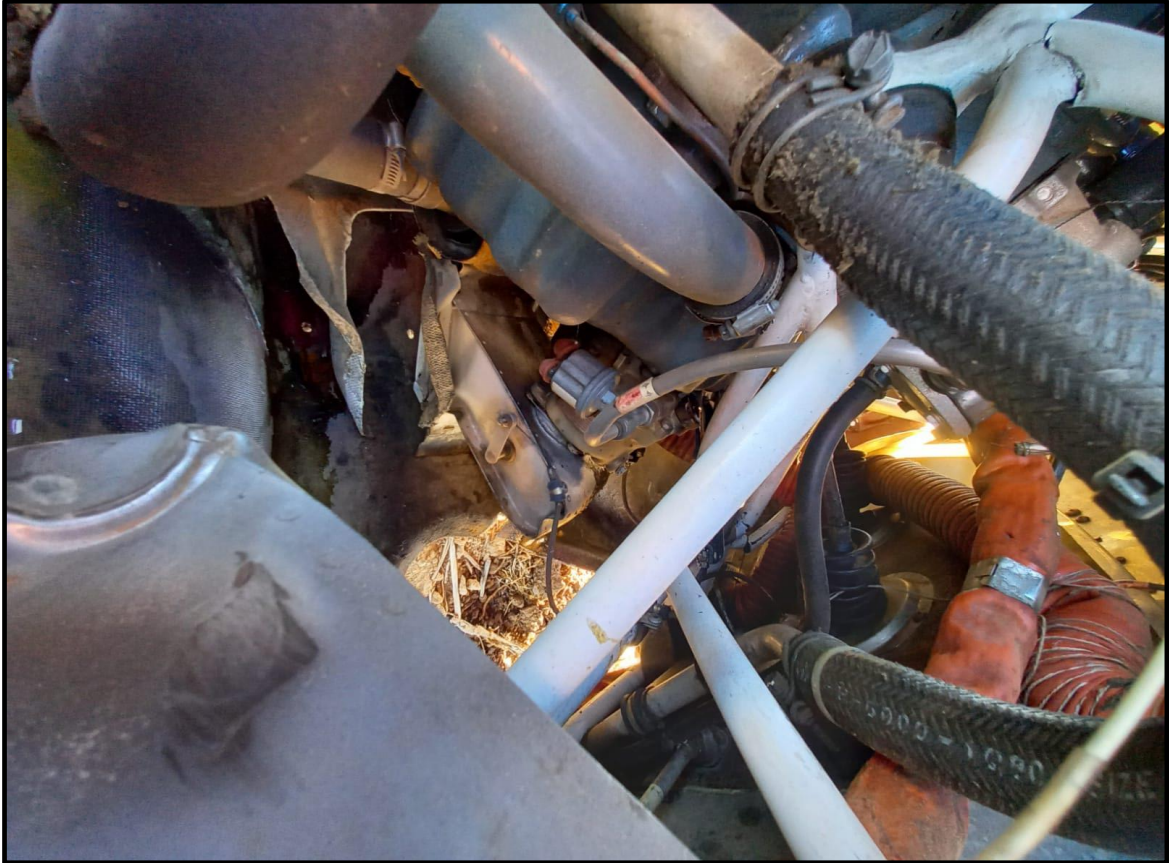
**Figure 6:** Damages sustained in the engine compartment and the bent engine mountings.

- The engine compartment, firewall and the engine mountings sustained impact damages.
- The nose landing gear was observed bent backwards and was damaged further when it thrust (jabbed) into the bottom part of the nose compartment.
- There was evidence of fuel leak from the bottom of the fuselage. The damage around the area where fuel was leaking could be associated with damage caused during the accident sequence.
