LIMITED ACCIDENT INVESTIGATION REPORT
--

Reference Number	CA18/2/3/10145						
Classification	Accident	Date	15 April 2022	Time	1745Z		
Type of Operation	Private (Part 94)						
Location							
Place of Departure	Brakpan Aerodrome (FABB), Gauteng Province		Place of Intended Landing	Brakpan Aerodrome (FABB), Gauteng Province			
Place of Accident	Area (grass surface) between Runway 36 and 03 threshold at FABB, Gauteng Province						
GPS Co-ordinates	Latitude	26°14'31.51" S	Longitude	28°18'08.98" E	Elevation	5 346 feet	
Aircraft Information							
Registration	ZS-BGL						
Model/Make	De Haviland Tiger Moth (Serial Number: T7852)						
Damage to Aircraft	Substantial		Total Aircraft Hours	4 920.7			
Pilot-in-command							
Licence Type	Private Pilot Licence (PPL) Aeroplane	Gender	Female		Age	51	
Licence Valid	Yes						
Total Hours on Type	150		Total Flying Hours	1 677.1			
People On-board	1 + 1	Injuries	0	Fatalities	0	Other (on ground)	0
What Happened

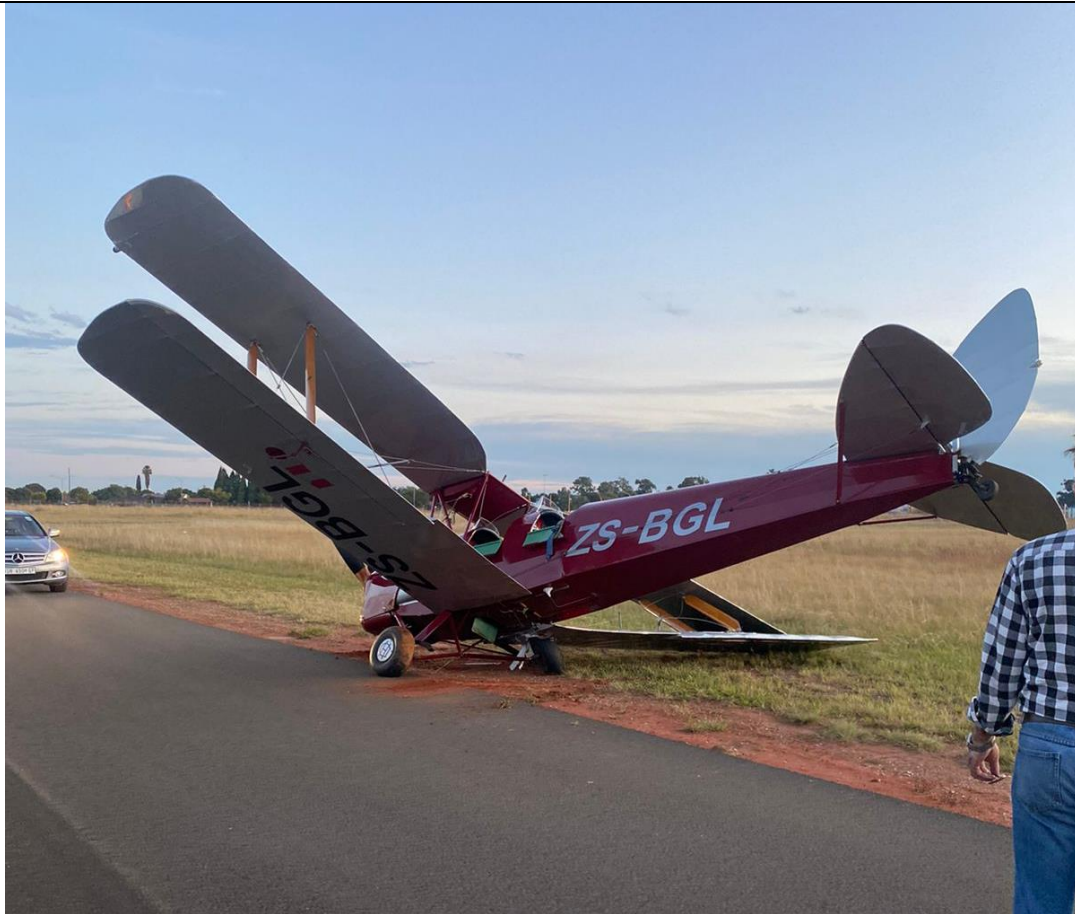
brakes. When the aircraft was abeam the windsock of Runway 03 and approximately 100ft AGL, the engine stopped without warning or spluttering and lost height as the indicated airspeed was 95 miles per hour (mph) at that time. The pilot then turned left to stay within the airfield boundary and, this time, she planned to land on Runway 36. However, she could not make it to Runway 36 and, thus, landed on the grass area between Runway 03 and 36 thresholds. The aircraft landed hard and, as a result, the right landing gear broke and the right wing impacted the ground. Thereafter, the aircraft skidded for approximately 20m before it came to a stop. The aircraft was substantially damaged, and the pilot and the passenger were not injured.

Figure 2: The aircraft as it came to rest. (Source: Pilot)

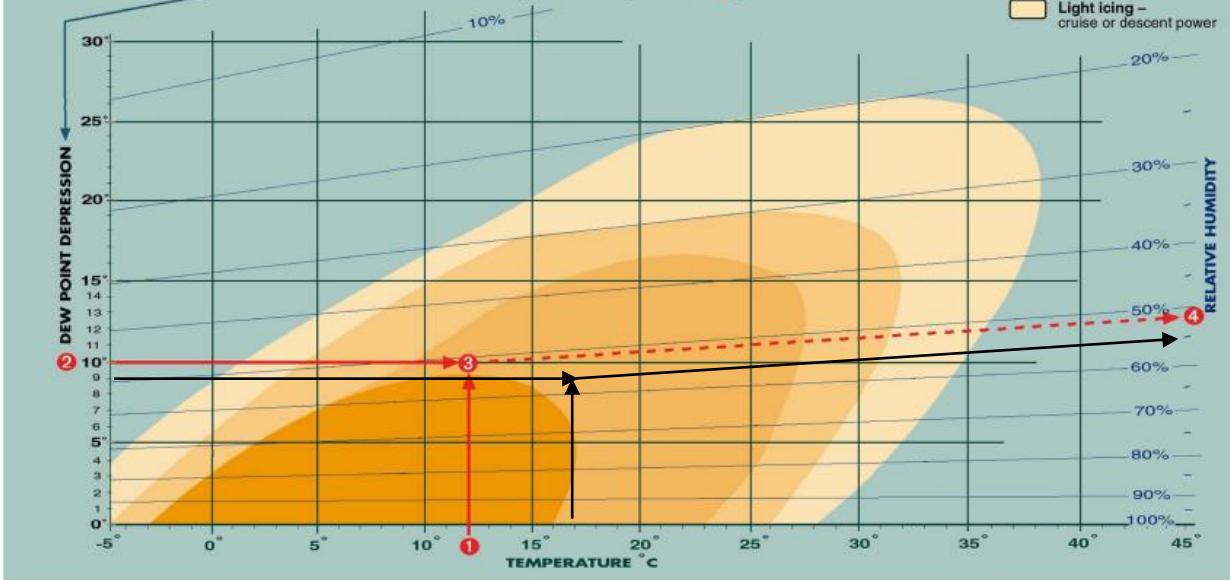
New Carburettor icing-probability chart

- A weather report was obtained from the South African Weather Service which stated that the temperature was 17°C and the dew point was 8°C on the day. The dew point depression was calculated to be 9°C, whilst the relative humidity was at 55%. Thus, according to the Carburettor Icing-probability Chart, the icing probability was serious at descent power (see Figure 3).

- The carburettor was blocked by ice build-up (ice particles). Therefore, the engine was starved of fuel which resulted in engine stoppage.

Figure 3: The Carburettor Icing-probability Chart.
(Source: https://www.atsb.gov.au/media/47763/carb_icing.pdf)

Engine stoppage during descent as a result of ice formation in the carburettor, which blocked fuel flow to the engine.

Pilots are reminded to consider the effects of carburettor icing when operating in cooler weather conditions and when planning flights.
