LIMITED ACCIDENT INVESTIGATION REPORT

Reference Number	CA18/2/3/10146						
Classification	Accident	Date	21 April 2022	Time	0800Z		
Type of Operation	Private (Part 91)						
Location							
Place of Departure	Eike Farm in Standerton, Mpumalanga Province		Place of Intended Landing	Wonderboom Aerodrome (FAWB), Gauteng Province			
Place of Accident	Private Farm in Brakspruit, Mpumalanga Province						
GPS Co-ordinates	Latitude	S 26° 56' 24.4"	Longitude	E 029° 08' 51.5"	Elevation	5100 ft	
Aircraft Information							
Registration	ZS-TCG						
Model/Make	Cessna T210N (Serial Number: 210-63438)						
Damage to Aircraft	Substantial		Total Aircraft Hours	3342.5			
Pilot-in-command							
Licence Type	Private Pilot Licence	Gender	Male		Age	41	
Licence Valid	Yes						
Total Hours on Type	14.7		Total Flying Hours	212.15			
People On-board	1+0	Injuries	0	Fatalities	0	Other (on ground)	0
What Happened							
<p>On 21 April 2022 at approximately 0800Z, a pilot on-board a Cessna T210N Centurion aircraft with registration ZS-TCG took off on a private flight from Runway 09 at Die Eike Private Farm Airstrip, situated 7 kilometres (km) west of Standerton in Mpumalanga province. The pilot intended to

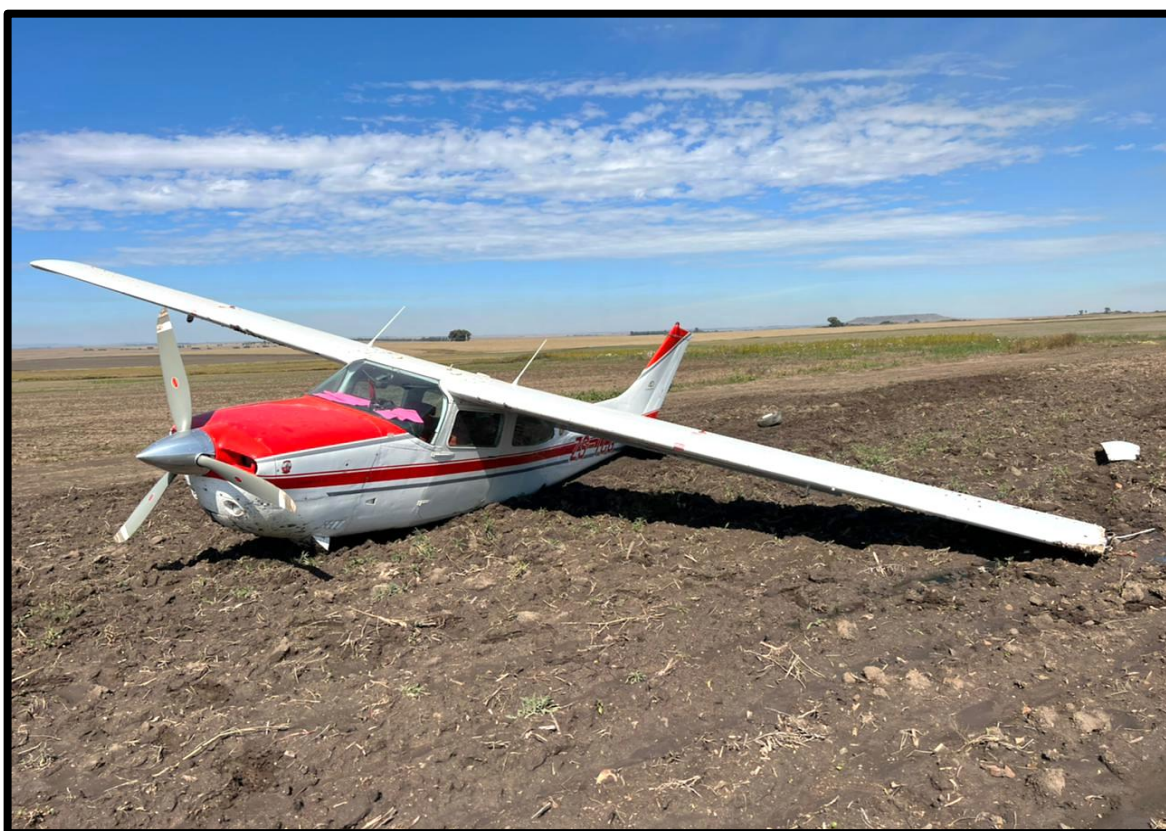
According to the pilot, after touchdown and during the landing roll, the aircraft's left main gear collided with a rock and broke off. As a result, the aircraft's left wing dropped, and the left aileron made contact with the ground and broke off. The aircraft veered off to the left-side of the gravel road and onto the cultivated area. During this process, the nose gear collapsed and the propeller contacted the ground with its blade tips. Thereafter, the aircraft slid on the ground until it came to a stop approximately 40 metres (m) from the initial touchdown point facing north-east.

The aircraft was substantially damaged during the accident sequence, and the pilot was not injured.

Figure 1: The aircraft at the accident site. (Source: Pilot)
