LIMITED ACCIDENT INVESTIGATION REPORT

Reference Number		CA18/2/3/10148					
Classification	Accident	Date	26 April 2022		Time	1410Z	
Type of Operation		Training (Part 141)					
Location							
Place of Departure		Springs Aerodrome (FASI), Gauteng Province		Place of Intended Landing		Springs Aerodrome (FASI), Gauteng Province	
Place of Accident		FASI's boundary concrete palisade fencing at the end of Runway 21					
GPS Co-ordinates	Latitude	S26°15'19.88"	Longitude	E028°23'50.12"	Elevation	5 364ft	
Aircraft Information							
Registration		ZS-BFC					
Make/Model		Piper PA-28-180 Cherokee (Serial Number: 28-7305276)					
Damage to Aircraft		Substantial		Total Aircraft Hours		3641.1	
Pilot-in-command							
Licence Valid		Yes		Gender		Female	
						Age	
						31	
Licence Type		Commercial Pilot Licence (Aeroplane)					
Total Hours on Type		420.2		Total Flying Hours		1431	
People On-board	1+1	Injuries	0	Fatalities	0	Other (On Ground)	0
What Happened

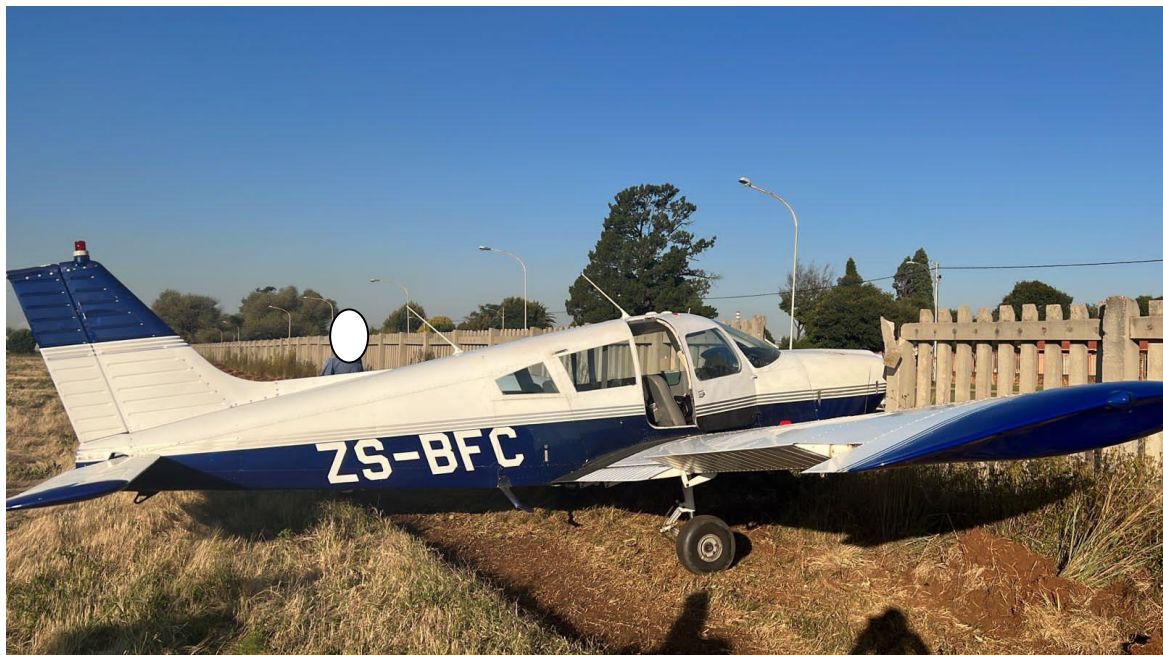
Figure 1: The aircraft as it came to rest. (Source: Instructor)

The aircraft collided with the aerodrome’s palisade concrete fence following a rejected take-off.

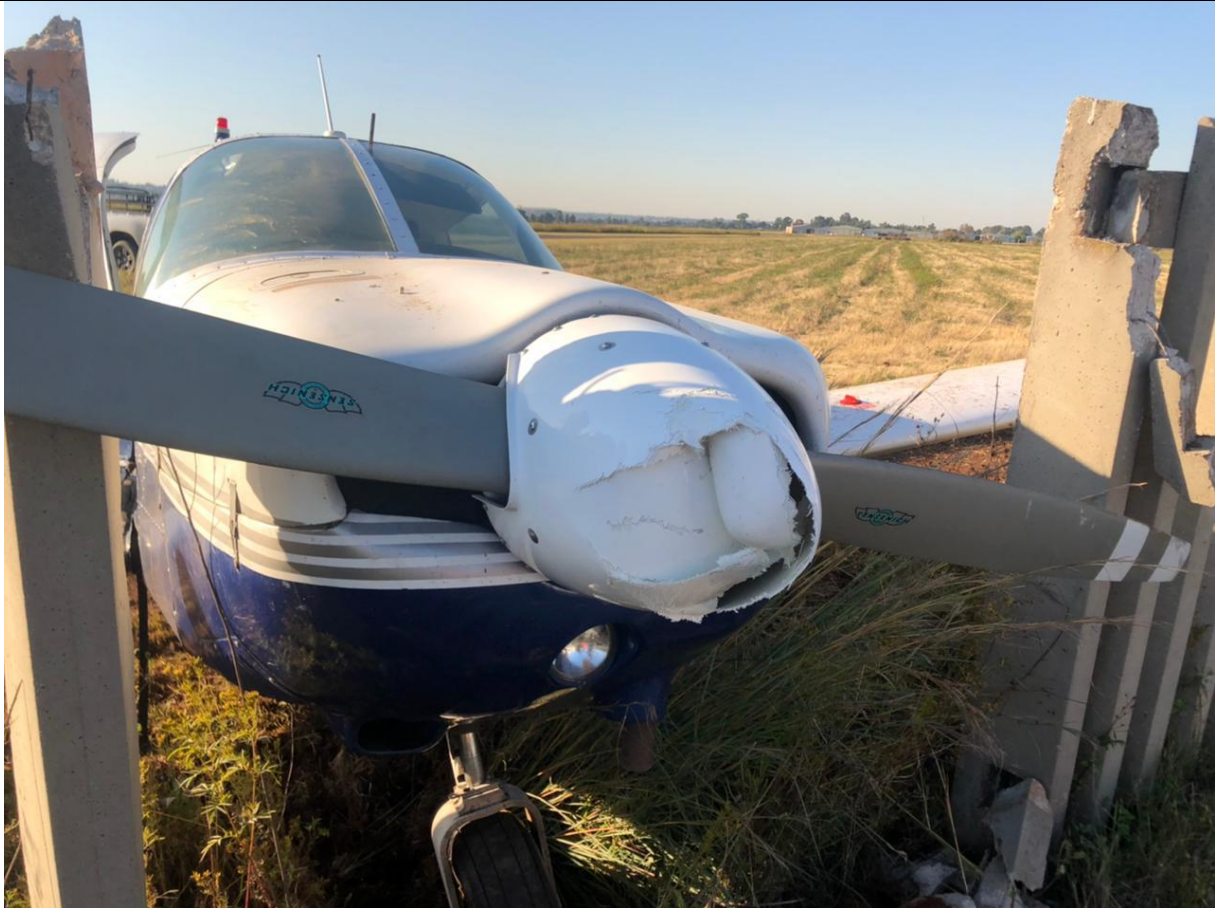
Figure 2: The nose of the aircraft against the aerodrome's concrete palisade fence. (Source: Instructor)

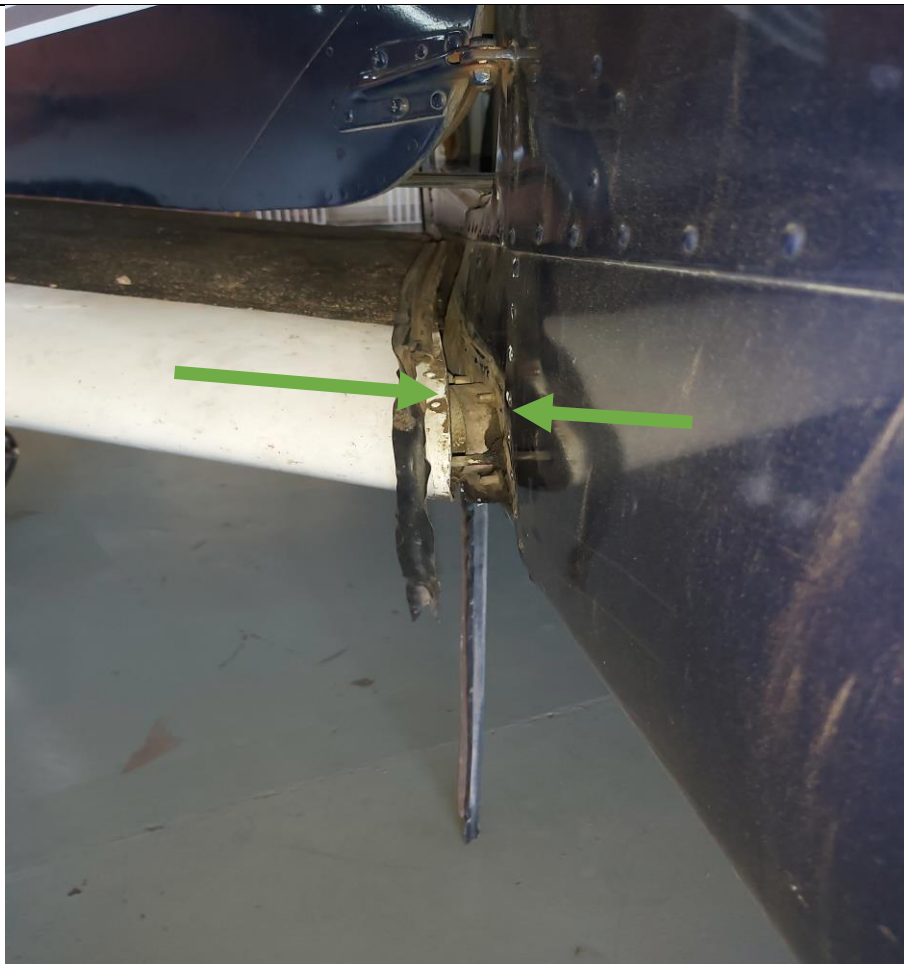
Figure 3: Arrows showing separation of the right-side wing from the fuselage.

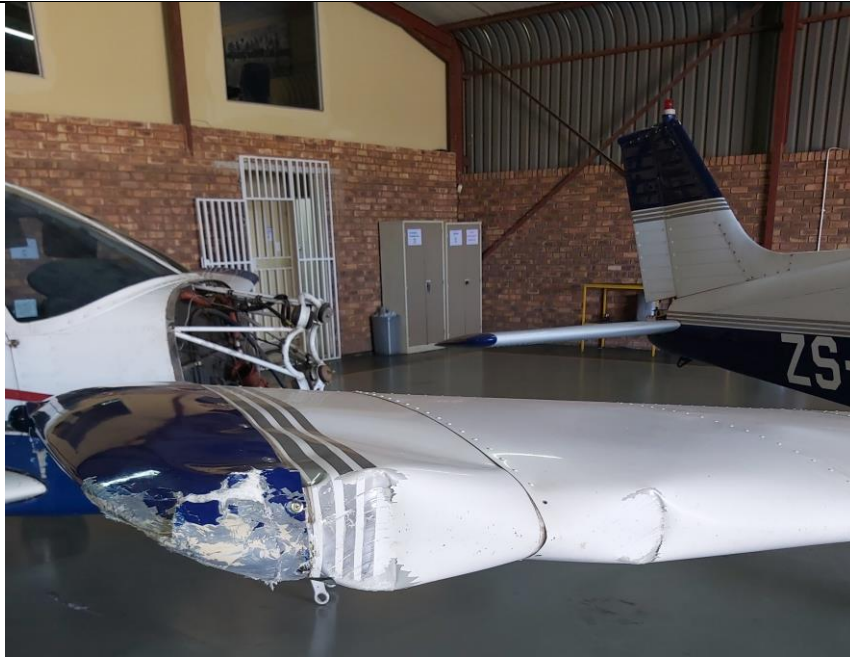
Figure 4: Damage to the right wing leading edge outboard.

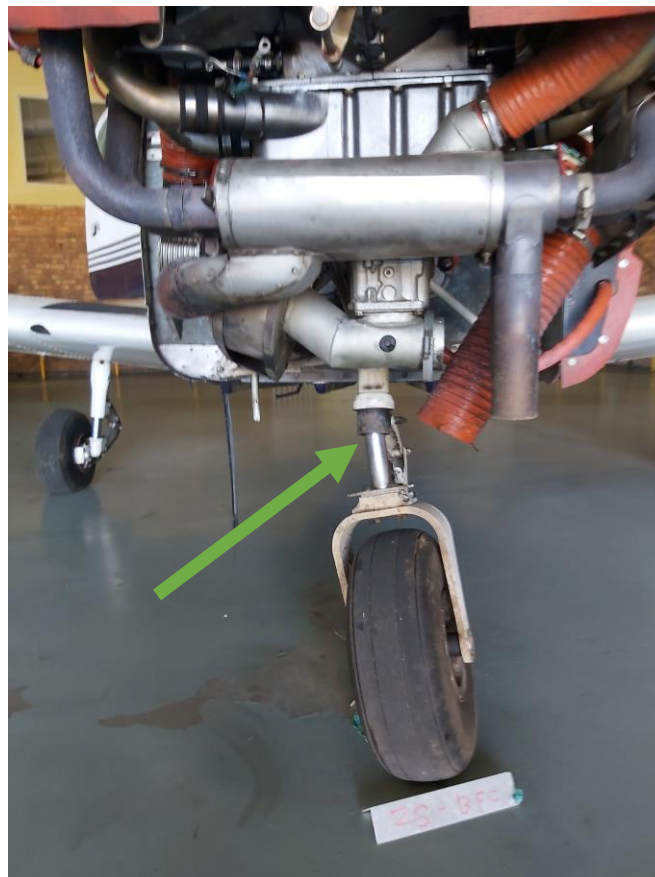
Figure 5: Arrow showing the bent nose landing gear shock absorber.

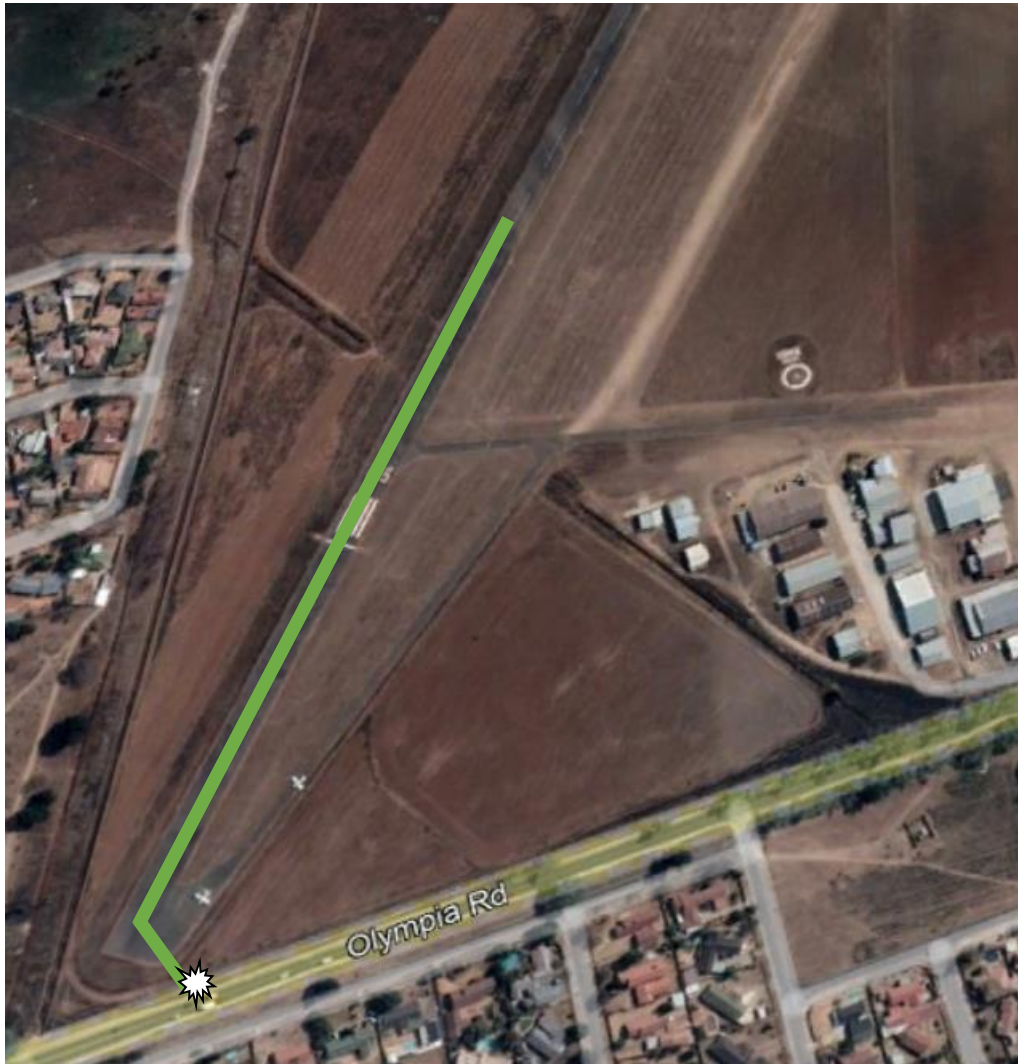
Figure 6: The line shows the path of the aircraft from touchdown until it collided with the palisade fence. (Source: Google earth)

A late decision to reject take-off was made as the aircraft was already near the end of the runway at maximum power; the duo could not bring the aircraft to a halt.
