**LIMITED ACCIDENT INVESTIGATION REPORT**

<b>Reference Number</b>	CA18/2/3/10149						
<b>Classification</b>	Accident	<b>Date</b>	28 April 2022		<b>Time</b>	1525Z	
<b>Type of Operation</b>	Private (Part 94)						
<b>Location</b>							
Place of Departure	Kitty Hawk Aerodrome (FAKT), Gauteng Province		Place of Intended Landing	Kitty Hawk Aerodrome (FAKT), Gauteng Province			
Place of Accident	Runway 01 at FAKT, Gauteng Province						
GPS Co-ordinates	Latitude	25° 51'.42 S	Longitude	28° 26'.49 E	Elevation	4 586ft	
<b>Aircraft Information</b>							
Registration	N-818WT						
Make/Model	Giles G-202 (Serial Number: 0030)						
Damage to Aircraft	Substantial		Total Aircraft Hours	773.8			
<b>Pilot-in-command</b>							
Licence Type	Private Pilot Licence		Gender	Male		Age: 44	
Licence Valid	Yes						
Total Hours on Type	63.6		Total Flying Hours	264.7			
People On-board	2 + 0	Injuries	0	Fatalities	0	Other (On ground)	0
<b>What Happened</b>							
<p>On Thursday afternoon, 28 April 2022 at approximately 1445Z, two pilots on-board a Giles G-202 aircraft with registration N-818WT took off from Kitty Hawk Aerodrome (FAKT), located south-east of Pretoria in Boschkop, Gauteng province, with th

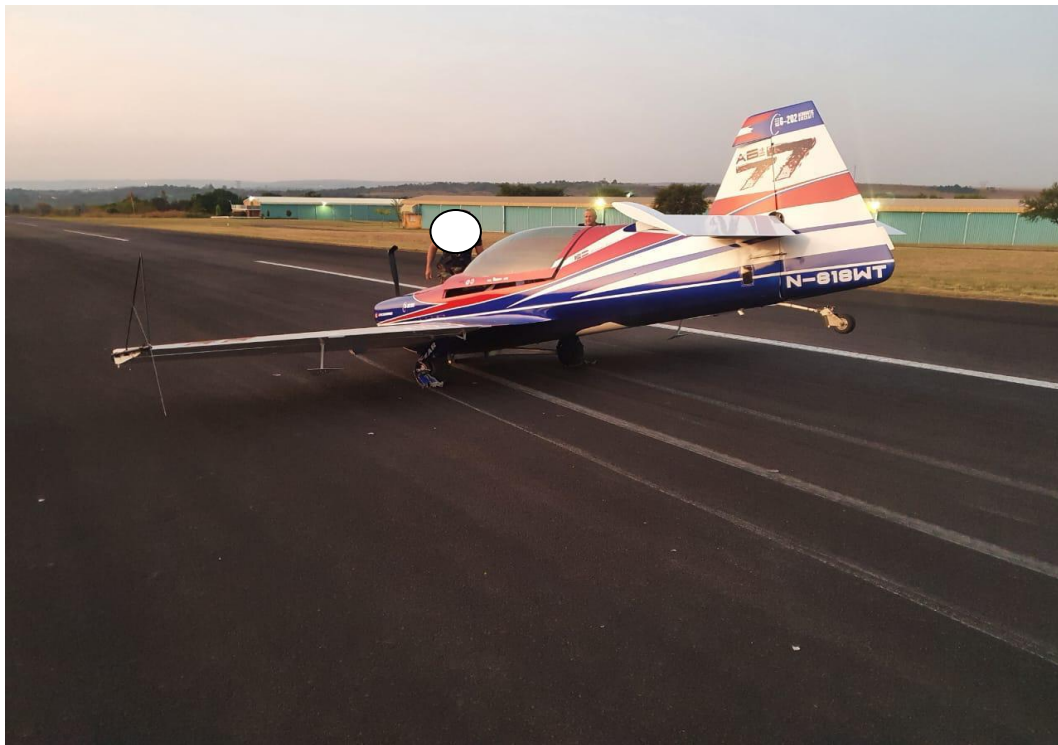
**Figure 1:** The aircraft post-accident, and skid marks on the runway.

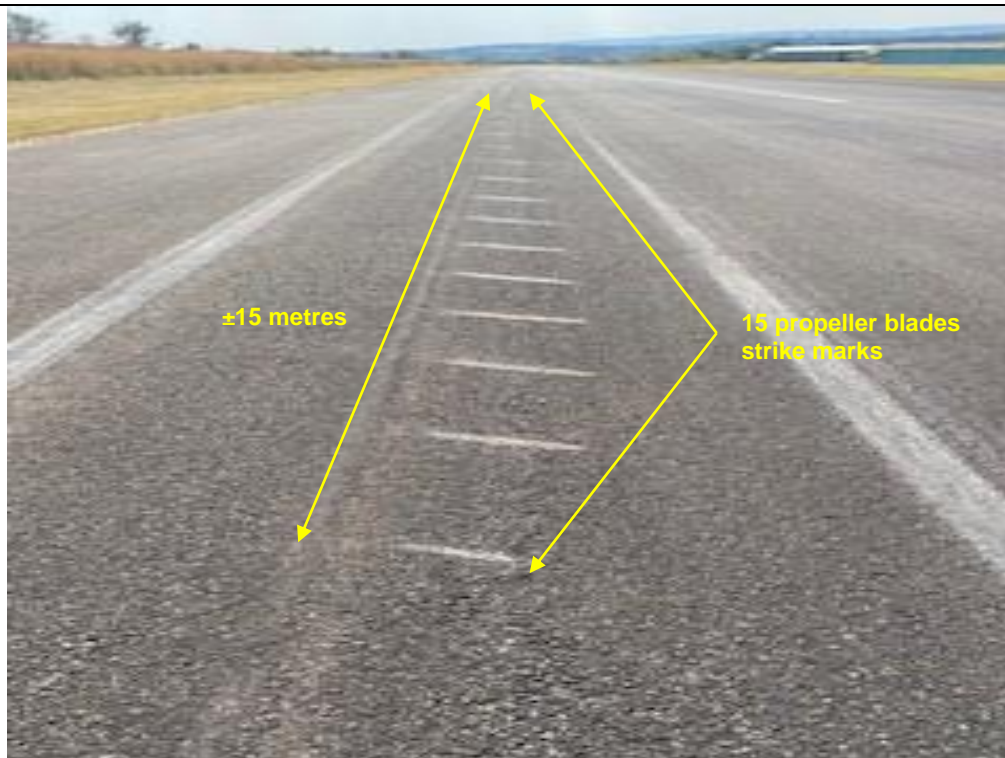
**Figure 2:** Propeller blades strike marks on the runway.

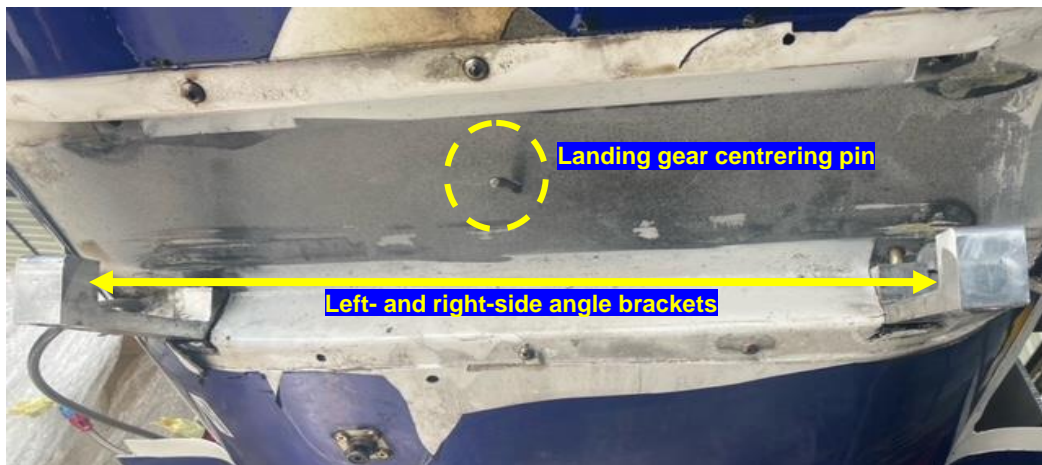
**Figure 3:** The saddle brackets holding the landing gear to the under-fuselage.

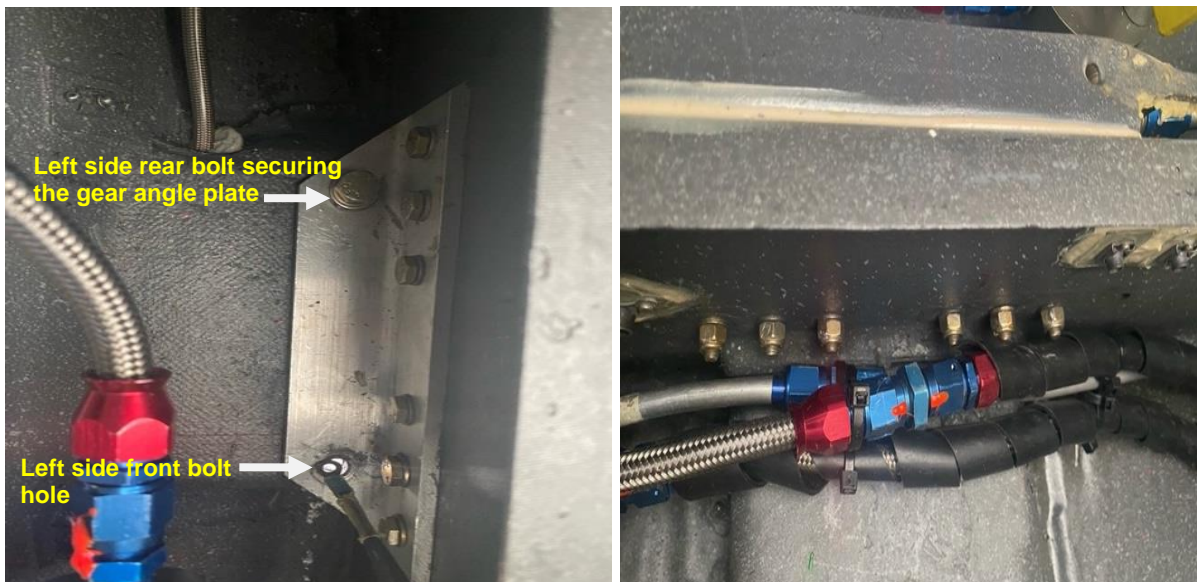
**Figures 4 and 5:** Left side aluminium angle plate (left) and how it was secured to the spar box (right).

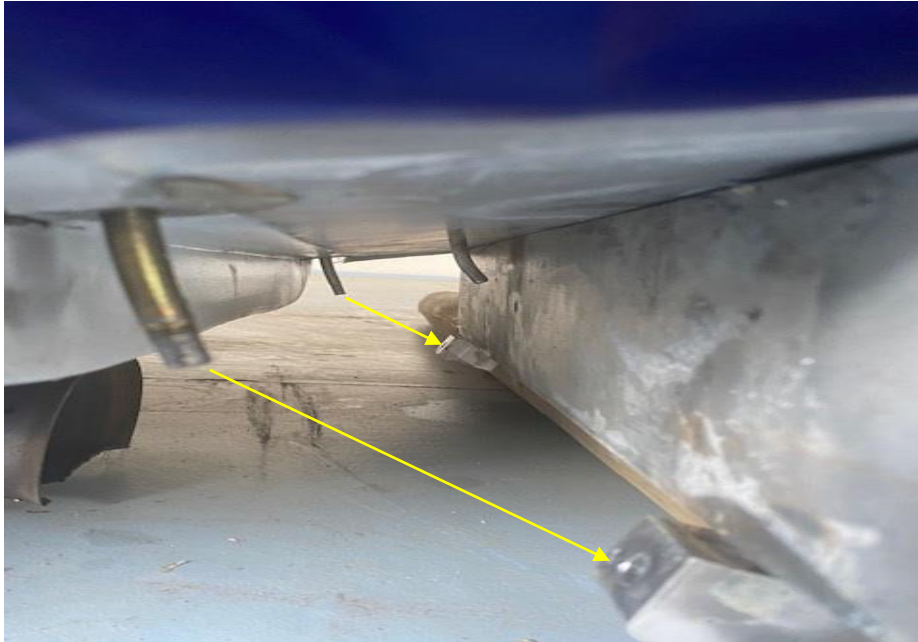
Visual examination of the aircraft indicated that the landing gear aluminium angle iron plates front nuts and bolts which secure the landing gear to the under-fuselage assembly had separated, causing the landing gear to collapse. The threads on the bolts which protrude on the underbelly had stripped. One of the nuts with stripped threads was found on the runway surface of the aircraft's landing path. Inspection of the under-fuselage (belly) area where the bolts protrude showed no signs of damage. Both main wheel tyres were found to be correctly inflated, and the threads were well defined.

**Figure 6:** The collapsed landing gear showing the saddle brackets and the bolts protruding from the underbelly.

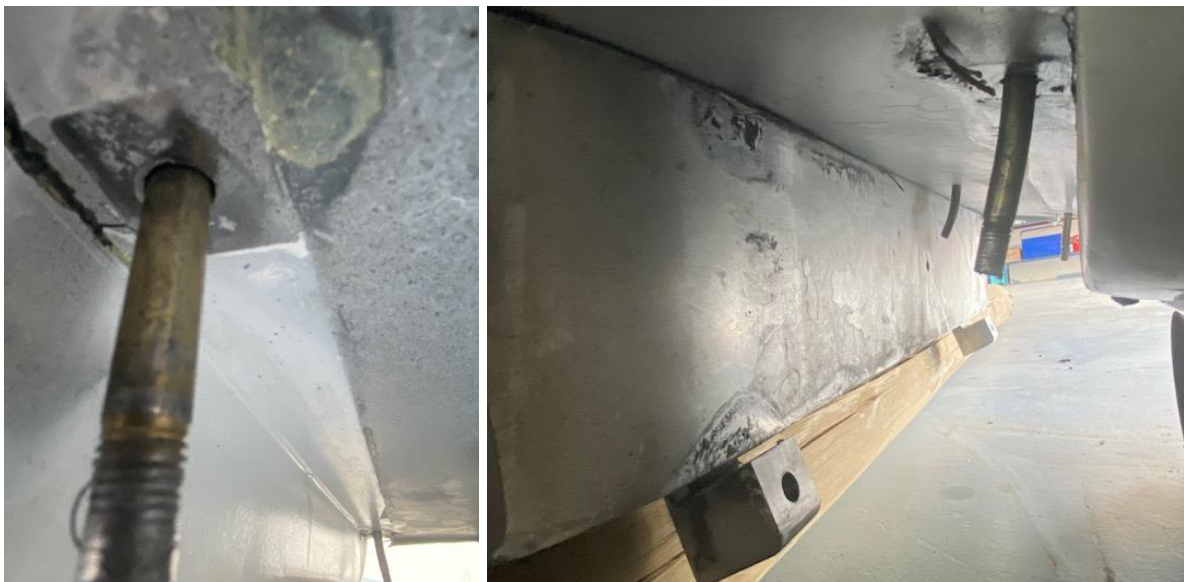
**Figures 7 and 8:** Stripped threads on the landing gear's left front bolt (left picture). Stripped threads on the landing gear's front right bolt (right picture).

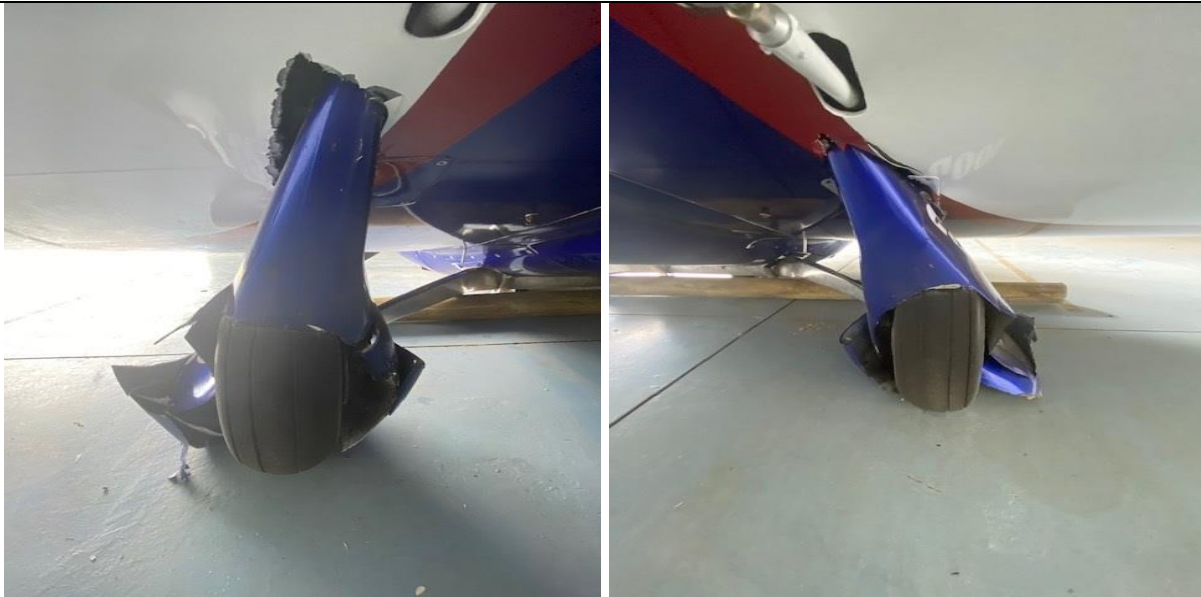
**Figures 9 and 10:** The left and right main landing gear struts showing the wheel fairings that cut through the underwing structure.
