LIMITED ACCIDENT INVESTIGATION REPORT
--

Reference Number		CA18/2/3/10150					
Classification	Accident	Date	1 May 2022	Time	1500Z		
Type of Operation		Private (Part 91)					
Location							
Place of Departure		Goedehoop Farm Private Airstrip, Free State Province		Place of Intended Landing		Goedehoop Farm Private Airstrip, Free State Province	
Place of Accident		Goedehoop Farm Private Airstrip, 6nm south-west of Koppies, Free State Province					
GPS Co-ordinates	Latitude	S27°20'01.1"	Longitude	E027°34'05.4"	Elevation	4584ft	
Aircraft Information							
Registration		ZS-FYH					
Model/Make		Piper PA28-180 (Serial Number: 28-5301)					
Damage to Aircraft		Substantial		Total Aircraft Hours		3088.57	
Pilot-in-command							
Licence Valid		Yes	Gender	Male	Age	30	
Licence Type		Private Pilot Licence (Aeroplane)					
Total Hours on Type		63.4		Total Flying Hours		118.9	
People On-board	1 + 3	Injuries	2	Fatalities	0	Other (On Ground)	0
What Happened

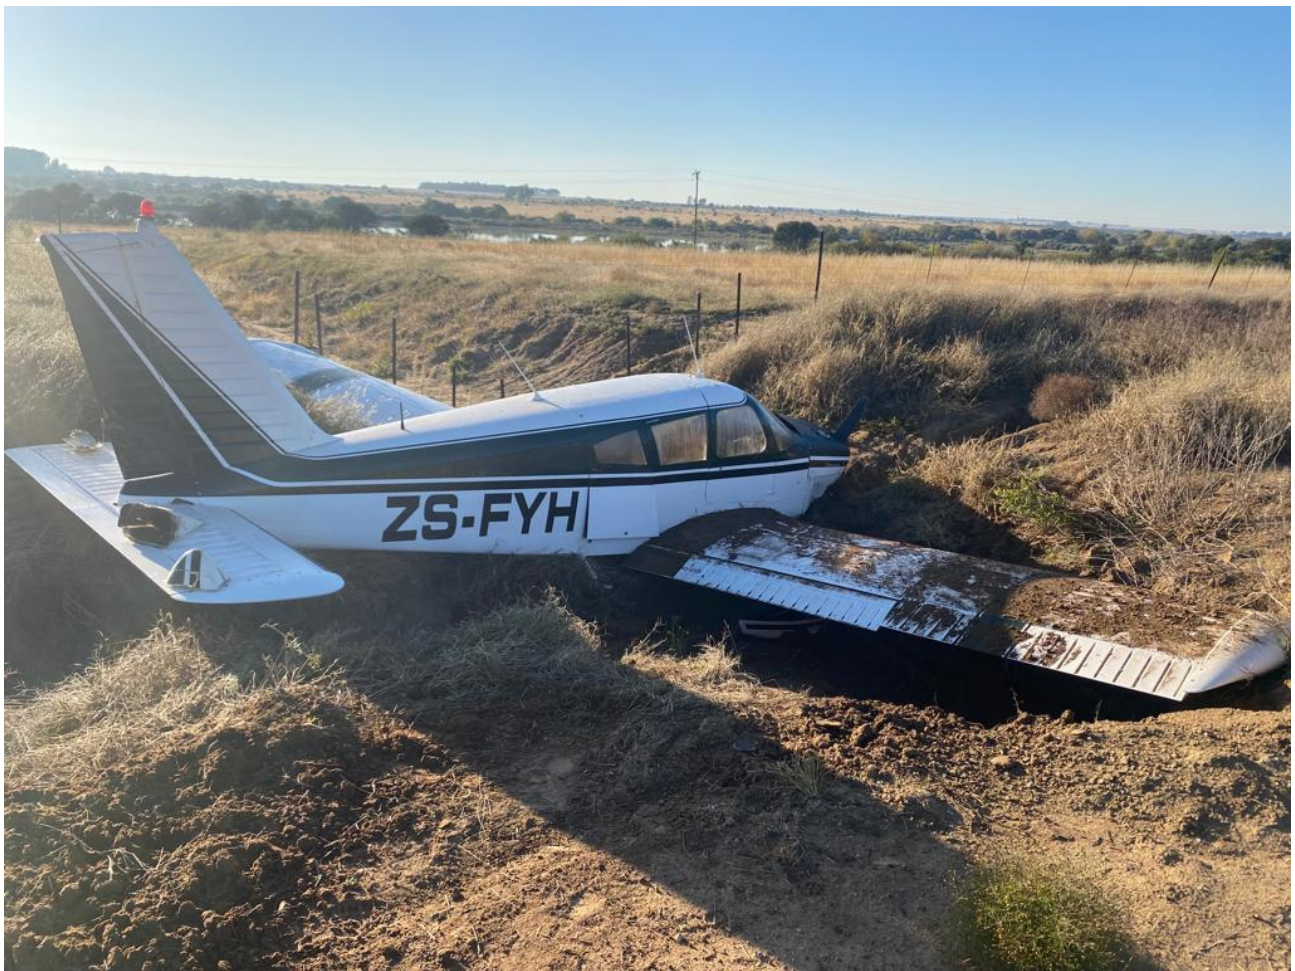
<p>On Sunday, 1 May 2022, a pilot accompanied by three passengers on-board a Piper PA28-180 aircraft with registration ZS-FYH took off on a private flight from Goedehoop Farm Private Airstrip situated south-west of Koppies, Free State province, with the intention to return to the same take-off airstrip. The flight was conducted under the provisions of Part 91 of the Civil Aviation Regulations (CAR) 2011 as amended.</p> <p>The take-off from Goedehoop Farm Private Airstrip Runway 21 (RWY21) was uneventful. The short flight around the farm lasted about 30 minutes, and the aircraft landed back on the gravel airstrip (RWY21) after an approach of approximately 80 knots with a light wind of less than 2 knots. The pilot reported that he lost directional control during the landing roll and the aircraft veered off to the left-side of the gravel runway before coming to rest in a ditch.</p> <p>The pilot and one passenger were injured and were transported to the hospital; the other two passengers were unharmed. The aircraft sustained damages to the landing gear, propeller, fuselage and left wing during the accident.</p>

Figure 1: The accident site. (Source: Pilot)

The aircraft was unstable on final approach, which resulted in the pilot losing directional control of the aircraft after touchdown.
