LIMITED ACCIDENT INVESTIGATION REPORT

Reference Number	CA18/2/3/10151					
Classification	Accident	Date	2 May 2022	Time	0843Z	
Type of Operation	Private (Part 94)					
Location						
Place of Departure	Springs Aerodrome (FASI) Gauteng Province		Place of Intended Landing	Springs Aerodrome (FASI) Gauteng Province		
Place of Accident	Runway 03 at Springs Aerodrome					
GPS Co-ordinates	Latitude	S26°14' 57.05"	Longitude	E 28° 23' 50"	Elevation	5337 ft
Aircraft Information						
Registration	ZU-DPD					
Make/Model	Jabiru J450 (Serial Number: 194)					
Damage to Aircraft	Substantial		Total Aircraft Hours	907.3		
Pilot-in-command						
Licence Valid	Yes	Gender	Male	Age	62	
Licence Type	Private Pilot Licence (PPL) Aeroplane					
Total Hours on Type	13.4		Total Flying Hours	133.7		
People On-board	1 + 1	Injuries	0	Fatalities	0	Other (On Ground) 0
What Happened						
<p>On Monday morning, 2 May 2022, a pilot and a passenger on-board a Jabiru J450 aircraft with registration ZU-DPD took off on a private flight from Springs Aerodrome (FASI) to Cullinan, both in Gauteng province, with the intention to return to FASI. The flight was conducted under visual meteorological conditions (VMC) by day a

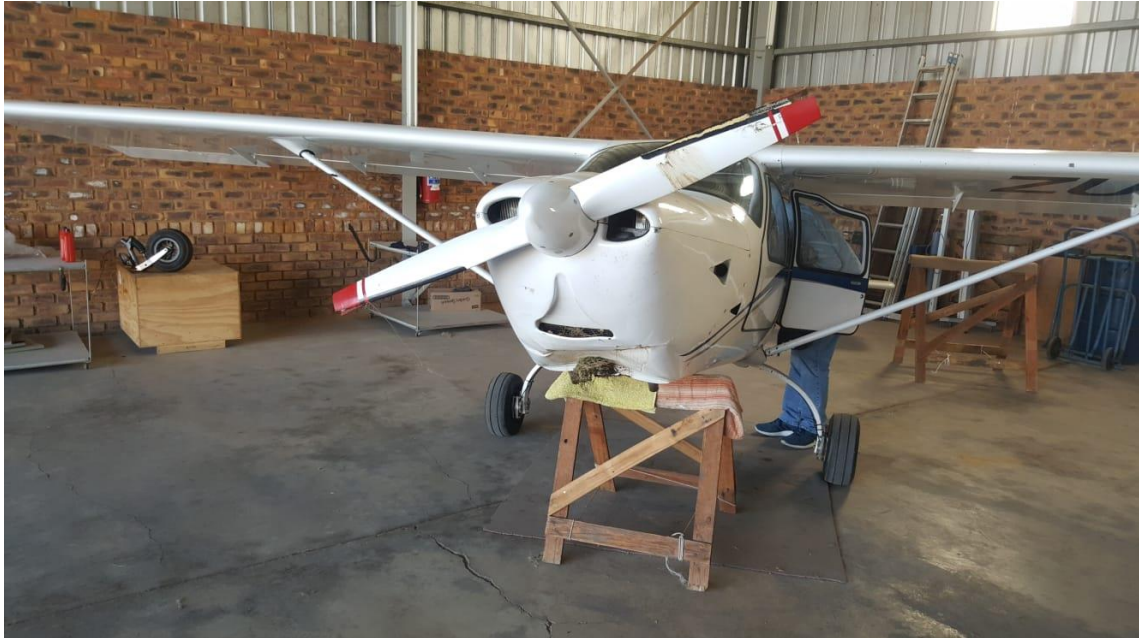
overload and the propeller struck the ground before the aircraft came to a stop on the left-side of the runway. The pilot switched off the master and, together with the passenger, disembarked the aircraft unaided.

Figure 1: The aircraft without the nose gear strut after it was recovered. (Source: Pilot)

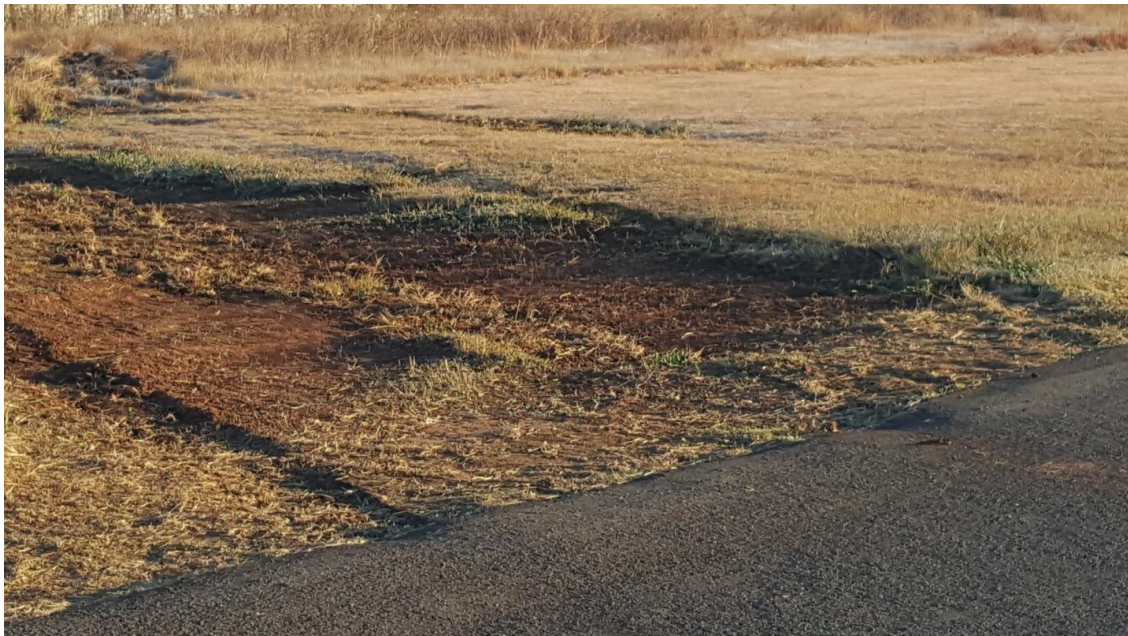
Figure 2: Water runoff point. (Source: Pilot)

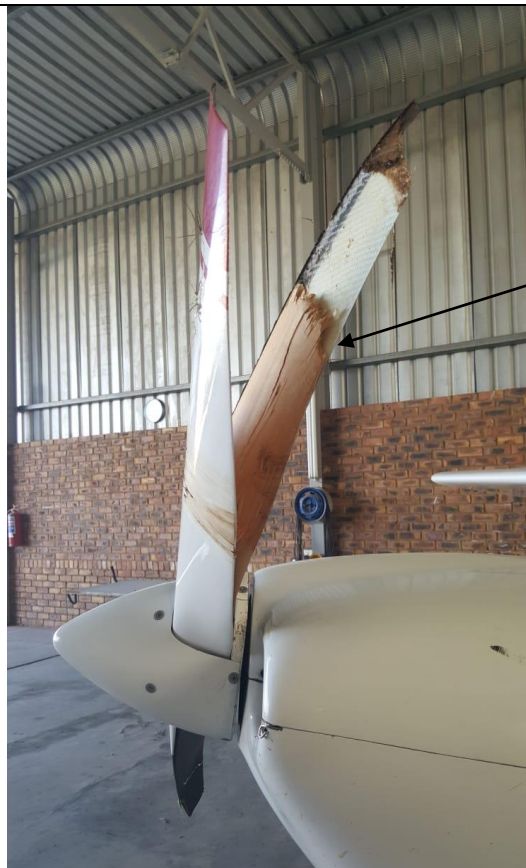
Figure 3: Damaged propeller blades. (Source: Pilot)
