LIMITED ACCIDENT INVESTIGATION REPORT
--

Reference Number		CA18/2/3/10154					
Classification	Accident	Date	7 May 2022	Time	0800Z		
Type of Operation		Training (Part 141)					
Location							
Place of Departure		Cape Winelands Aerodrome (FAWN), Western Cape Province		Place of Intended Landing		Diemerskraal Airfield, Western Cape Province	
Place of Accident		Runway 22 at Diemerskraal Airfield					
GPS Co-ordinates	Latitude	33° 34' 38.4" S	Longitude	18° 54' 58.3" E	Elevation	280 ft	
Aircraft Information							
Registration		ZU-BJI					
Make/Model		Bushbaby 450 (Serial Number: 051)					
Damage to Aircraft		Substantial		Total Aircraft Hours		3137.4	
Pilot-in-command							
Licence Type		National Pilot Licence (NPL)		Gender	Male	Age	51
Licence Valid		Yes					
Total Hours on Type		442		Total Flying Hours		1613	
People On-board	2 + 0	Injuries	0	Fatalities	0	Other (on ground)	0
What Happened							
<p>On Saturday morning, 7 May 2022 at approximately 0730Z, a flight instructor and a student pilot on-board a Bushbaby 450 aircraft with registration ZU-BJI took off on a training flight from the Cape Winelands Aerodrome (FAWN) in the Western Cape province, to Diemerskraal Aerodrome (near Welli

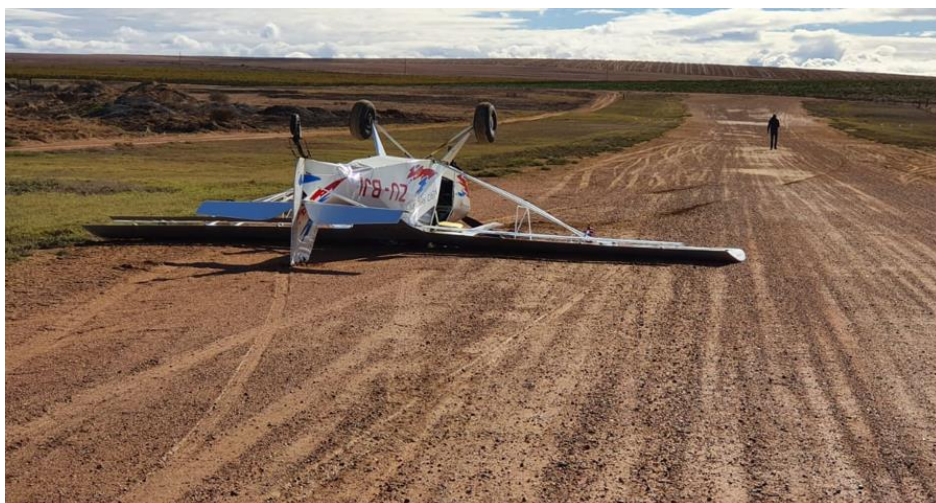
The aircraft sustained significant damage to both wings, propeller, fuselage and empennage; however, both occupants were not injured during the accident sequence.

Figure 1: The aircraft at the accident site. (Source: Operator)

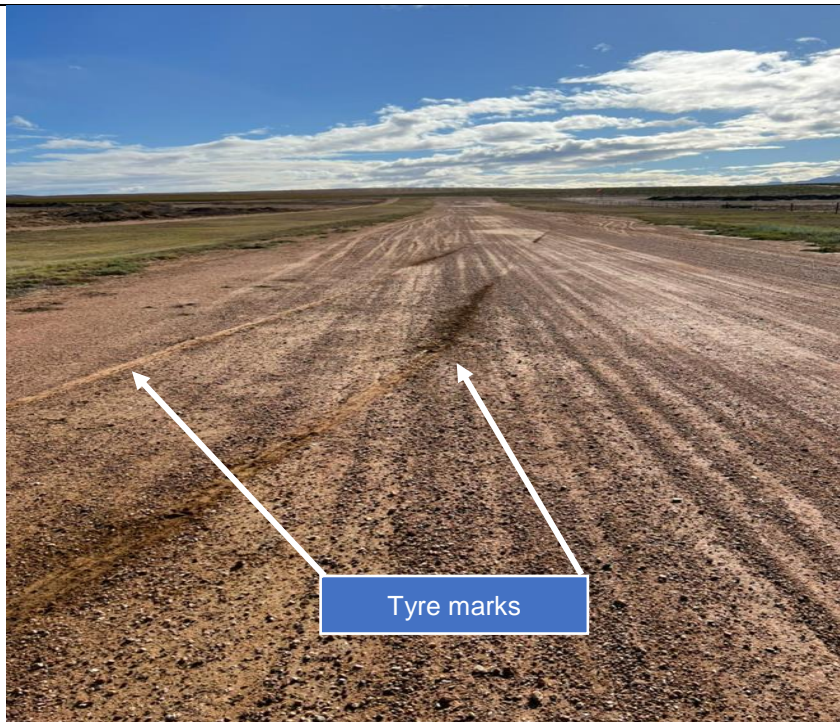
Figure 2: Tyre marks on the runway. (Source: Operator)

- The student pilot acknowledged that he inadvertently activated the left brake, causing the left wheel to lock.
- Although the student pilot reported that he applied the left rudder pedal, evidence shows (see Figure 2) that both rudder pedals/brakes were applied excessively whilst trying to get the aircraft back on the centreline, ultimately causing the aircraft to nose over.

Loss of directional control during landing, which resulted in the aircraft veering off to the right of the runway before it nosed over.

Incorrect use of the rudder pedal and braking technique during landing.

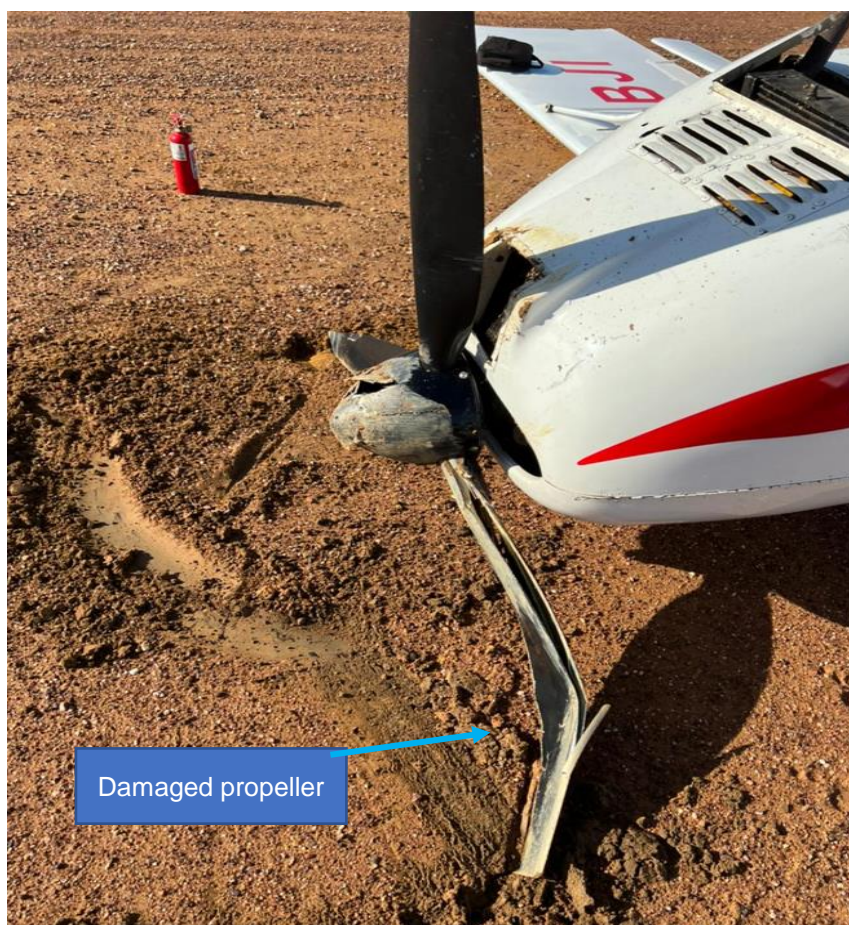
Figure 3: Damaged propeller. (Source: Operator)

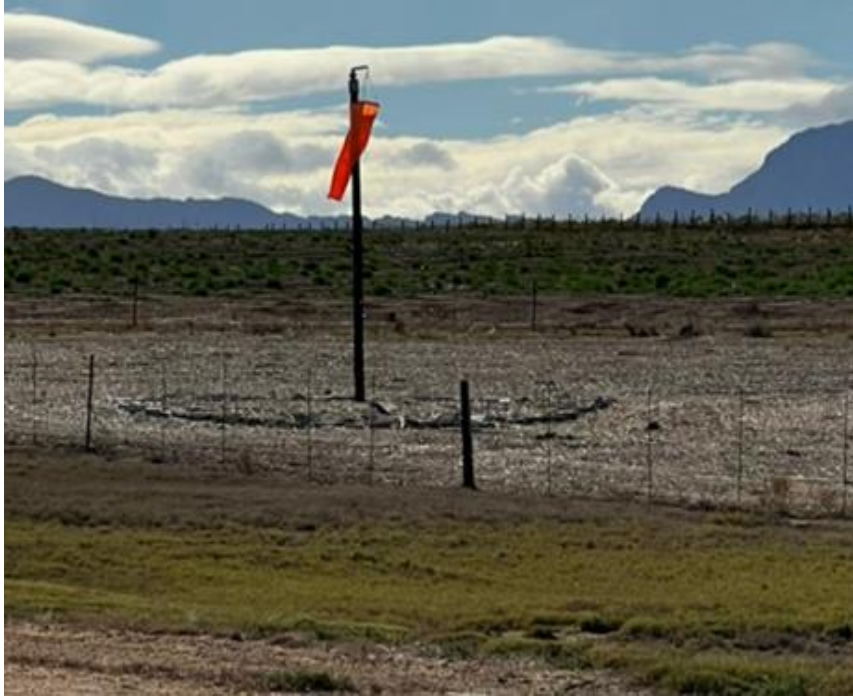
- The weather information was sourced from the pilot questionnaire, which indicated that local wind was 135° at 03 knots with fine weather conditions at the time of the accident.

Figure 4: Windsock indicating wind speed and direction. (Source: Operator)
