**LIMITED ACCIDENT INVESTIGATION REPORT**

<b>Reference Number</b>	CA18/2/3/10155						
<b>Classification</b>	Accident	<b>Date</b>	31 December 2021	<b>Time</b>	0412Z		
<b>Type of Operation</b>	Agricultural (Part 137)						
<b>Location</b>							
<b>Place of Departure</b>	Hartswater Private Airstrip, Northern Cape Province		<b>Place of Intended Landing</b>	Welkom Aerodrome (FAWM), Free State Province			
<b>Place of Accident</b>	6F12 Private Farm in Hartswater, Northern Cape Province						
<b>GPS Co-ordinates</b>	<b>Latitude</b>	27°48'21.99" S	<b>Longitude</b>	24°44'48.13" E	<b>Elevation</b>	3583 feet	
<b>Aircraft Information</b>							
<b>Registration</b>	ZS-XBX						
<b>Model/Make</b>	Air Tractor 502A (Serial Number: 502A-3309)						
<b>Damage to Aircraft</b>	Substantial		<b>Total Aircraft Hours</b>	146.6			
<b>Pilot-in-command</b>							
<b>Licence Type</b>	Commercial Pilot Licence (A)	<b>Gender</b>	Male	<b>Age</b>	34		
<b>Licence Valid</b>	Yes

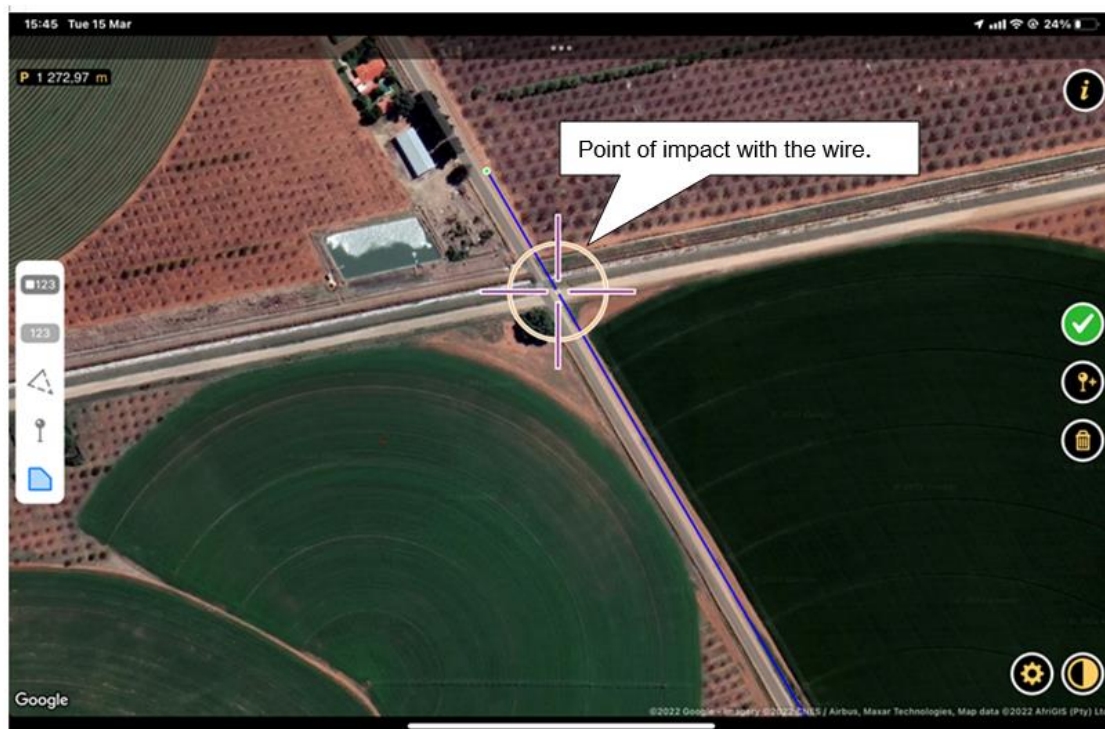
**Figure 1:** Point of impact with the powerline. The powerline is shaded in blue. (Source: Google/Pilot)

The aircraft collided with a powerline during a crop-spraying operation which was conducted as per the operator's procedure.

Pilots are encouraged to perform a fly-by/reconnaissance before commencing work that involves low flying to identify obstruction in their flight path to avoid collisions.

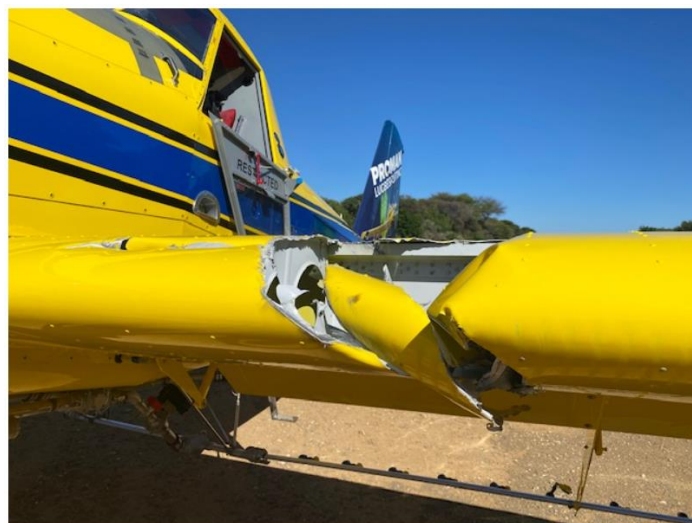
The pilot stated that after the accident, he flew back to Hartswater private airstrip and landed safely on the gravel runway. The aircraft sustained damage to the left-side leading edge, wing spar, windshield and wiper, antennae, and the tail section. The pilot was not injured during the accident. Post-accident examination of the aircraft revealed that the powerline wire had cut the outboard side of the left-wing leading edge through to the inboard leading edge, approximately midway between the fuel cap and the cockpit area.

**Figure 2:** Damage to the left-wing leading edge inboard (from the skin to the main spar).  
(Source: Pilot)

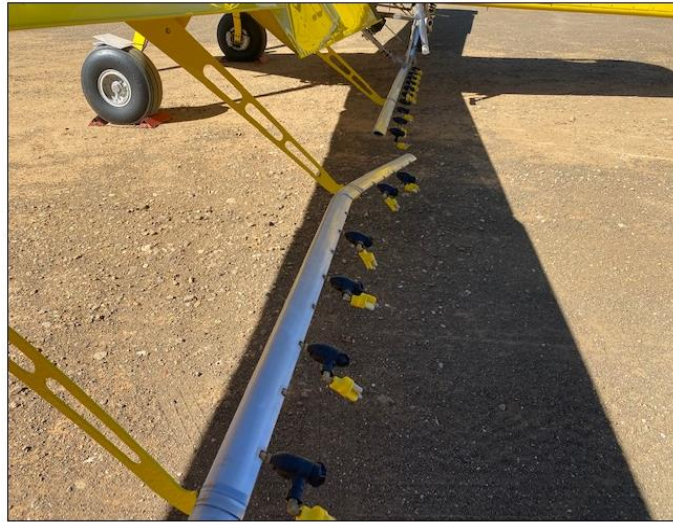
**Figure 3:** The broken left-side spray boom and damaged boomhangers. (Source: Pilot)

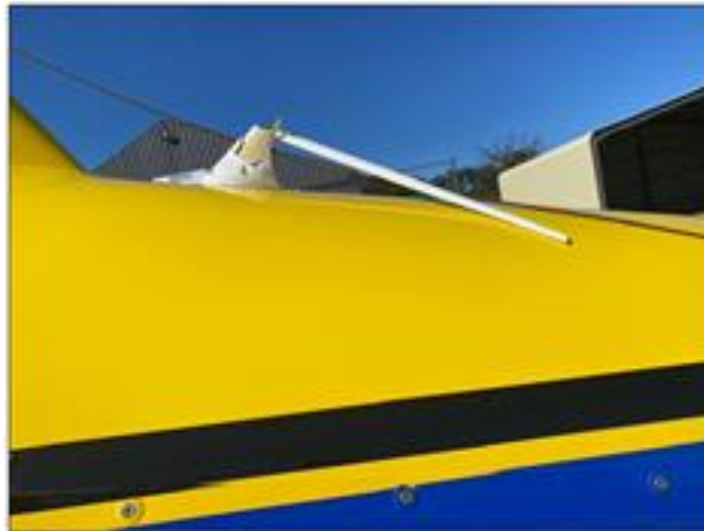
**Figure 4:** The broken emergency locator transmitter (ELT) and very high frequency (VHF) communication antennae. (Source: Pilot)

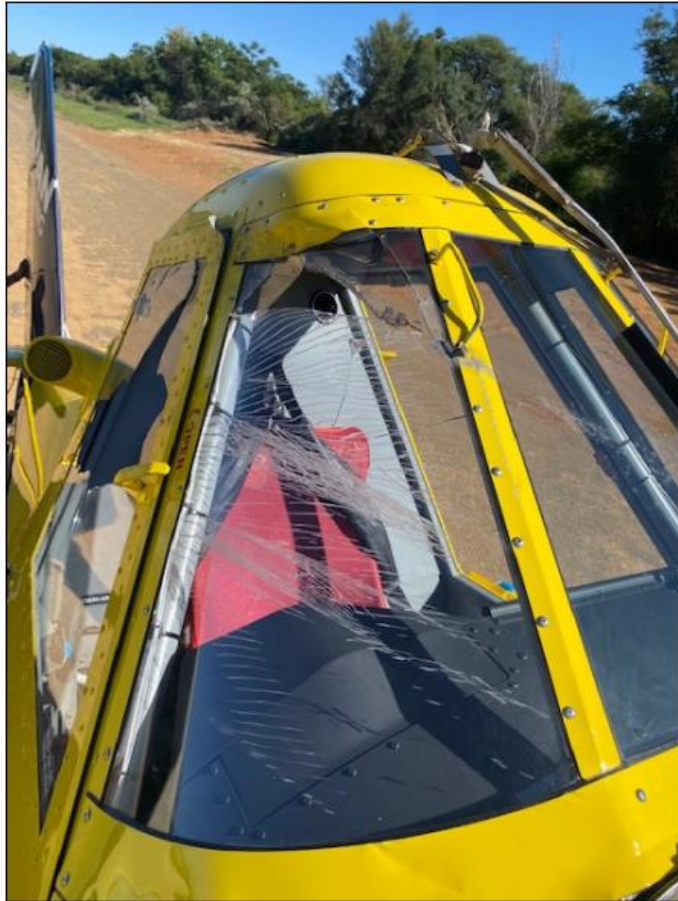
**Figure 5:** The damaged cockpit windscreen frames. (Source: Pilot)

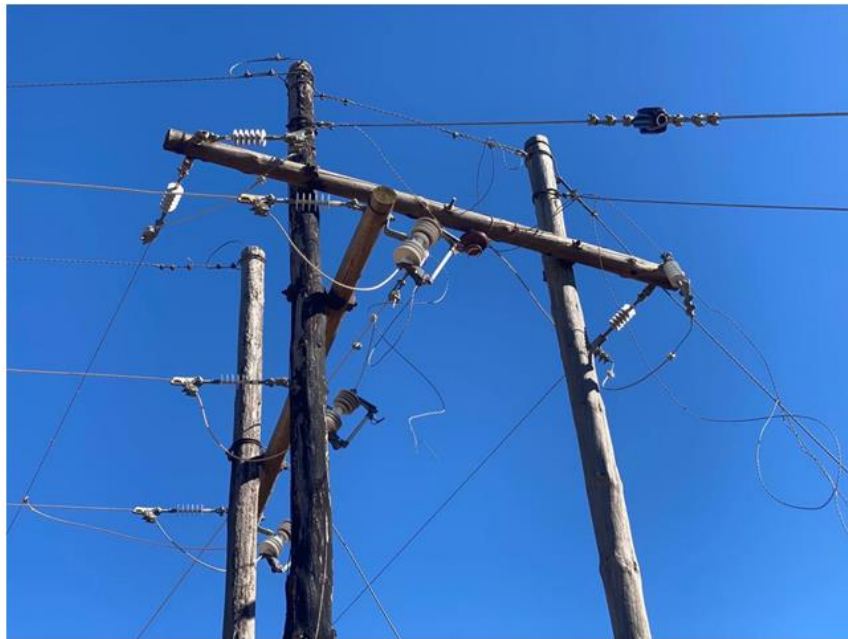
**Figure 6:** The broken powerline that the aircraft collided with. (Source: Pilot)
