LIMITED ACCIDENT INVESTIGATION REPORT

Reference Number	CA18/2/3/10158						
Classification	Accident	Date	4 May 2022	Time	1328Z		
Type of Operation	Remotely Piloted Aircraft (Part 101)						
Location							
Place of Departure	Lincoln Farm, KwaZulu-Natal Province		Place of Intended Landing	Lincoln Farm, KwaZulu-Natal Province			
Place of Accident	Lincoln Farm						
GPS Co-ordinates	Latitude	S 29° 55' 17.34"	Longitude	E 030° 25' 20.50"	Elevation	6131ft	
Aircraft Information							
Registration	ZT-XIY						
Model/Make	Agras T30 / DJI (Serial Number: 3UB5J45001001J)						
Damage to Aircraft	Substantial		Total Aircraft Hours	15.58			
Pilot-in-command							
Licence Type	Remote Pilot Licence (RPL)	Gender	Male	Age	27		
Licence Valid	Yes						
Total Hours on Type	60.4		Total Flying Hours	257.40			
People Controlling	1+0	Injuries	0	Fatalities	0	Other (on ground)	0
What Happened							
<p>On Wednesday, 4 May 2022 at approximately 1328Z, a Remotely Piloted Aircraft System (RPAS) aircraft, Agras T30, with registration ZT-XIY was launched for agricultural operation from Lincoln Farm in KwaZulu-Natal province. The aircraft was programmed to land back at the same launch location. The flight was c

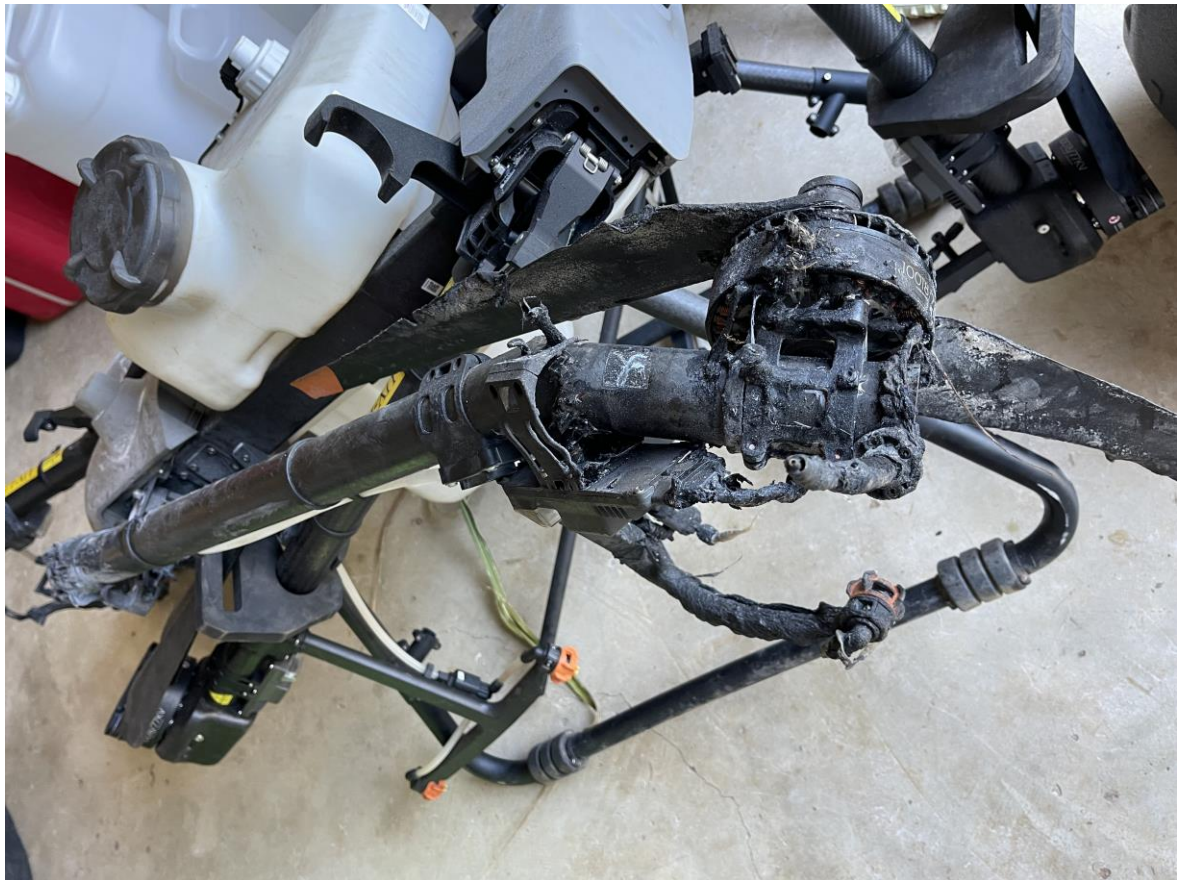
ultimately electrified the aircraft. A fire erupted soon after, and the aircraft fell to the ground. The aircraft was substantially damaged. No persons on the ground were injured during the accident sequence.

Figure 1: Damages on the aircraft. (Source: Operator)

The aircraft was electrified by power lines during an attempt (by the pilot) to manually restore flight of the aircraft, following an obstacle detection.
