LIMITED ACCIDENT INVESTIGATION REPORT

Reference Number	CA18/2/3/10159						
Classification	Accident	Date	4 May 2022		Time	1038Z	
Type of Operation	Remotely Piloted Aircraft Systems (Part 101)						
Location							
Place of Departure	Seriti Middelburg Mine, Mpumalanga Province		Place of Intended Landing	Seriti Middelburg Mine, Mpumalanga Province			
Place of Accident	Seriti Middelburg Mine, Mpumalanga Province						
GPS Co-ordinates	Latitude	25°59'45.72" S	Longitude	029°22'46.15" E	Elevation	5 125ft	
Aircraft Information							
Registration	ZT-XJD						
Make/Model	DJI Matrice 300 RTK (Serial Number: 1ZNBJ6F00C01D9)						
Damage to Drone	Substantial		Total Drone Hours	11 hours 21 minutes 42 seconds			
Pilot-in-command							
Licence Type	Remote Pilot Licence (RPL)		Gender	Male		Age: 33	
Licence Valid	Yes						
Total Hours on Type	89.0		Total Flying Hours	89.0			
People	N/A	Injuries	0	Fatalities	0	Other (On ground)	0
What Happened							
<p>On Wednesday afternoon, 4 May 2022 at 1038Z, a DJI Matrice 300RTK drone with registration ZT-XJD took off from a remote location at Seriti Middelburg Mine. The drone was remotely controlled by a pilot with a Remote Pilot Licence (RPL). The flight

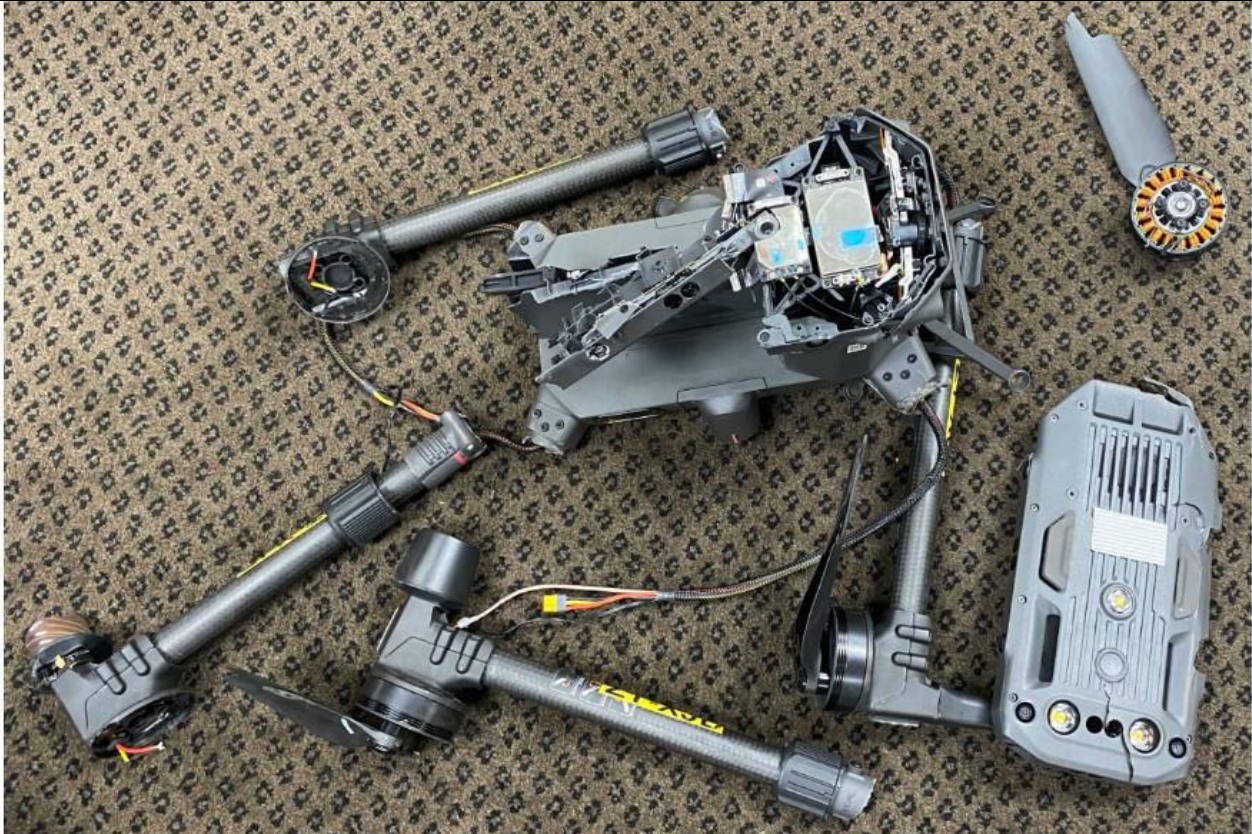
Figure 3: This photograph was taken after the drone was recovered. (Source: Operator)

On-site photographs or video footage were not taken prior to the recovery of the drone. From the photographs that were taken post-recovery, it could be seen that the drone was destroyed.

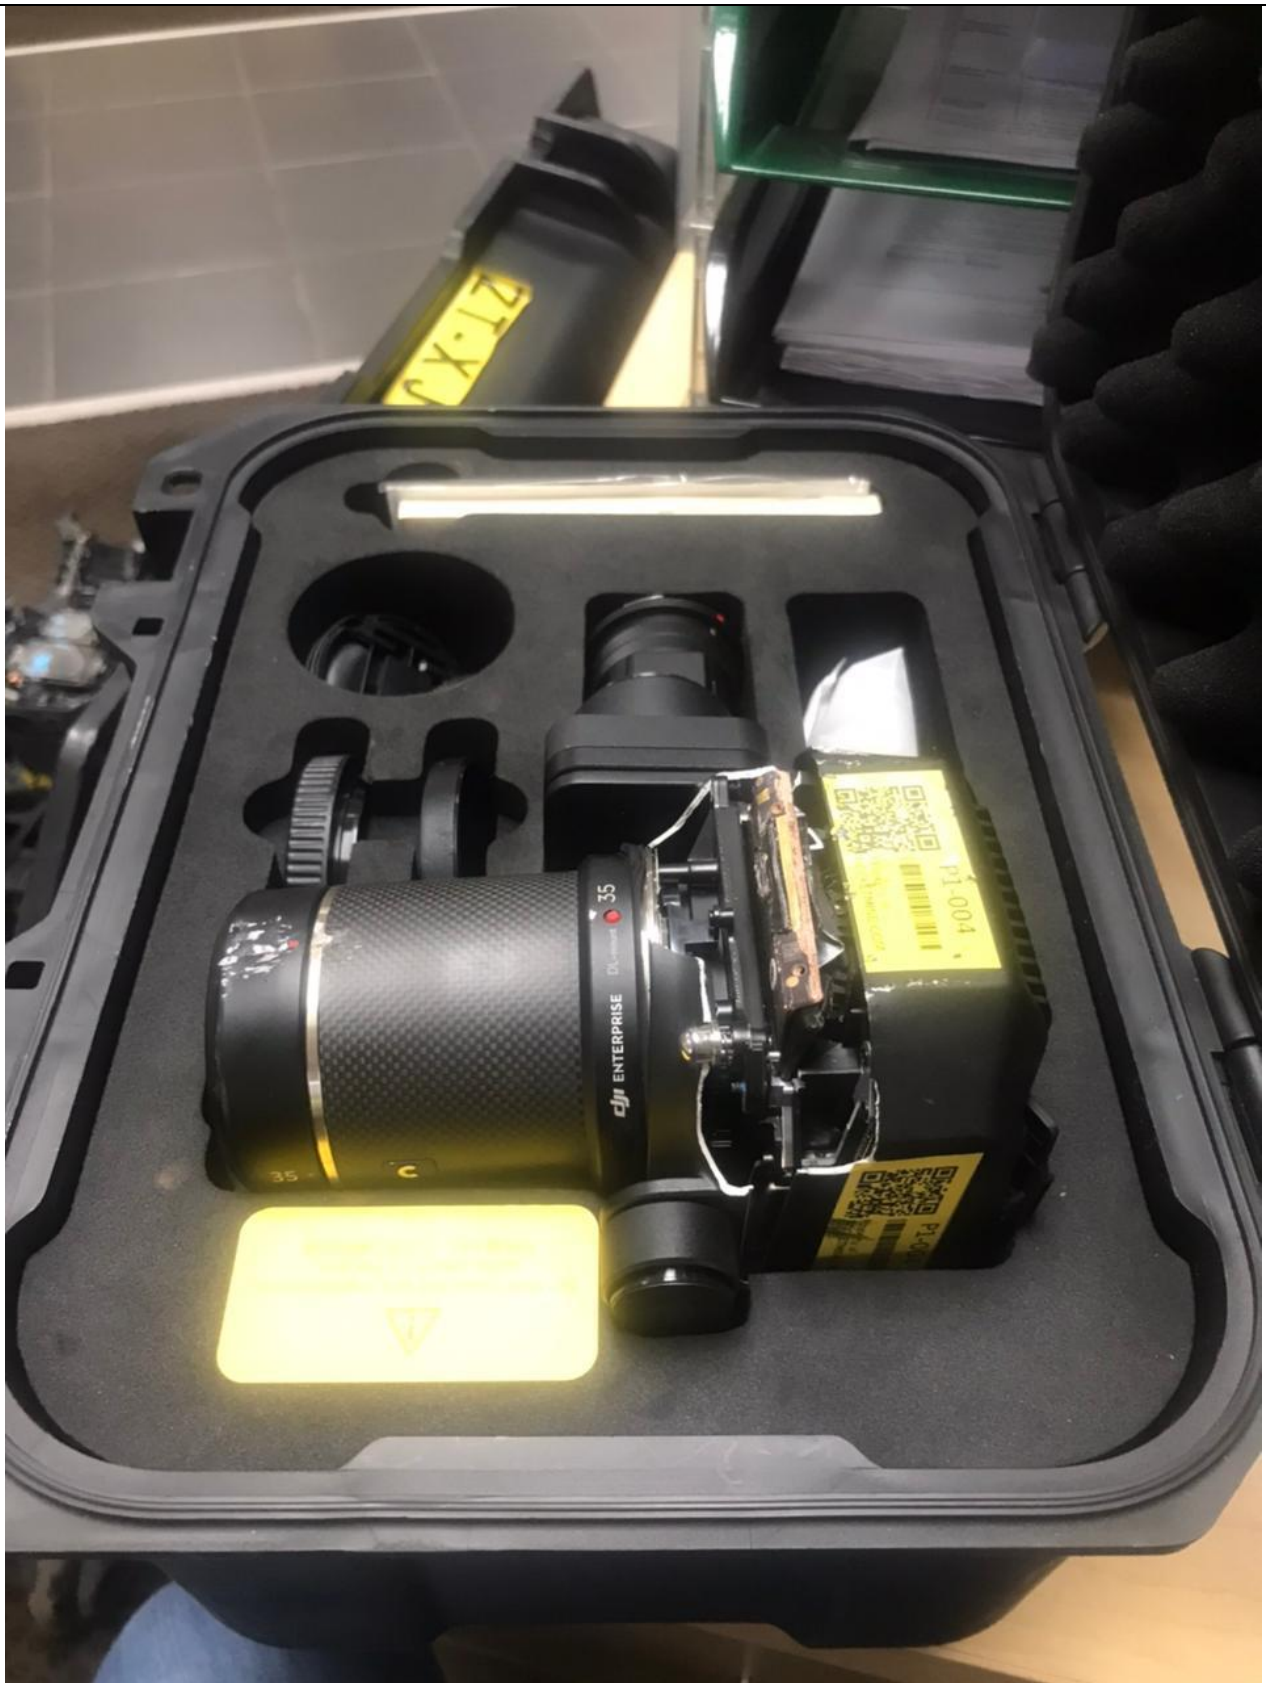
Figure 4: Damage to the camera that was attached to the drone. (Source: Operator)
