LIMITED ACCIDENT INVESTIGATION REPORT

Reference Number	CA18/2/3/10161					
Classification	Accident	Date	18 March 2022	Time	1049Z	
Type of Operation	Surveillance (Part 101)					
Location						
Place of Departure	Camps Drift Canal near Pietermaritzburg, KwaZulu-Natal Province		Place of intended landing	Camps Drift Canal near Pietermaritzburg, KwaZulu-Natal Province		
Place of Accident	Camps Drift Canal near Pietermaritzburg in KwaZulu-Natal Province					
GPS Co-ordinates	Latitude	29° 37'.28." S	Longitude	030° 22'.15" E	Elevation	2059ft
Aircraft Information						
Registration	ZT-UKY					
Make/Model	DJI Phantom 4 Pro (Serial Number: OAXDECD00S1153)					
Damage to Aircraft	Substantial		Total Aircraft Hours	164.04		
Pilot-in-command						
Licence Type	Remote Pilot Licence (RPL)		Gender	Male		Age: 31
Licence Valid	Yes					
Total Hours on Type	44.31		Total Flying Hours	257.04		
What Happened						
<p>On 18 March 2022, a DJI Phantom 4 Pro remotely piloted aircraft (RPA) with registration ZT-UKY was piloted for surveillance purposes at Camps Drift, near Pietermaritzburg in KwaZulu-Natal province. The operation was conducted under visual line of sight (VLOS) by day and under the provisions o

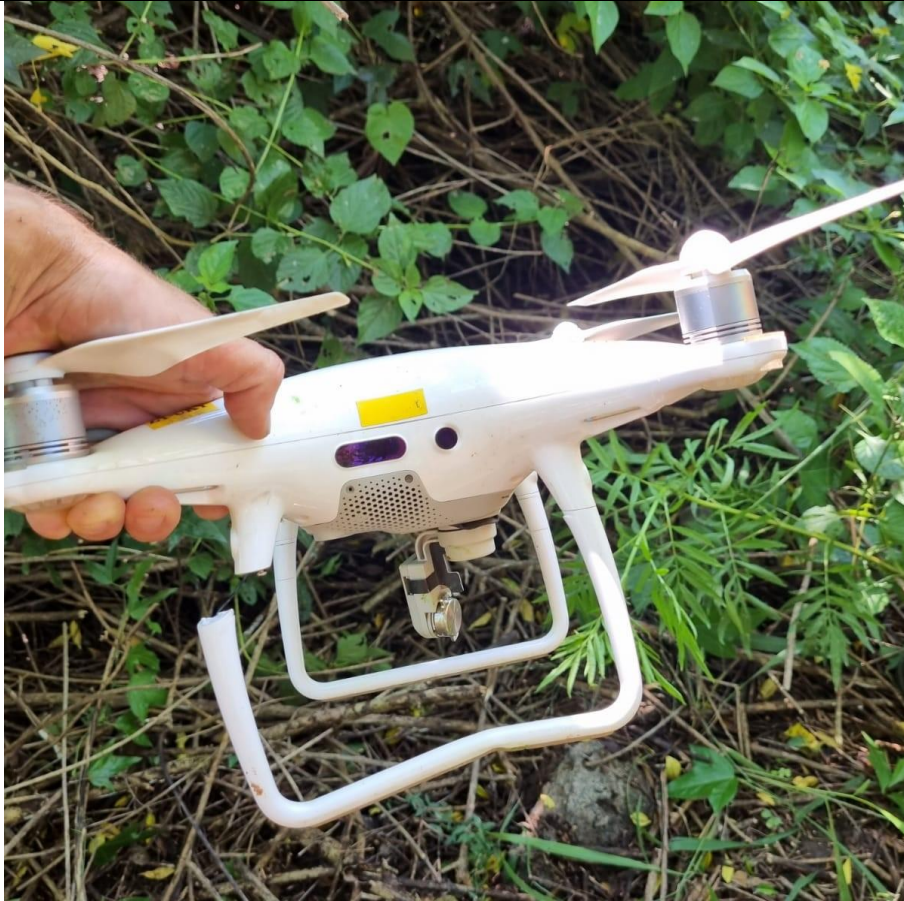
Figure 1: The damaged landing gear. (Source: Operator)

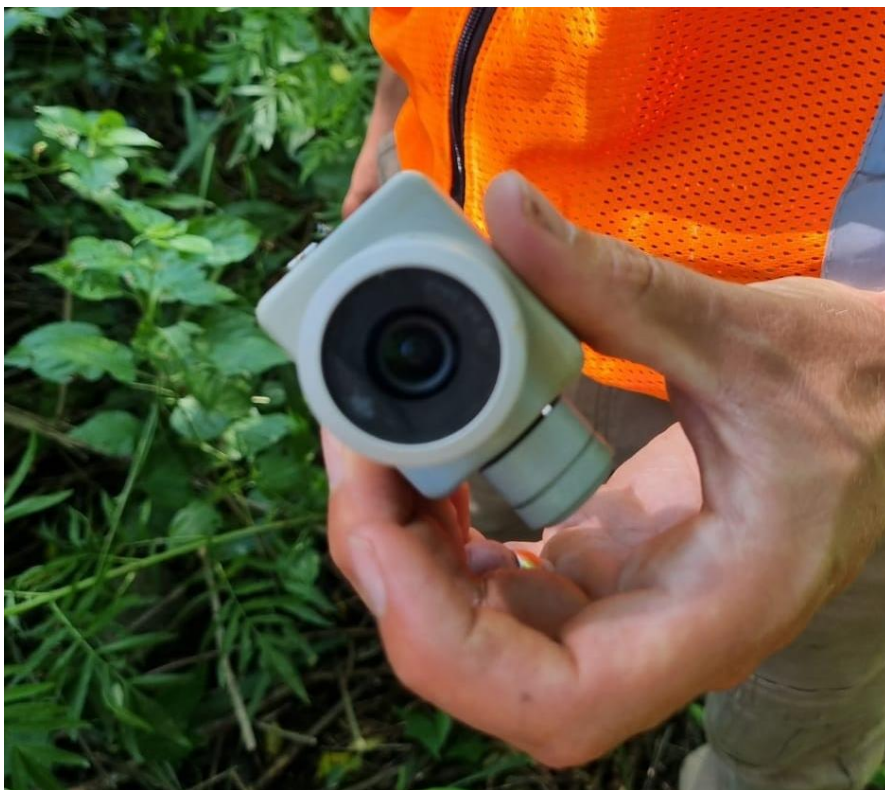
Figure 2: The gimbal that broke off. (Source: Pilot)

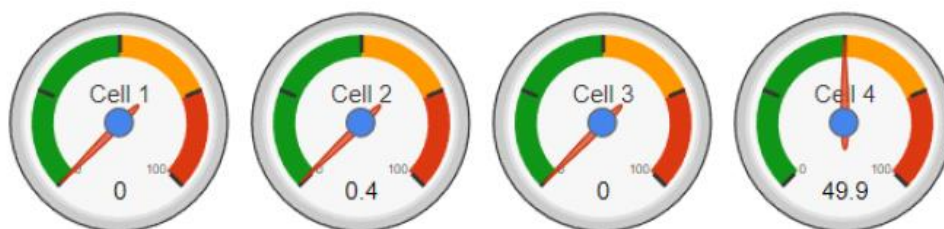
- The battery's date of manufacture is 27 September 2017, and the purchase date is 23 July 2019.
- During testing, the failed battery cell number 4 showed a higher deviation voltage than the other battery cells (see results below).

Minor cell voltage deviation(0.01v) per minute
Lower numbers are better

Figure 2: Test results of the battery cells. (Source: Operator)

- According to the operator, the pilots have been visually monitoring all batteries and they have been monitoring the trends on batteries digitally and in line with their policy.
- The operator stated that the cause of the battery cell failure was because of the prolonged usage and potentially not being strict enough in grounding batteries that showed digital signs of wear and tear. Although the operator's battery monitoring systems have statistically proven to be successful.

The RPA lost connection because of the battery cell failure and, subsequently, collided with a tree during a return-to-home flight.
