LIMITED ACCIDENT INVESTIGATION REPORT
--

Reference Number		CA18/2/3/10163						
Classification	Accident	Date	24 May 2022	Time	1435Z			
Type of Operation		Private (Part 94)						
Location								
Place of Departure		Kroon Airfield, Pretoria North, Gauteng Province		Place of Intended Landing		Kroon Airfield, Pretoria North, Gauteng Province		
Place of Occurrence		Runway 29 at Kroon Airfield, Gauteng Province						
GPS Co-ordinates	Latitude	S25° 39'.33. 90"	Longitude	E27° 59' .53.37"	Elevation	4330 feet		
Aircraft Information								
Registration		ZU-ICK						
Model/Make		Savannah VG (Serial Number: 090651829)						
Damage to Aircraft		Substantial		Total Aircraft Hours		1321.9		
Pilot-in-command								
Licence Valid		Yes	Gender		Male	Age		35
Licence Type		Private Pilot Licence (PPL)						
Total Hours on Type		139.3		Total Flying Hours		263.9		
People On-board		1 + 1	Injuries	0	Fatalities	0	Other (On Ground)	0
What Happened								
<p>On Tuesday, 24 May 2022, a pilot accompanied by a passenger on-board a Savannah VG aircraft with registration ZU-ICK took off on a private flight from Kroon Airfield in Pretoria North (close to the N4 Highway to Rustenburg) with the intention to land ba

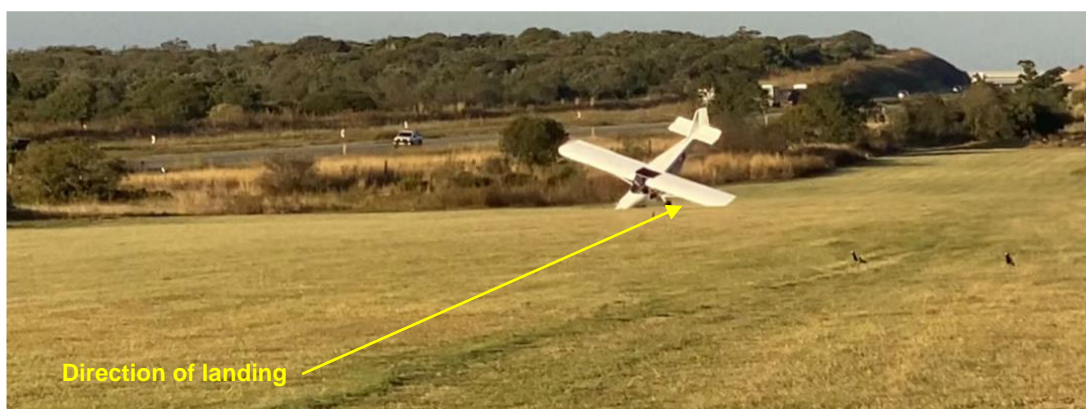
In trying to avoid colliding with the birds at high speed, the pilot intentionally applied the left rudder pedal to ground-loop the aircraft. The aircraft's nose gear strut broke during the process and the propeller struck the runway's surface. The aircraft came to rest in a tail-high position, balancing on its nose and left wing. The aircraft sustained substantial damages; none of the occupants were injured.

Figure 1: The aircraft at the accident site. (Source: Pilot)
