LIMITED ACCIDENT INVESTIGATION REPORT

Reference Number	CA18/2/3/10166						
Classification	Accident	Date	28 May 2022	Time	0800Z		
Type of Operation	Private (Part 91)						
Location							
Place of Departure	Lynedoch Private Airfield, Eastern Cape Province		Place of Intended Landing	Cape Town International Aerodrome (FACT), Western Cape province			
Place of Occurrence	50m left of Runway 07 at Lynedoch Private Farm, Eastern Cape Province						
GPS Co-ordinates	Latitude	32°30'40.16" S	Longitude	26°00'06.92" E	Elevation	2 647 feet	
Aircraft Information							
Registration	ZS-PTE						
Model/Make	Beechcraft King Air 200 (Serial Number: BB-1184)						
Damage to Aircraft	Substantial		Total Aircraft Hours	8 108.9			
Pilot-in-command							
Licence Type	Commercial Pilot Licence (CPL)		Gender	Male	Age	30	
Licence Valid	Yes						
Total Hours on Type	136.1		Total Flying Hours	2 506.1			
People On-board	2+2	Injuries	1	Fatalities	0	Other (on ground)	0
What Happened

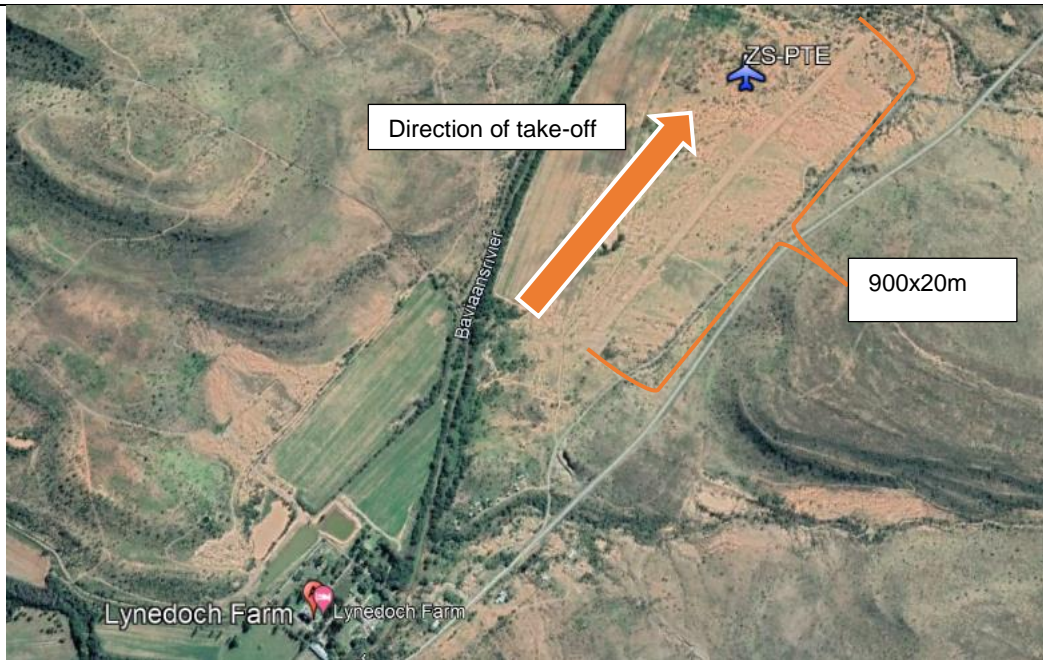
Figure 1: Aerial view of the runway. (Source: Google Earth)

- The gravel runway's length is 900 metres (m) and the width is 20m.
 - The runway has an uphill slope when viewed from the hangar side, and a downward slope midway.

- The surface appeared smooth as the runway was graded recently.
 - The first tree that the aircraft impacted was 450m away from the take-off point and was situated 10m from the left of the runway edge.

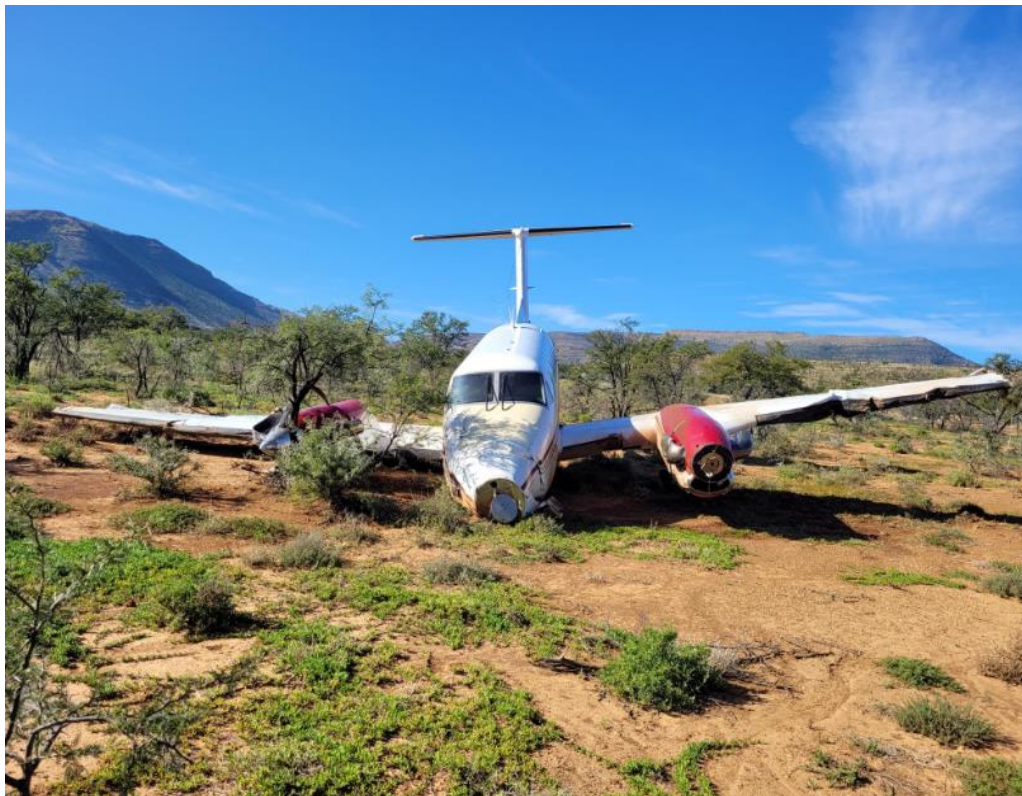
Figure 2: Final resting position of the aircraft.

- Ground marks indicated that the left-wing tip came into contact with the ground first, followed by the undercarriage, left- and right-side propeller blades and the right-side wing.

- The nose gear broke off and separated from the aircraft. It was found 30m from the main wreckage.
 - The left-side propeller blades were severed and had separated from the hub, whilst the right-side propeller blades were still attached but had curled backwards around the engine cowling.

- The left-wing leading edge was damaged, causing fuel pipes to rupture. The damage was consistent with impact with a tree.
 - The right-side wing sustained buckling damage on the centre and the outboard wing tip was ripped off due to impact with the ground. The flight controls surface was still attached, and the flaps were observed to have been set for take-off.

- The right-side aileron was bent.
 - The empennage had compression loads on the skin surface on the right-side. The nose section exhibited compression load on the upper surface, and buckling on the lower side.

- The right-side undercarriage had collapsed, and the tyre came off from the wheel hub. There were streaks of fuel as well as a strong smell of fuel (JetA1) underneath and on the right-side of the aircraft.

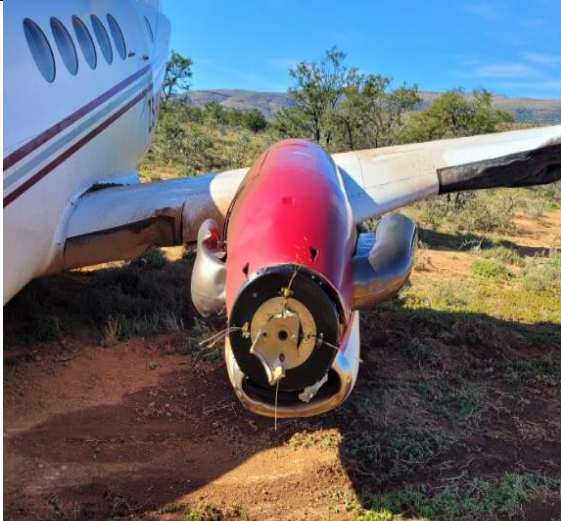
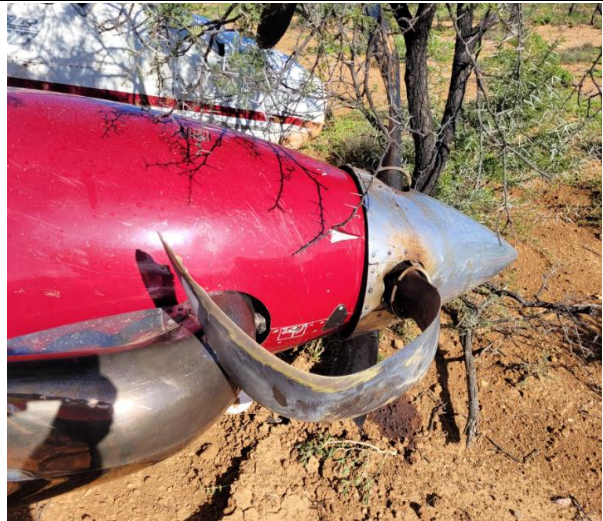
Figures 3 and 4: Left- and right-side propeller damages.

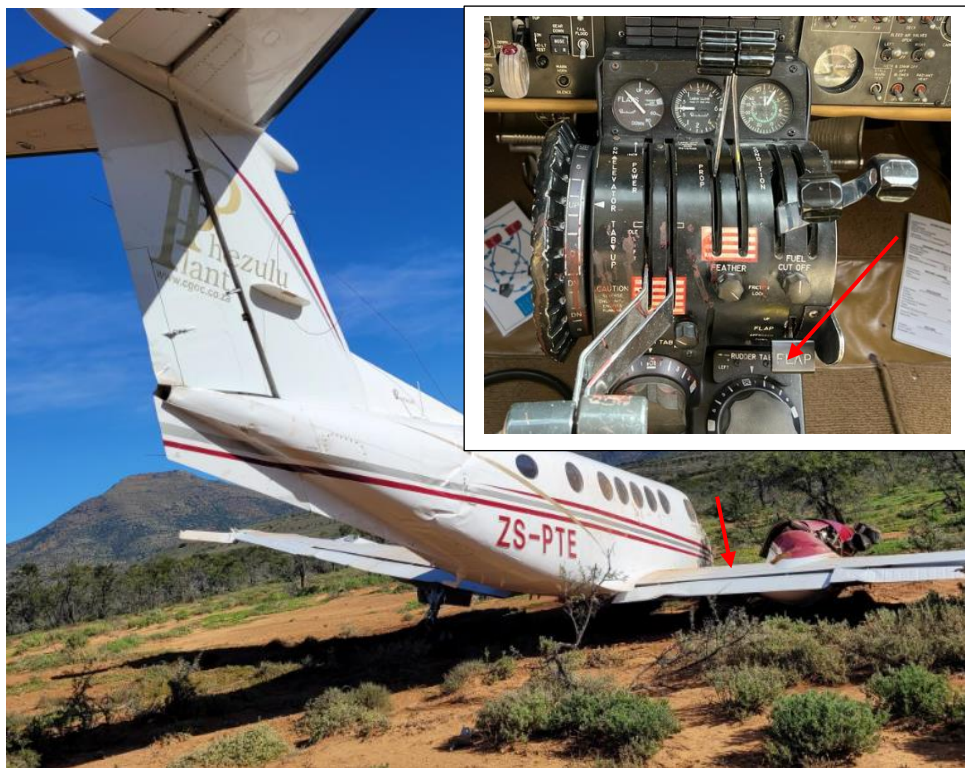
Figure 5: Flap position (take-off/approach position) viewed from the rear. The inset picture indicates flap lever position and the master switch in the 'off' position.

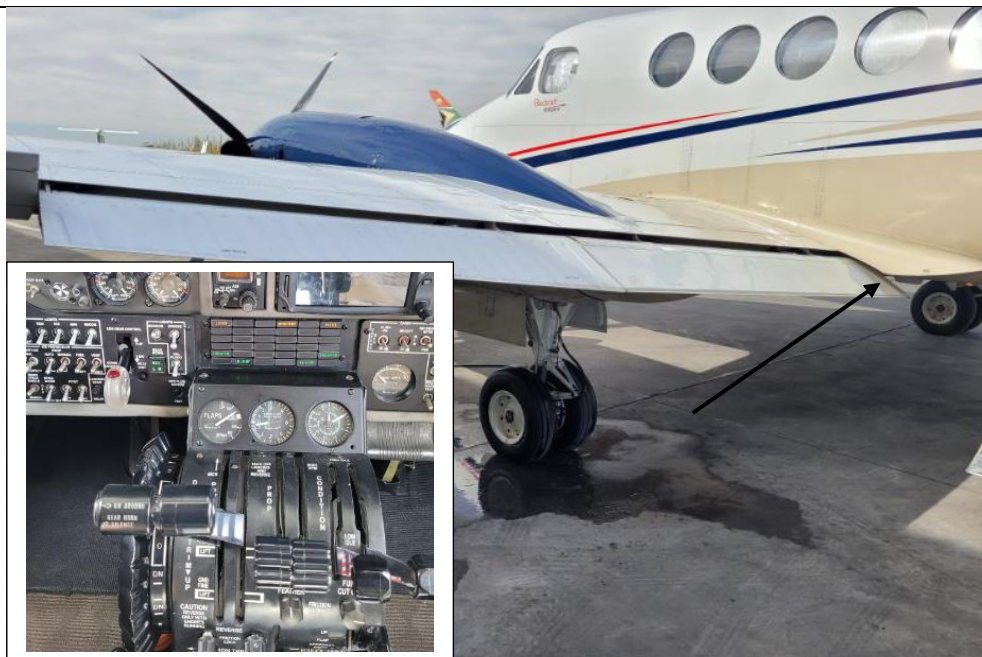
Figure 6: Flap position (take-off/approach position) comparison on a serviceable aircraft. The inset picture shows flap position and the master switch in the 'on' position.
