LIMITED ACCIDENT INVESTIGATION REPORT
--

Reference Number	CA18/2/3/10170					
Classification	Accident	Date	2 June 2022	Time	0630Z	
Type of Operation	Training (Part 141)					
Location						
Place of Departure	Durban Skydive Airfield, KwaZulu-Natal Province		Place of Intended Landing	Durban Skydive Airfield, KwaZulu-Natal Province		
Place of Accident	Right-side of Runway 01 at Durban Skydive Airfield, KwaZulu-Natal Province					
GPS Co-ordinates	Latitude	S 29°49'40.6"	Longitude	E 30°30'22.1"	Elevation	2295 ft
Aircraft Information						
Registration	ZU-JXF					
Make/Model	Bushbaby Safari (Serial Number: 143-10-08-SAF)					
Damage to Aircraft	Substantial		Total Aircraft Hours	532.4		
Pilot-in-command						
Licence Valid	Yes	Gender	Male	Age	43	
Licence Type	National Pilot Licence (NPL)					
Total Hours on Type	233.0		Total Flying Hours	256.4		
People On-board	2 + 0	Injuries	0	Fatalities	0	Other (On Ground) 0
What Happened						
<p>On 2 June 2022, an instructor and a student pilot on-board a Bushbaby Safari aircraft with registration ZU-JXF were engaged in a simulated engine failure training flight at Durban Skydive Airfield in KwaZulu-Natal when the accident occurred. The flight was co

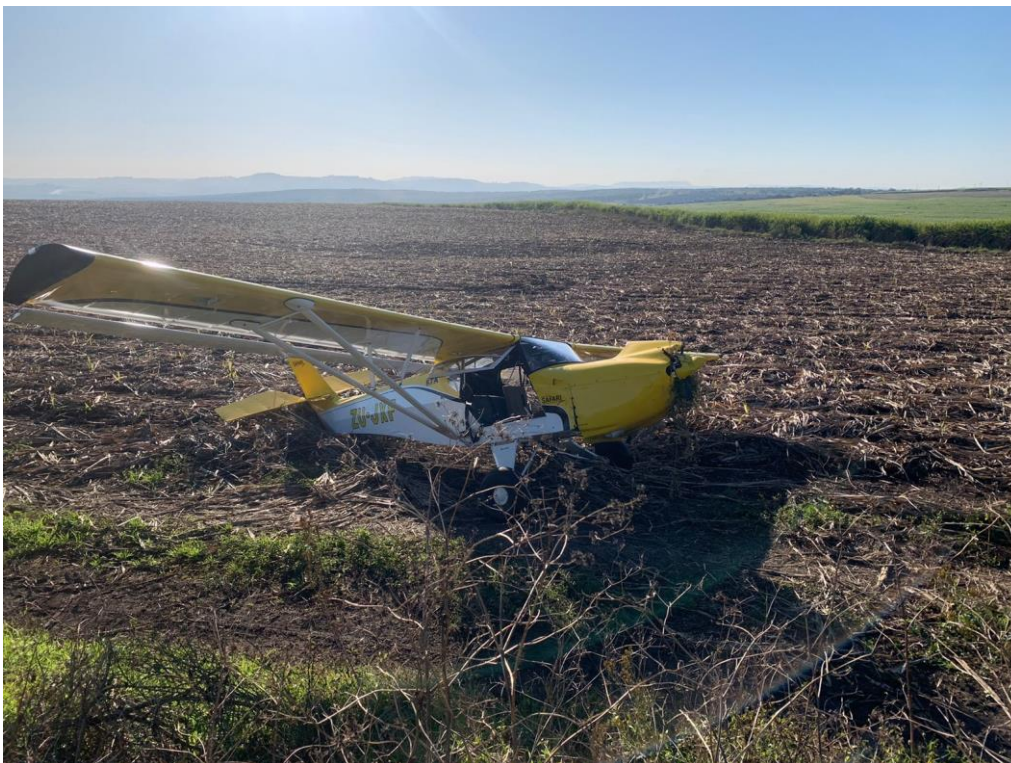
gear; it then touched down with the nose gear first, followed by the propeller striking the ground as it veered off the runway before it came to a stop on the right-side of it (runway). The aircraft made a 180° turn to face the opposite direction of landing.

Figure 2: The aircraft after the accident. (Source: Pilot)

The aircraft was flared too high and it stalled, resulting in loss of height and control before it bounced and veered off to the right of the runway.
