LIMITED ACCIDENT INVESTIGATION REPORT

Reference Number	CA18/2/3/10171						
Classification	Accident	Date	11 June 2022	Time	1105Z		
Type of Operation	Private (Part 94)						
Location							
Place of Departure	Richmond Airfield, KwaZulu-Natal Province		Place of Intended Landing		Bingelela Private Airstrip, KwaZulu-Natal Province		
Place of Accident	200m from the end of Runway 33 at Bingelela Private Airstrip						
GPS Co-ordinates	Latitude	S 28°42'30"	Longitude	E 29°19'35"	Altitude	3789 feet (ft)	
Aircraft Information							
Registration	ZU-IBX						
Model/Make	RV 9, Vans Aircraft (Serial Number: 91877)						
Damage to Aircraft	Substantial		Total Aircraft Hours		576.9		
Pilot-in-command							
Licence Type	Private Pilot Licence (PPL)	Gender	Male		Age	63	
Licence Valid	Yes						
Total Hours on Type	576		Total Flying Hours		1610		
People On-board	1+1	Injuries	2	Fatalities	0	Other (on ground)	0
What Happened							
<p>On 11 June 2022 at 1020Z, a pilot and a passenger on-board a Raven RV9 with registration ZU-IBX were engaged in a navigational flight from Richmond Airfield to Bingelela Private Airstrip, both situated in KwaZulu-Natal province. The flight was conducted during daylight me

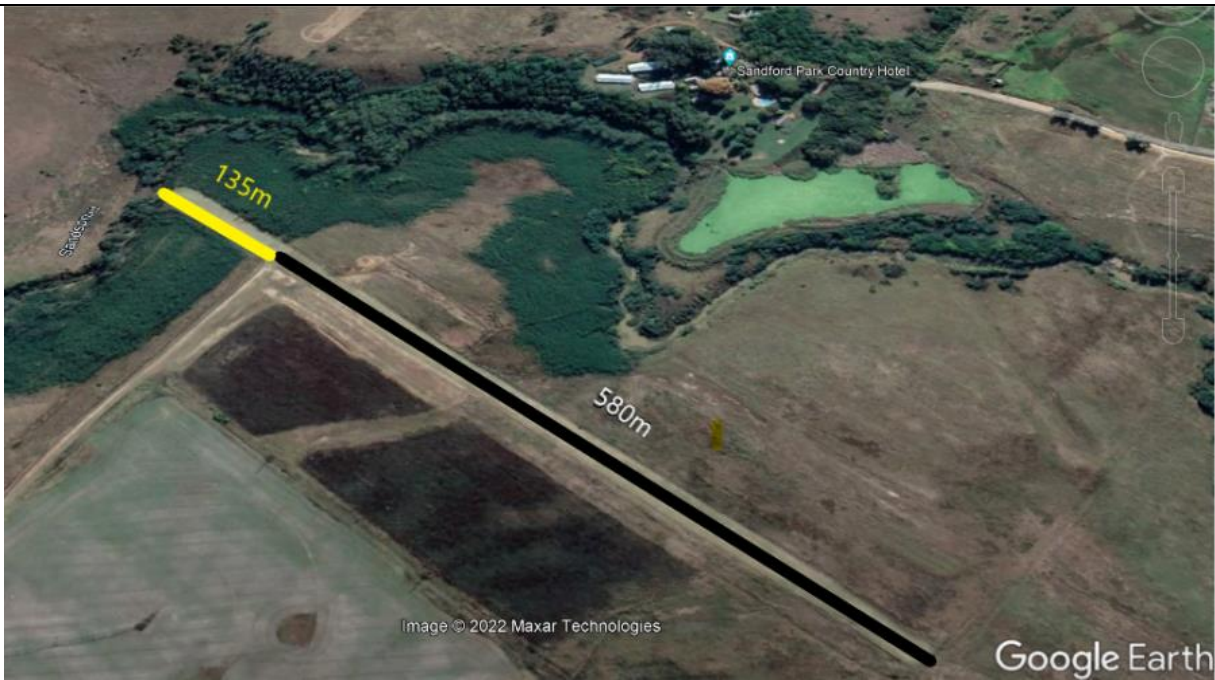
Figure 2: The runway length was adequate as for the aircraft could stop in 410ft (128m).
 (Source: Google Earth)

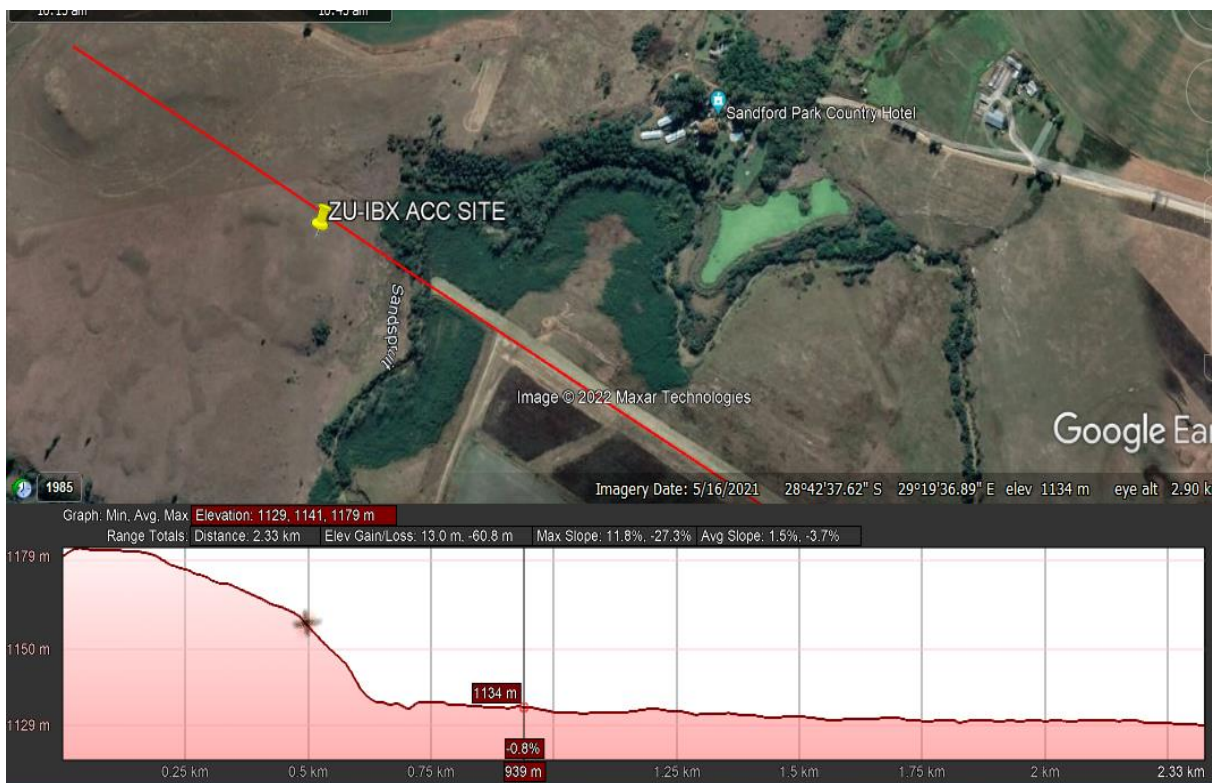
Figure 3: The aircraft was unable to clear the inclined terrain ahead of the runway, and it impacted the terrain at 67.2 feet above ground level. (Source Google Earth)

The aircraft was landed at a high-speed, resulting in the aircraft floating and the pilot executing an unsuccessful go-around due to the rising terrain and, subsequently, crashed.

Pilots are reminded to always opt for a go-around when the aircraft is not stable during approach for landing.

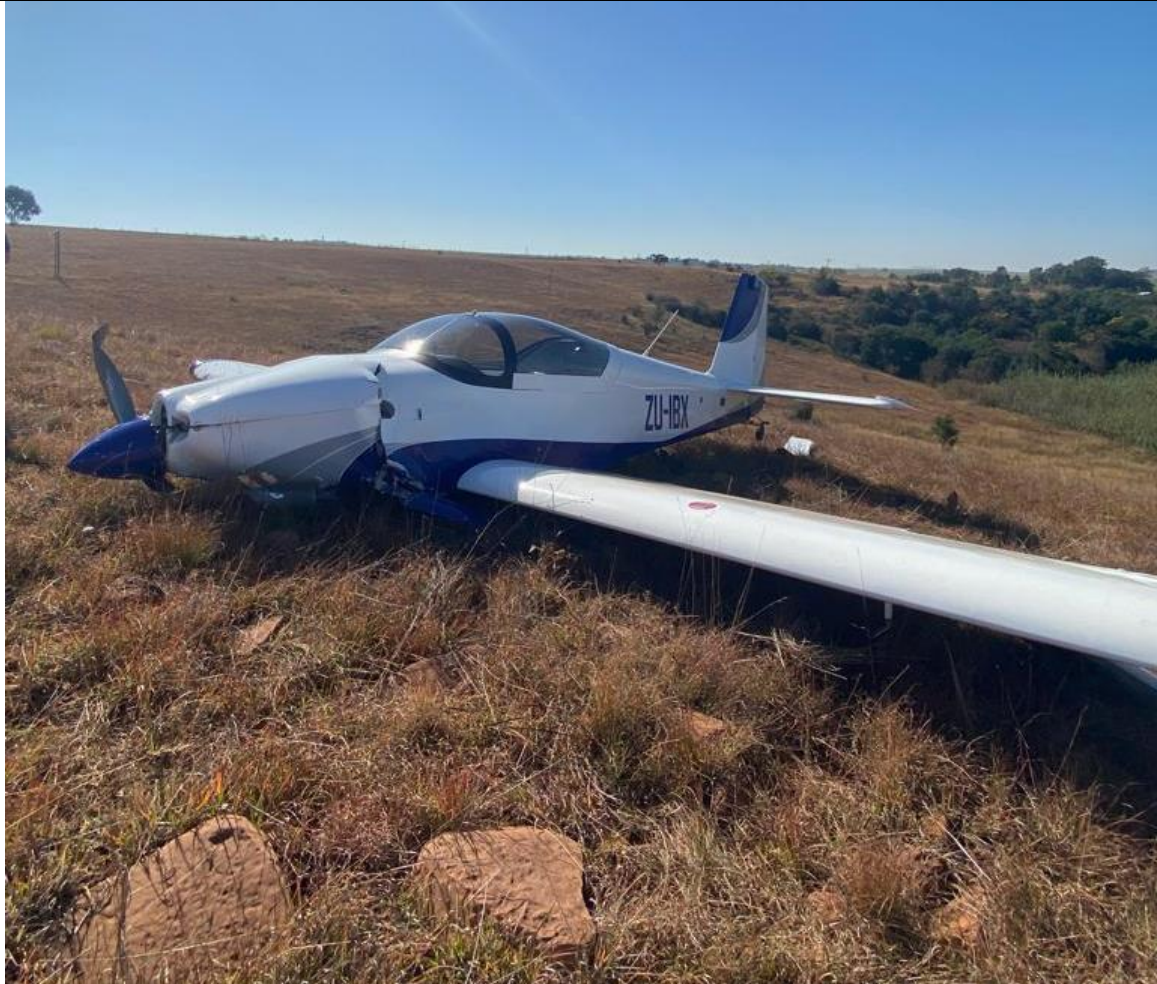
around was initiated towards the last part of the runway with the intention to clear the hill at the end of the runway. The pilot had selected 20° take-off flaps but due to the steep angle of attack, the aircraft could not achieve a positive rate of climb to clear the inclined terrain ahead. Upon deducing that the aircraft was not going to clear the hill, the pilot decided to fly the aircraft as close to a stall as possible until it impacted the hill. It came to a stop 20 metres (m) from the point of first impact. Both occupants sustained minor injuries during the accident sequence. The aircraft's undercarriage, flaps, engine cowling and the propeller were damaged.

Figure 4: The aircraft as it came to rest on the hill. (Source: Owner)
