LIMITED ACCIDENT INVESTIGATION REPORT
--

Reference Number		CA18/2/3/10174					
Classification	Accident	Date	15 June 2022	Time	0720Z		
Type of Operation	Training (Part 141)						
Location							
Place of Departure	Grand Central Aerodrome (FAGC), Gauteng Province		Place of Intended Landing	Grand Central Aerodrome (FAGC), Gauteng Province			
Place of Occurrence	Runway 17 at FAGC, Gauteng Province						
GPS Co-ordinates	Latitude	S25° 59'.13. 44"	Longitude	E28° 08' .25.97"	Elevation	5325 feet	
Aircraft Information							
Registration	ZS-STV						
Model/Make	Cessna 172M Skyhawk (Serial Number: 172-64720)						
Damage to Aircraft	Substantial		Total Aircraft Hours	7472.8			
Pilot-in-command							
Licence Valid	Yes	Gender	Male	Age	39		
Licence Type	Student Pilot Licence (SPL)						
Total Hours on Type	35.5		Total Flying Hours	39.7			
People On-board	1 + 0	Injuries	0	Fatalities	0	Other (On Ground)	0
What Happened							
<p>On Wednesday, 15 June 2022, a student pilot on-board a Cessna 172M Skyhawk aircraft with registration ZS-STV took off on a training flight from Grand Central Aerodrome (FAGC) in Midrand, Gauteng province, with the intention to land back at the same aerodrome. Visual mete

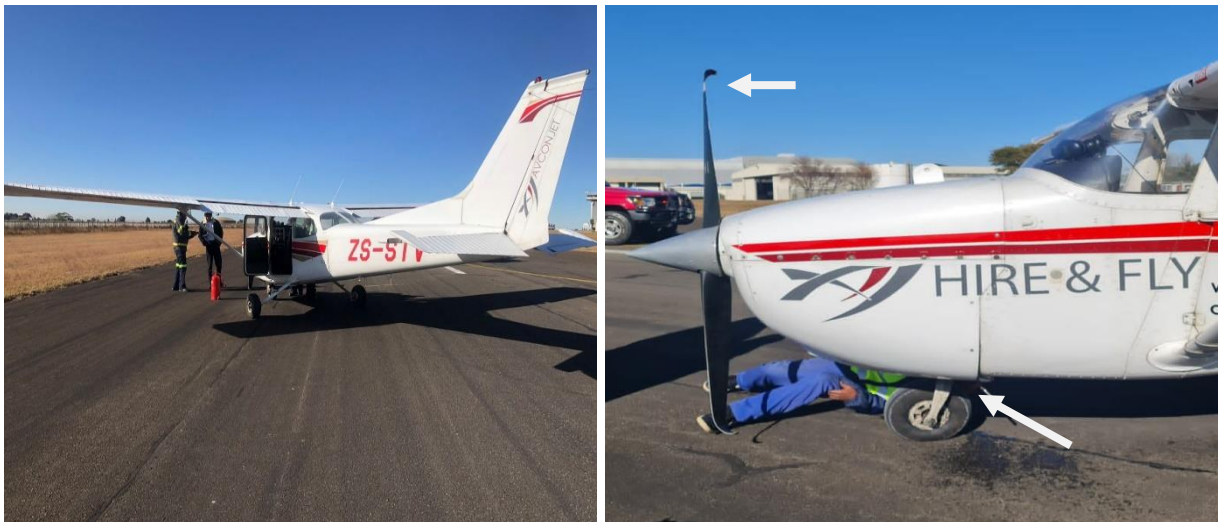
The aircraft had 26 US gallons of Avgas 100LL in the tanks. At approximately 0545Z, the student pilot commenced with the take-off roll from Runway 17 with the engine power set at 2600 revolutions per minute (RPM). After the aircraft had climbed to an altitude of 7500 feet (ft), the student pilot retarded the throttle lever to 2400 RPM and flew towards FAGC / Brits Aerodrome (FABS) general flying (GF) area where he practised steep turns and simulated precautionary landing exercises. Once satisfied, the student pilot navigated the aircraft back to FAGC for a full stop landing. Upon reaching FAGC, he contacted FAGC air traffic control (ATC) on frequency 122.8-Megahertz (MHz) to request clearance to join Runway 17. After receiving clearance from the ATC, the student pilot joined the traffic pattern and, later, approached at 90 miles per hour (mph). During landing with the flaps extended to 30°, the student pilot thought that the main landing gear wheels had already settled on the runway and he released the back pressure on the control column with the intention to settle the nose gear. However, the aircraft impacted the runway surface very hard with the nose gear, followed by propeller strikes on the runway surface. The aircraft sustained substantial damages.

Figures 1 and 2: The aircraft on the runway (left picture). The aircraft with the arrow shows the bent propeller blade tips and nose gear (right picture). (Source: Operator)

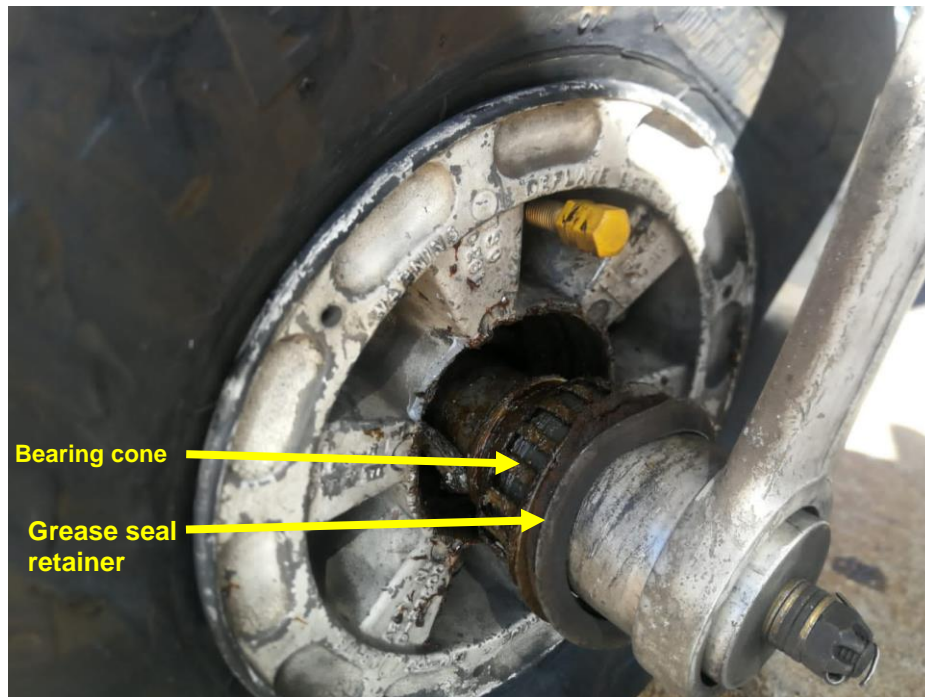
The aircraft was recovered to an approved AMO for further examination. Inspection of the aircraft revealed no evidence of flight control cables disconnection or control restrictions. The horizontal stabiliser and the elevator trim tab were correctly set on neutral position. The student pilot, when interrogated, reported no malfunction of flight instruments. The nose gear oleo was found bent forward, and the nose wheel assembly was displaced due to the hard landing. The wheel hubs circlips had detached, and the grease seal retainers and bearing cones were exposed. The nose gear tyre was found correctly inflated, and the treads were well defined.

Figure 3: The nose wheel assembly. (Source: Operator)
