LIMITED ACCIDENT INVESTIGATION REPORT
--

Reference Number	CA18/2/3/10176						
Classification	Accident	Date	18 June 2022	Time	1230Z		
Type of Operation	Private (Part 91)						
Location							
Place of Departure	Nelspruit Aerodrome (FANS), Mpumalanga Province			Place of Intended Landing	Rietfontein Airstrip, Mpumalanga Province		
Place of Accident	During landing on Runway 03 at Rietfontein Airstrip						
GPS Co-ordinates	Latitude	S 30° 11' 59"	Longitude	E 024° 56' 39"	Elevation	4500ft	
Aircraft Information							
Registration	ZU-INW						
Model/Make	Sling 4 (Serial Number: 073k)						
Damage to Aircraft	Substantial			Total Aircraft Hours	223		
Pilot-in-command							
Licence Type	Private Pilot Licence (PPL) Aeroplane	Gender	Male	Age	58		
Licence Valid	Yes						
Total Hours on Type	4.6			Total Flying Hours	126.0		
People On-board	1+0	Injuries	0	Fatalities	0	Other (on ground)	0
What Happened							
<p>On Saturday, 18 June 2022, a pilot on-board a Sling 4 aircraft with registration ZU-INW was on a private flight from Nelspruit Aerodrome (FANS) to Rietfontein Airstrip, both in Mpumalanga province. The flight was conducted under visual meteorological conditions (VMC) by day and under th

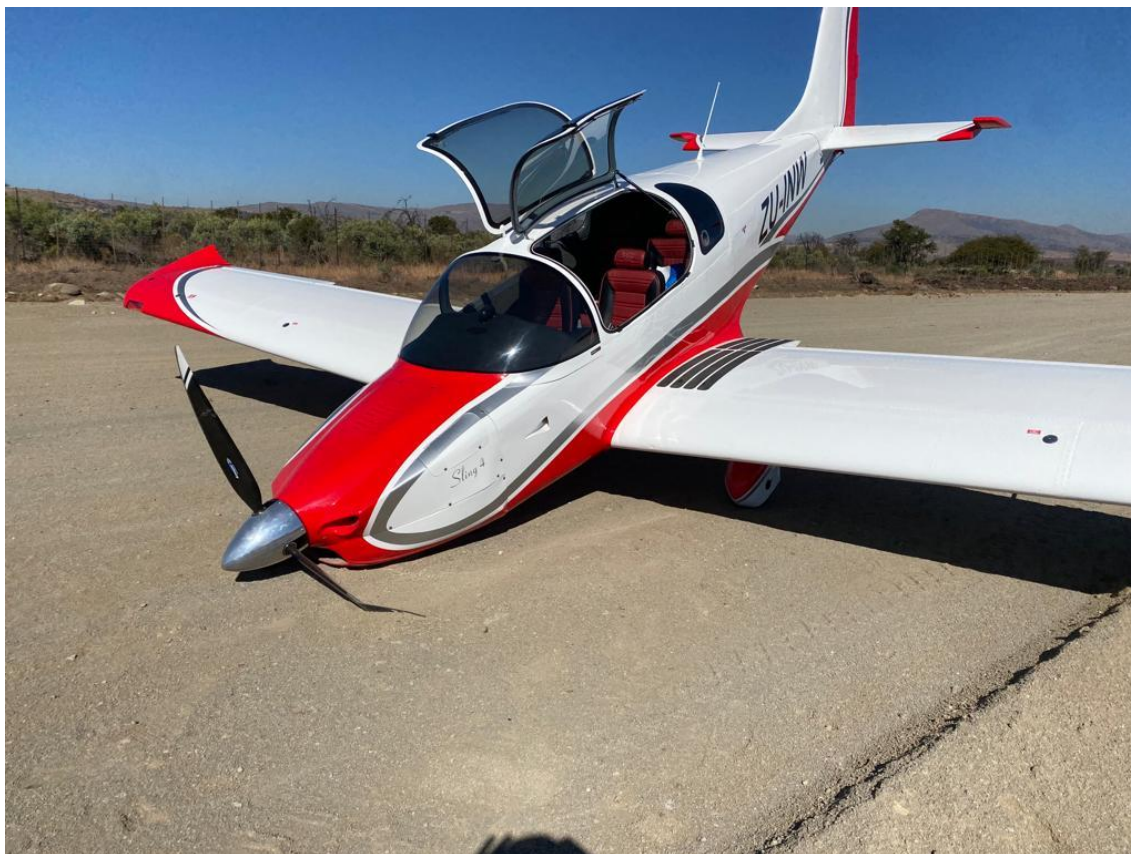
Figure 1: The aircraft post-accident. (Source: Pilot)

The aircraft's approach speed was low, resulting in a stall which caused the aircraft to drop or lose height before it bounced twice and landed on its nose gear, which subsequently broke off.
