LIMITED ACCIDENT INVESTIGATION REPORT

| Reference Number | CA18/2/3/10183 | | | | | |
| Registration | ZU-RKM | | | | | |
| Make/Model | Trojan (Serial Number: 1310) | | | | | |

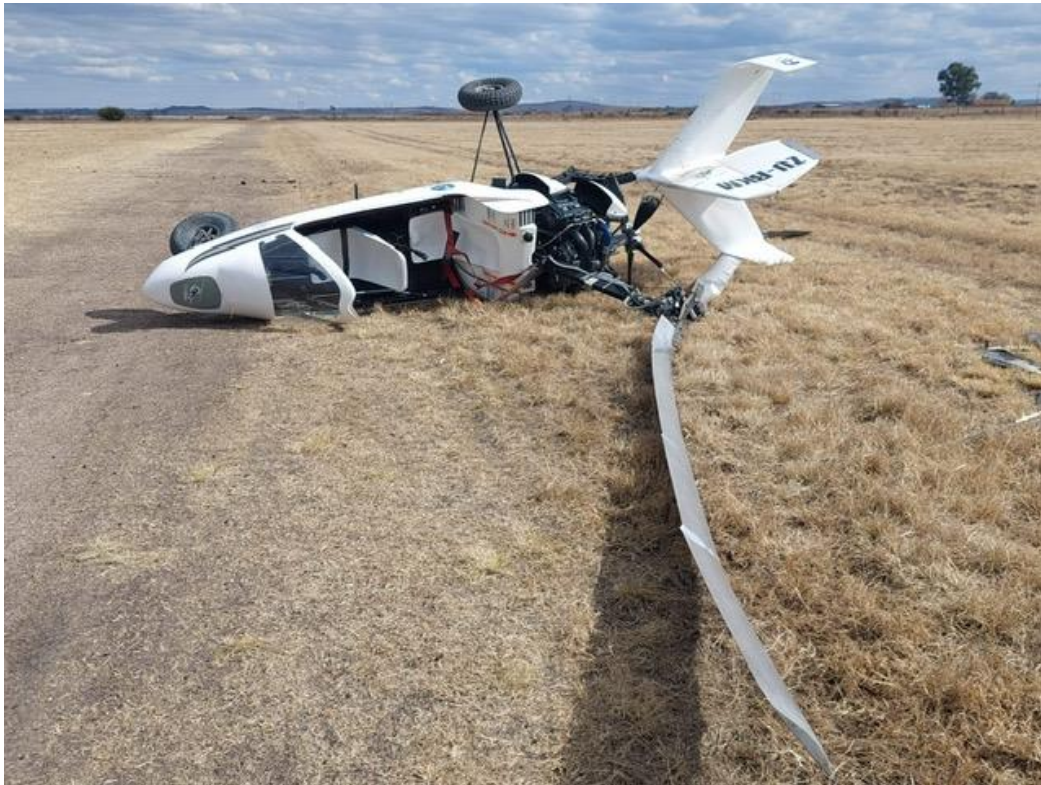
The duo then shut down the engine and evacuated the gyrocopter, they were uninjured. The gyrocopter sustained substantial damage to the propeller blades, main rotor blades and the left-side of the fuselage.

Figure 1: The gyrocopter at the site after the accident. (Source: Pilot)

The gyrocopter was rounded-out and flared too late, which resulted in the main rotor blades impacting the runway before the gyrocopter rolled on its left-side and remained in that position.

Contributory factor:

The instructor did not take over control of the gyrocopter to avoid losing too much height, resulting in late flaring by the student pilot.

The Approved Training Organisation (ATO) had a post-accident briefing with both the instructor and the student pilot about identifying the early signs of an unstable approach.
