**LIMITED ACCIDENT INVESTIGATION REPORT - FINAL**

| <b>Reference Number</b> | CA18/2/3/10184 | | | | | | |
| Registration | ZU-IPN | | | | | | |
| Make/Model | Van's RV-10 (Serial Number. 41813) | | | | | | |

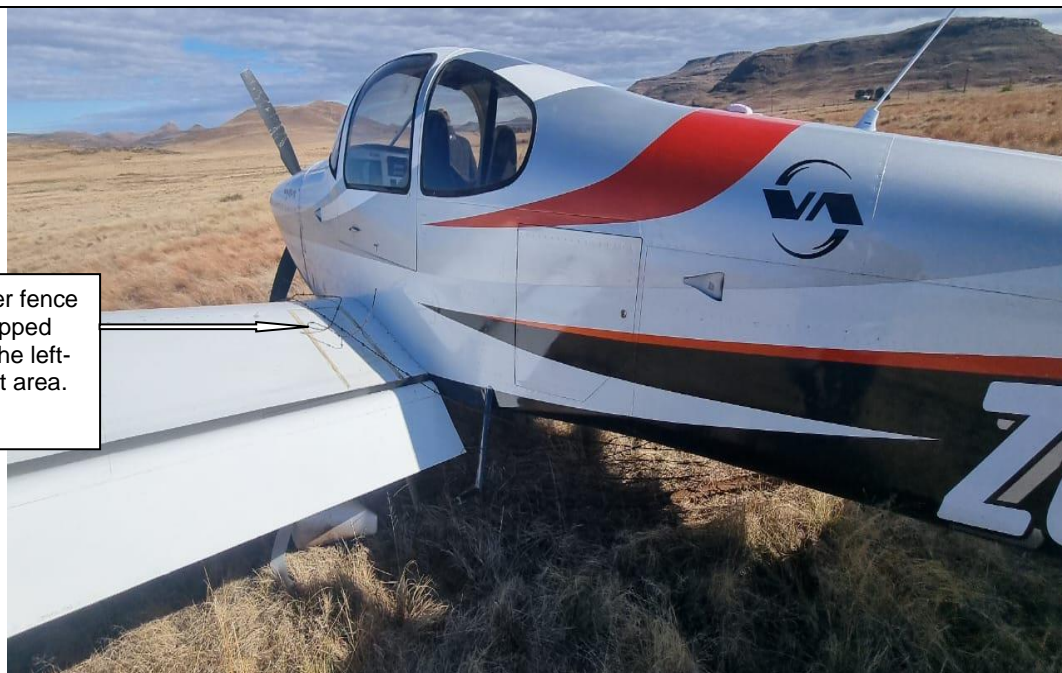
The pilot reported that after the passengers had boarded the aircraft, he started the engine and allowed it to run for a few minutes until all the indications were within limits. He later taxied the aircraft to the threshold of the gravel runway where pre-departure checks were carried out. At approximately 0915Z, he opened the throttle to 2 550 engine revolutions per minute (RPM) and took off into the wind in a northerly direction towards higher grounds/mountainous area. During the climb at approximately 75 feet above ground level (AGL), the pilot felt a severe vibration that was caused by a strong turbulent wind and, as a result, the aircraft entered an uncontrolled descent. The pilot's attempts to recover the aircraft were in vain and, thus, opted to perform a forced landing on an open field that was adjacent to the runway. During the landing roll, the aircraft collided with the perimeter fence which severed the aircraft's fuel tanks, causing all the remaining fuel to leak out. The aircraft sustained substantial damages; however, the occupants were not injured.

**Figure 2:** The aircraft post-accident.

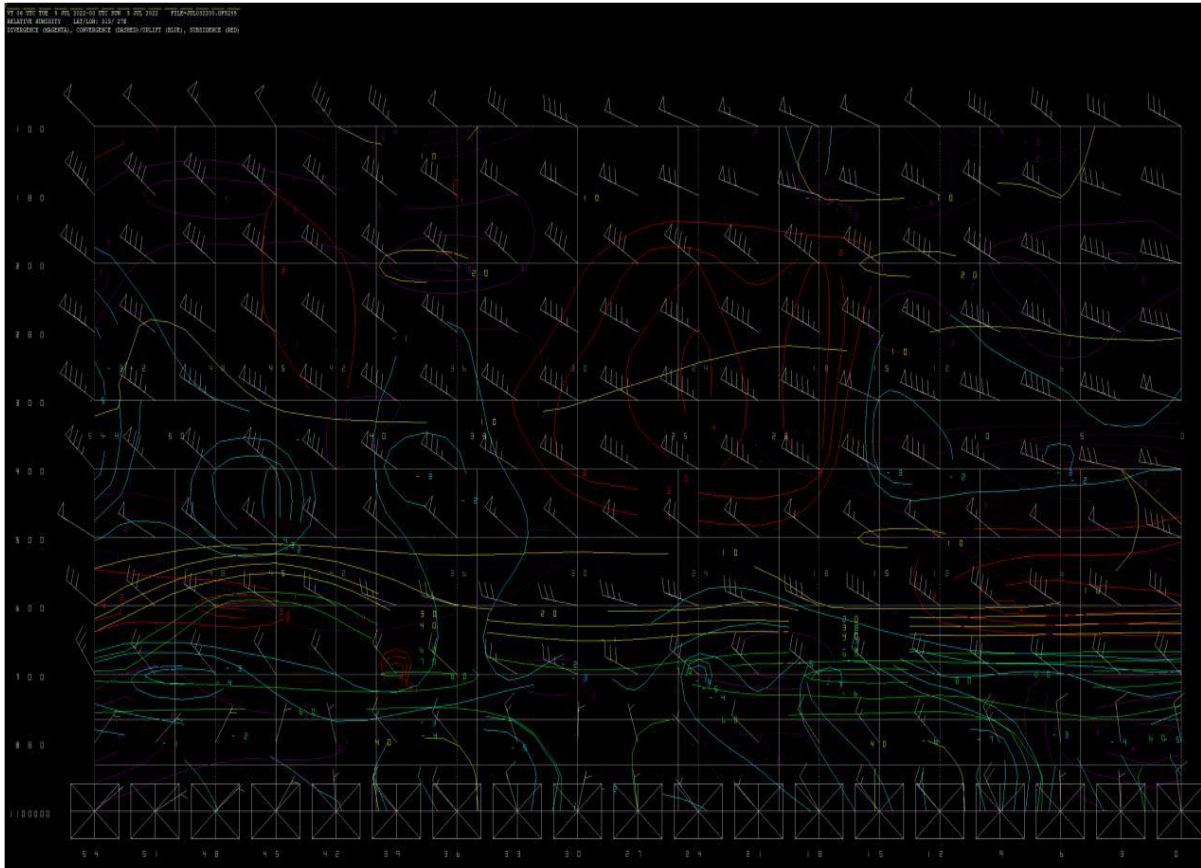
The vertical profile of the atmosphere over the accident area showed some moisture close to the surface which warranted for scattered clouds. In addition, strong north-westerly winds (approximately 30 knots) were noted at the altitude at which the aircraft began losing height. The drastic change in surface winds compared to winds at altitude indicated shearing (turbulence). The vertical analysis of wind changes also indicated some mountain waves from the mountain side which had an elevation of 7 000ft. This coincided with the wave-like pattern, indicating severe mountain wave turbulence.

**Figure 3:** The satellite image indicating upper air analysis over the accident area.

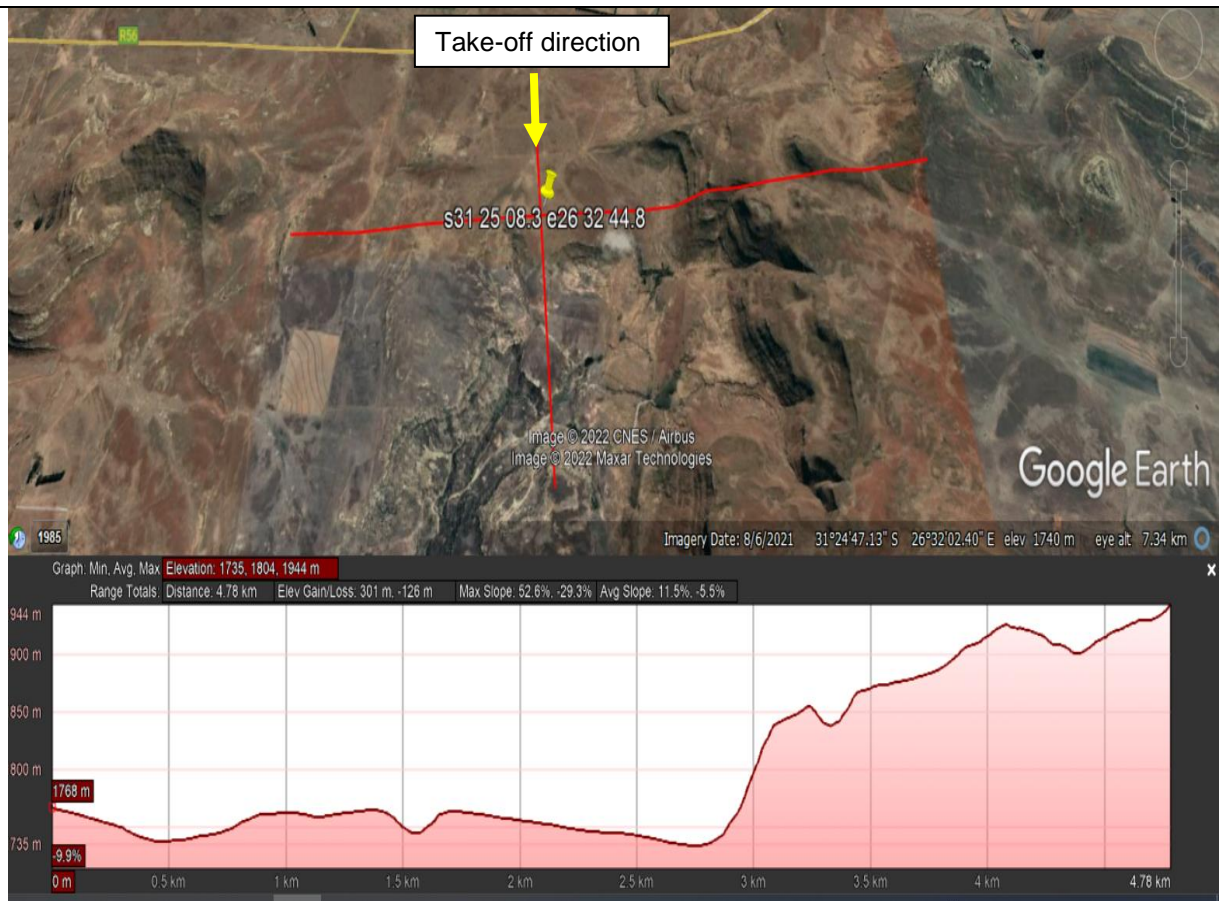
**Figure 4:** The topography of the area where the aircraft was operated. (Source: Google Earth)

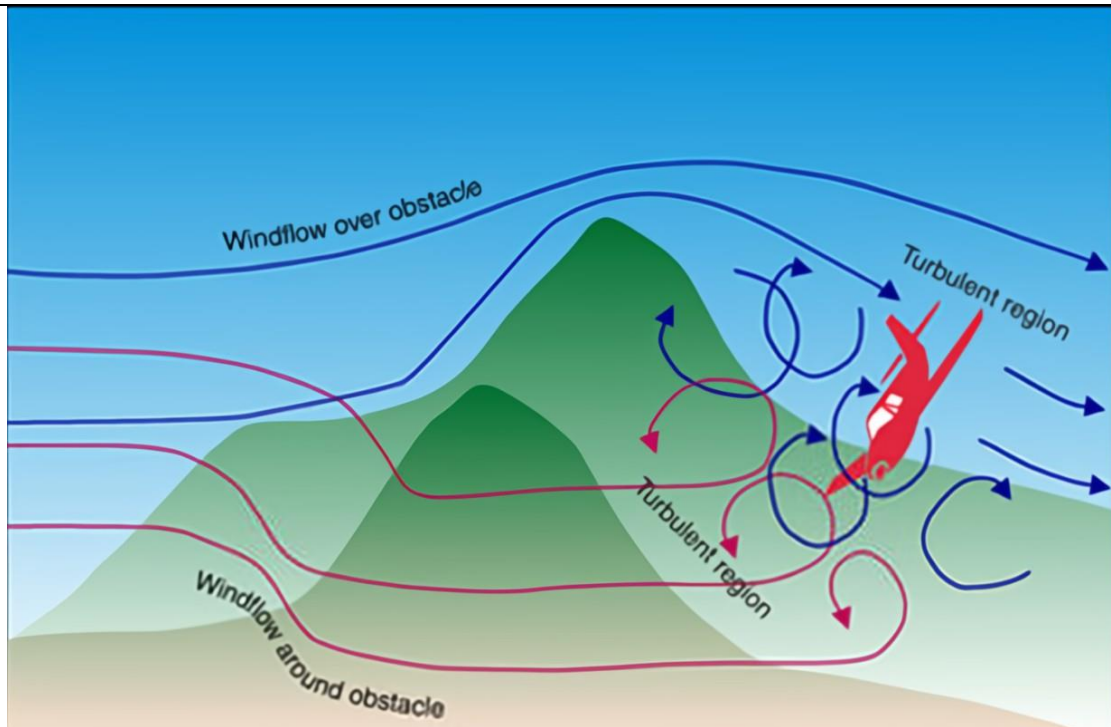
**Illustration 1:** The hypothetical air flow pattern associated with a mountain wave.

The aircraft took off in the direction of the mountain and, whilst on the climb, it lost lift because of the mountain wave; this was followed by an unsuccessful forced landing on a field next to the runway.
