AIRCRAFT SERIOUS INCIDENT SHORT REPORT

CA18/3/2/1189: ZS-MNS, Smoke in cockpit during flight.

Aircraft registration : ZS-MNS

Aircraft manufacturer and model : Piper Aircraft Corporation PA31-310

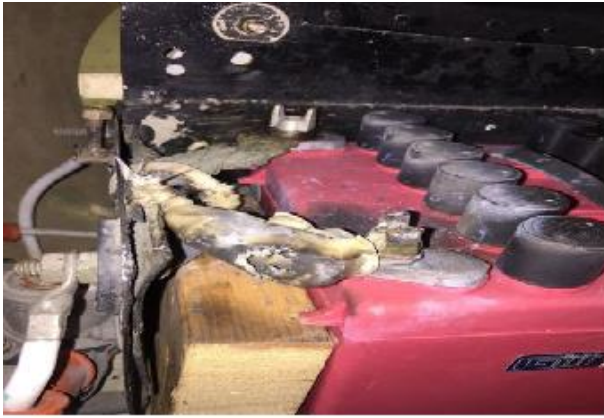
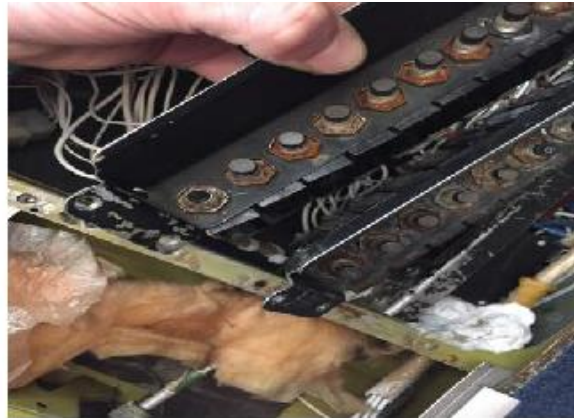
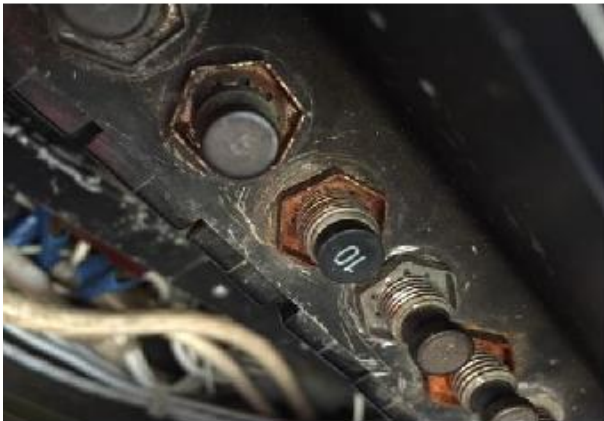
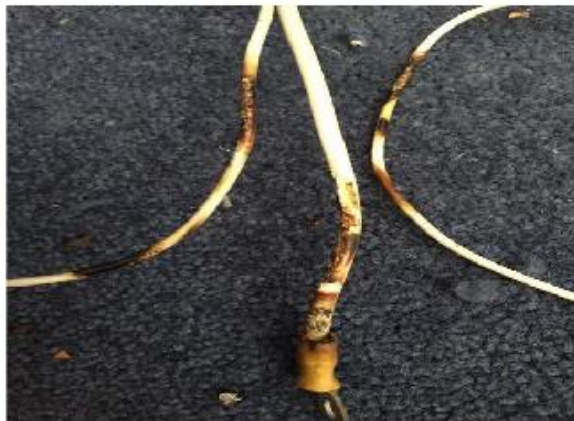
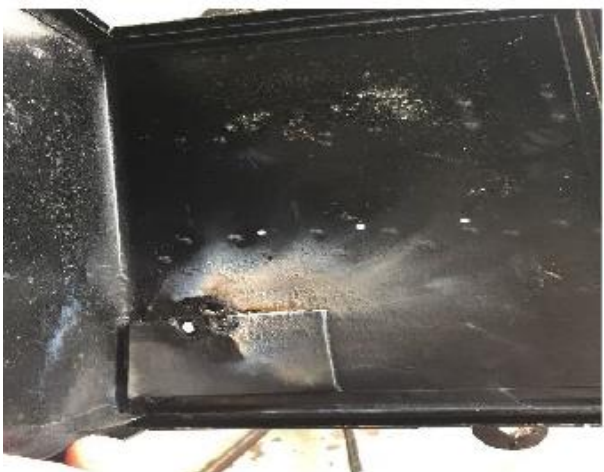
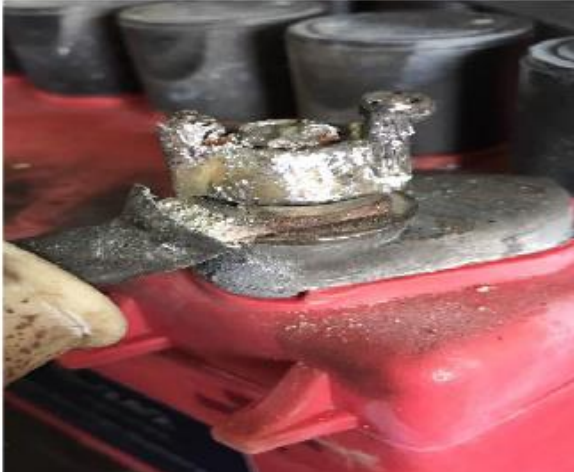
2.8 Burnt wires were found behind the circuit breaker panel and inside the nose area on the landing gear power pack system.

2.9 The circuit breakers were found to be old and corroded in the circuit breaker panel.

2.10 It was found that the battery had made contact with the metal lid when turbulence was encountered during the flight. The box top lid had burnt due to this. The battery box did not have a proper securing bracket to avoid this type of contact.

The contact of the battery terminals due to turbulence and the metal box lid caused severe arcing in the battery bay compartment. This created the smoke in the cockpit where the crew requested priority landing and the aircraft was cleared to land and landed safely at FAOR.

Figure 2: The damage sustained by the battery, battery lid and damaged wires

1. All burnt or damaged wiring were replaced.
2. Old corroded circuit breakers were replaced with new circuit breakers.
3. Corrosion was cleaned up on the circuit breaker panel.
4. New battery box was installed, which will ensure the battery is properly secured to avoid a re-occurrence of this incident.
5. Landing gear retractions and flap retractions inspection was satisfactory serviceability.
6. All electrical systems operated for 20 minutes with power to ensure no faults or failures occur.
