AIRCRAFT SERIOUS INCIDENT SHORT REPORT

CA18/3/2/1191: ZU-BAJ, Premature rotation during take-off roll

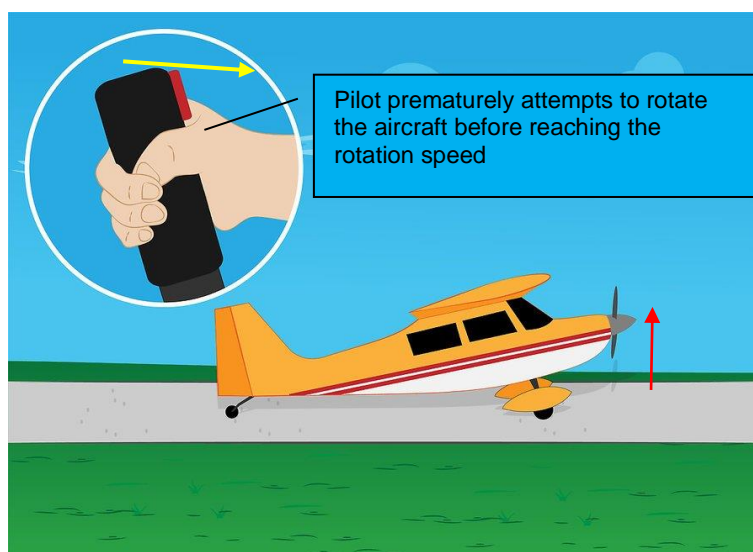
The pilot prematurely pulled the stick back in an attempt to rotate the aircraft (yellow arrow) (Source: wikihow)

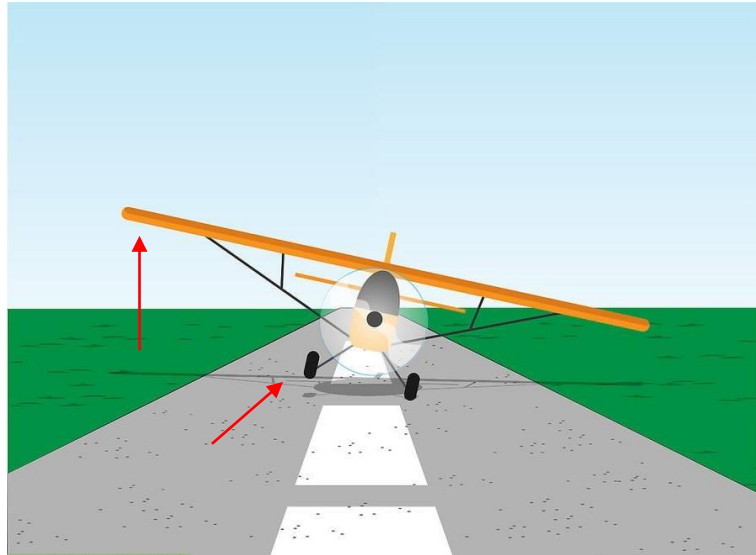
Due to the premature rotation, the right wing and main landing gear lifted off the runway surface (Source: wikihow)

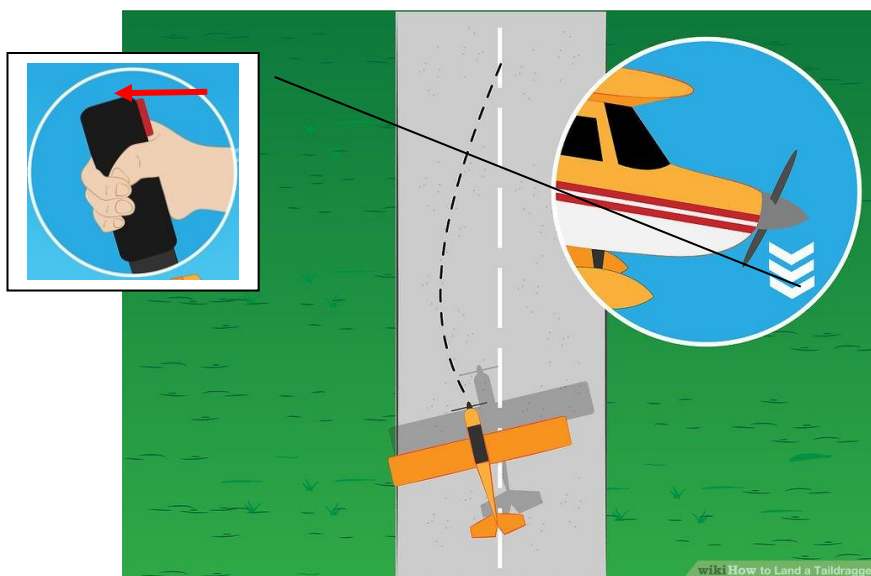
In an attempt to gain control and prevent a stall the pilot pushed the stick forward (red arrow) causing the nose of the aircraft to lower (white chevron). This caused the aircraft's propeller and nose cowling to impact the runway surface. (Source: wikihow)

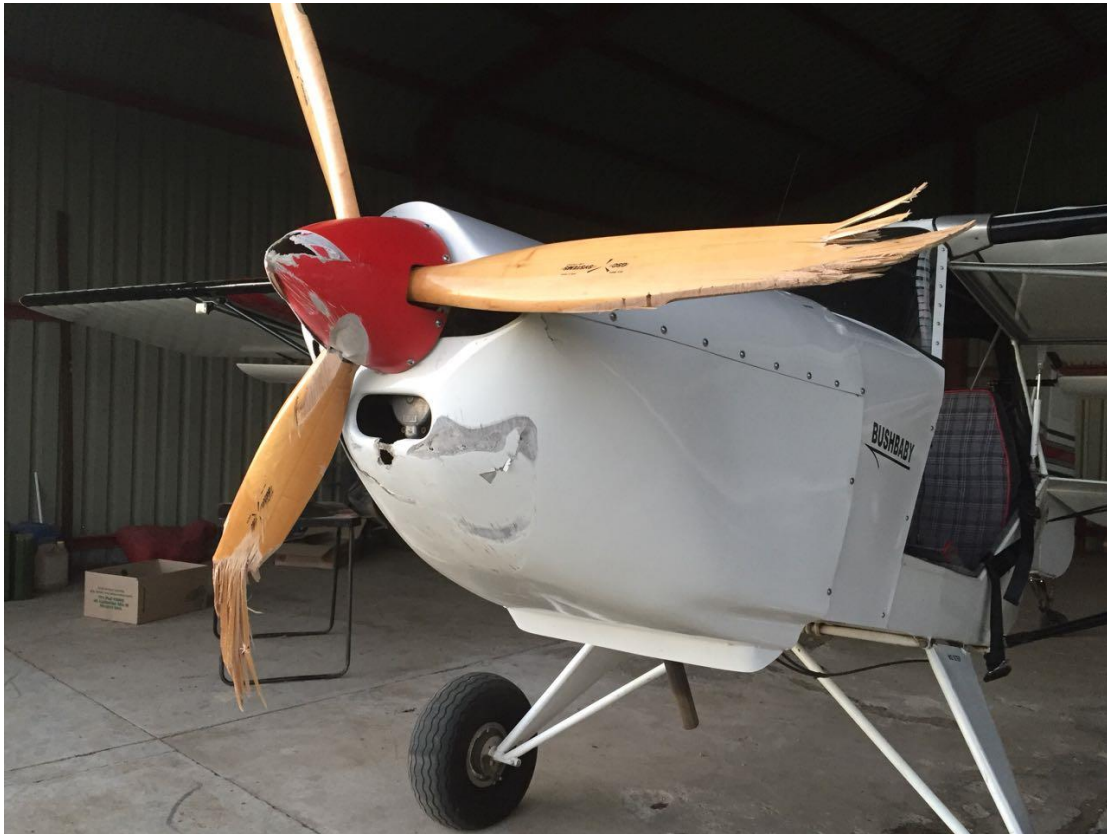
- 2.2 The pilot stated that the right wing and the right main wheel lifted off from the runway surface. He then reduced the throttle and pushed the stick forward in an attempt to land back on the remaining runway surface available with the intention of preventing a stall. The aircraft pitched nose down and the propeller and engine cowling impacted with the runway surface. The aircraft skidded on its nose for 10 m before coming to rest. The aircraft sustained damage to the propeller, spinner and engine cowling, as can be seen in Figure 1. The pilot was not injured in the incident.

Figure 1: Damage sustained to the aircraft (source: L le Roux)

The pilot prematurely attempted to rotate the aircraft which caused the right wing to gain lift before the left wing.

- The pilot debriefed the incident with a flying instructor to better understand what happened and how to prevent such an occurrence in the future.
- Before the next solo flight in a conventional gear aircraft, the pilot will do further flying training with a flying instructor.
- The pilot intends to upgrade his licence to a private pilot's licence from an NPL

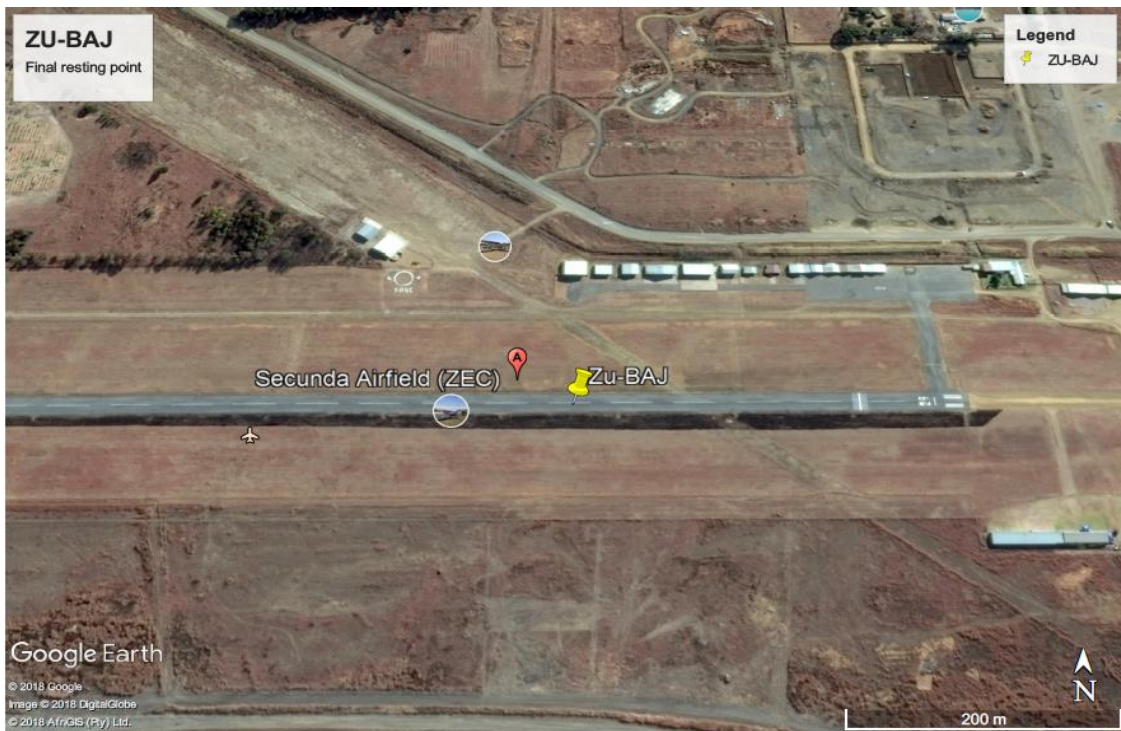
Figure 2: Location of ZU-BAJ on the runway after coming to rest (source: Google Maps)
