| <b>AIRCRAFT INCIDENT SHORT REPORT</b> |

CA18/3/2/1192 ZS-PAF, Ayres S2R T15 veered off grass runway.

**Aircraft manufacturer and model** : Ayres Corporation Ayres S2R – T15

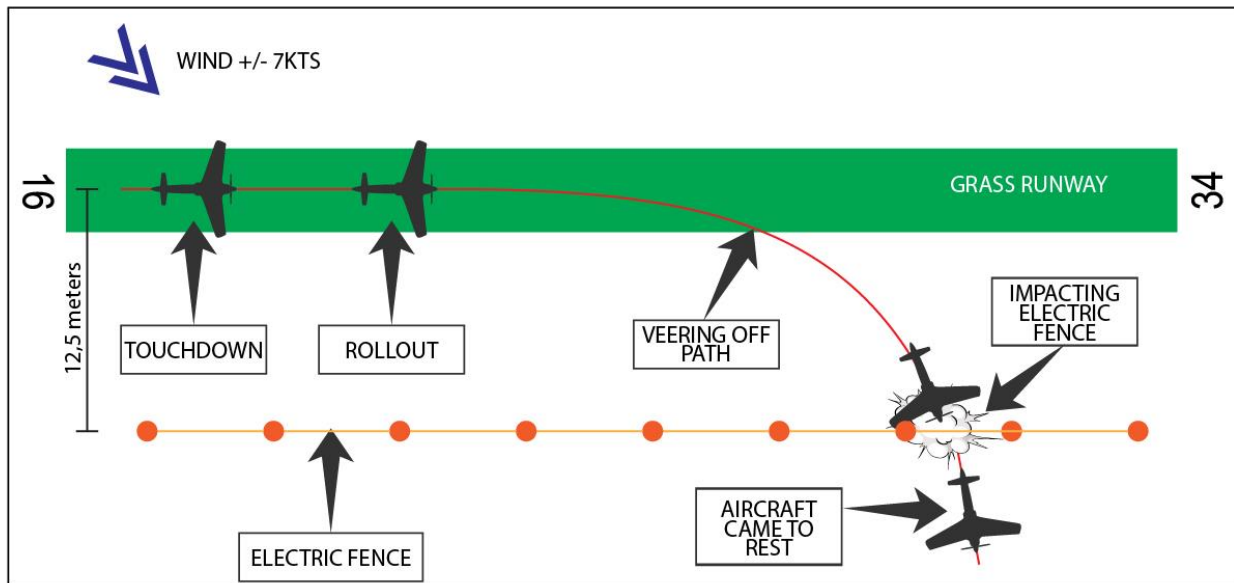
- 2.1.4 The aircraft came to rest after hitting the electric fence 12,5 meters right of the runway centre-line. The following damage was noted after impact:
- Both (left and right) flaps had tears
  - Dent to the right wing leading edge
  - Dent to the propeller tip leading edge
  - Deflated right tyre
- 2.1.5 The pilot did not sustain any injuries. Post flight inspection on the landing gear showed a deflated right tyre.
- 2.1.6 Good weather conditions prevailed at the time leading to the incident. The incident occurred in daylight.

**Figure 2:** Sketch showing approach direction and the layout after accident.

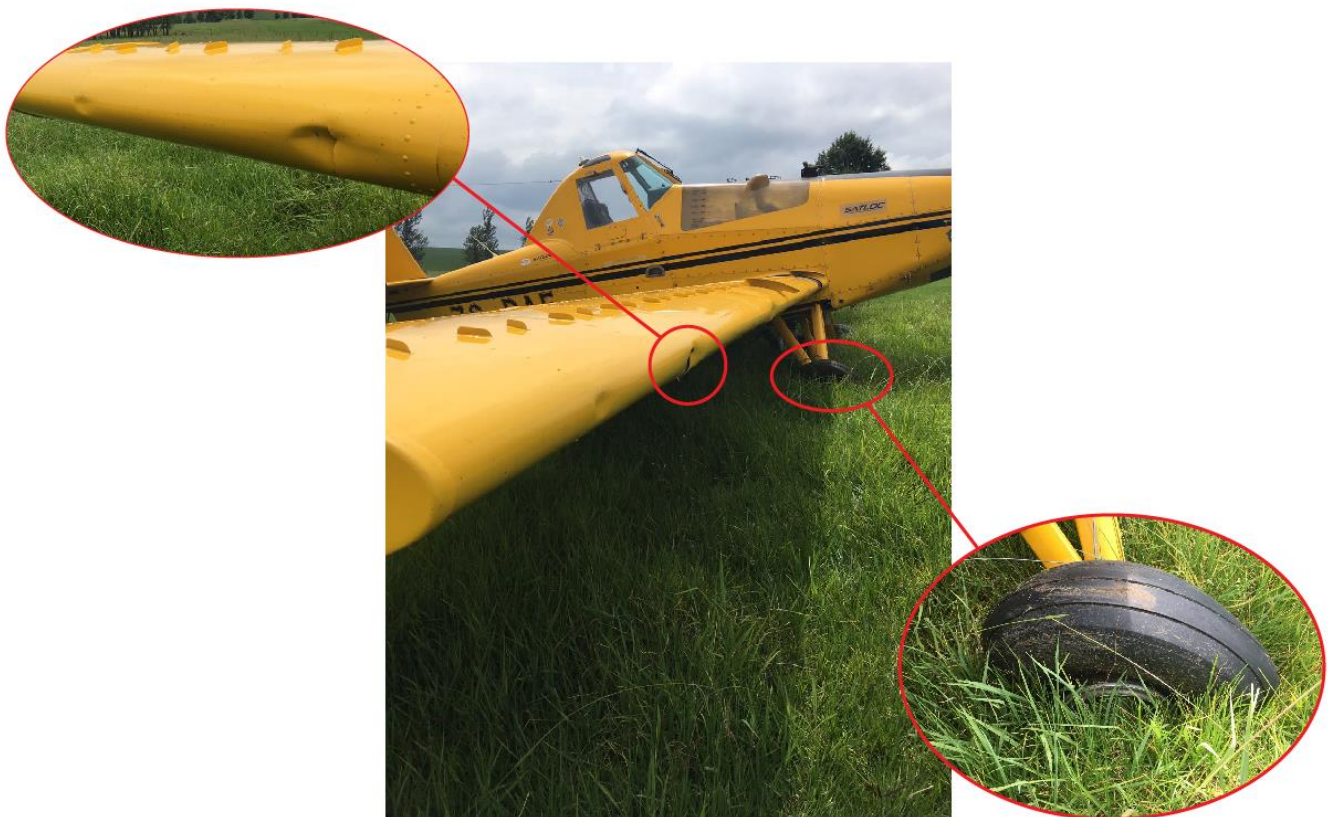
**Damage to aircraft** : The aircraft sustained the following damage: a tear in both (left and right) flaps, dent to the right wing leading edge, dent to the propeller tip leading edge, and deflated right tyre.

Figure 4: The deflated right tyre and damage caused to the right wing.

- 4.1 The loss of directional control was due to the deflated tyre on the right hand side landing gear, which resulted in the aircraft uncontrollably veering towards the right.

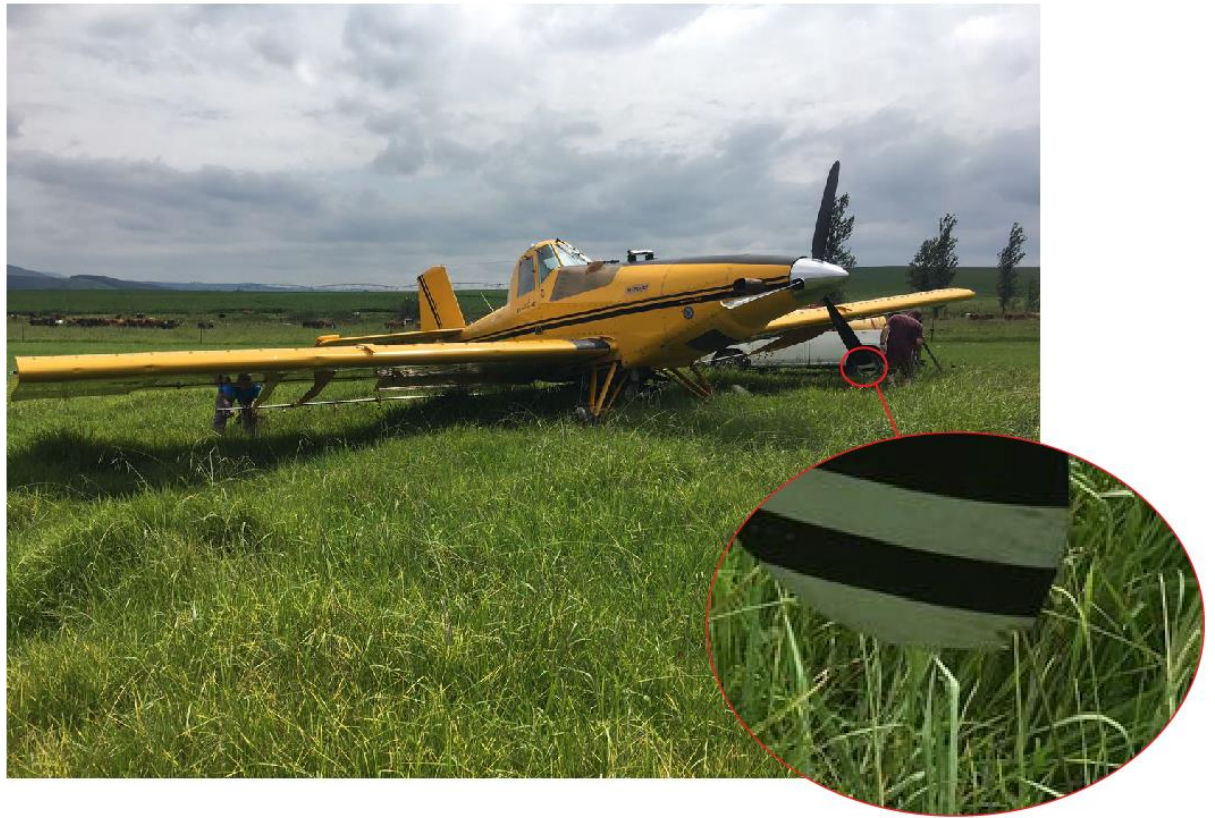
**Figure 5:** The damage sustained by the propeller.

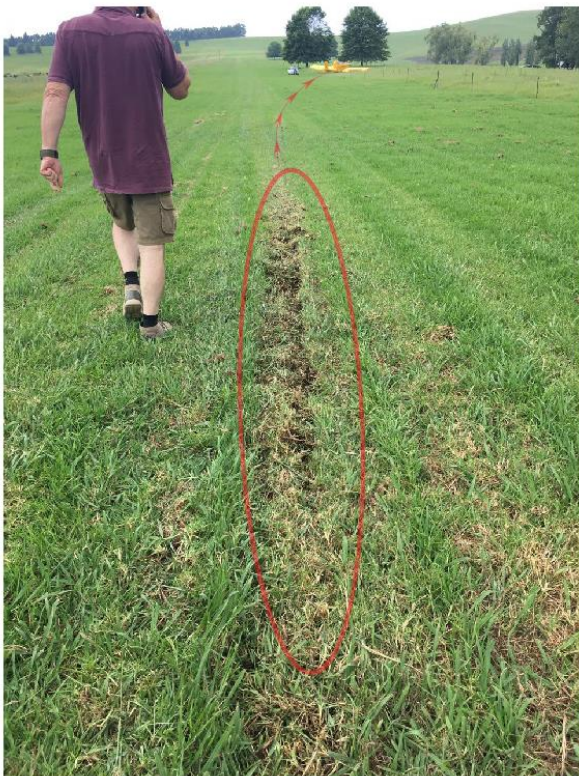
**Figure 6:** The point where the right tyre made contact with the grass runway and veered off towards the fence.

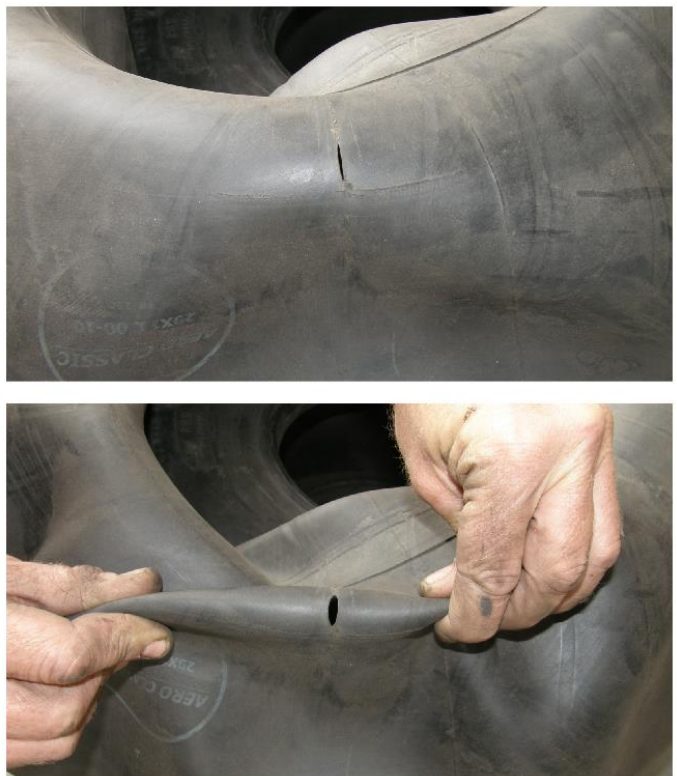
**Figure 7:** The deflated tube with the punctured area.
