<b>AIRCRAFT INCIDENT SHORT REPORT</b>
---------------------------------------

CA18/3/2/1193: ZU-IFA,

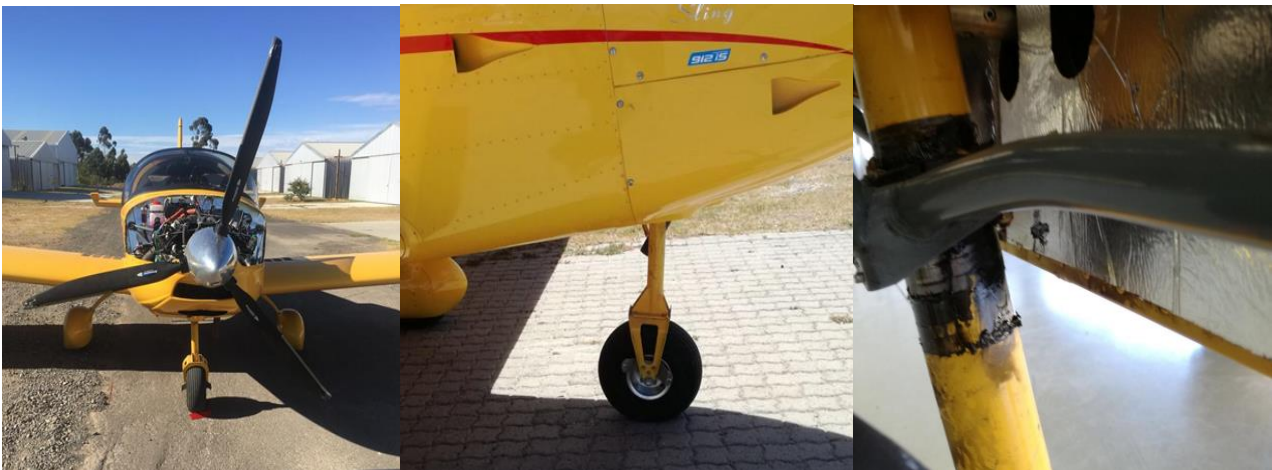
Figure 1: Shows damage on the propeller

Figure2: Nose landing gear bent backward

Figure 3: Nose gear mounting assembly damage

- 3.1 The aircraft experienced a sudden loss of height, in an attempt to recover the pilot's handling technique of the aircraft landing contributed to the nose gear damage.
