<b>AIRCRAFT INCIDENT SHORT REPORT</b>
---------------------------------------

**CA18/3/2/1196: ZU-EED, Forced landing after engine stoppage**

**Aircraft manufacturer and model** : Cubby Wings Tri-Cubby

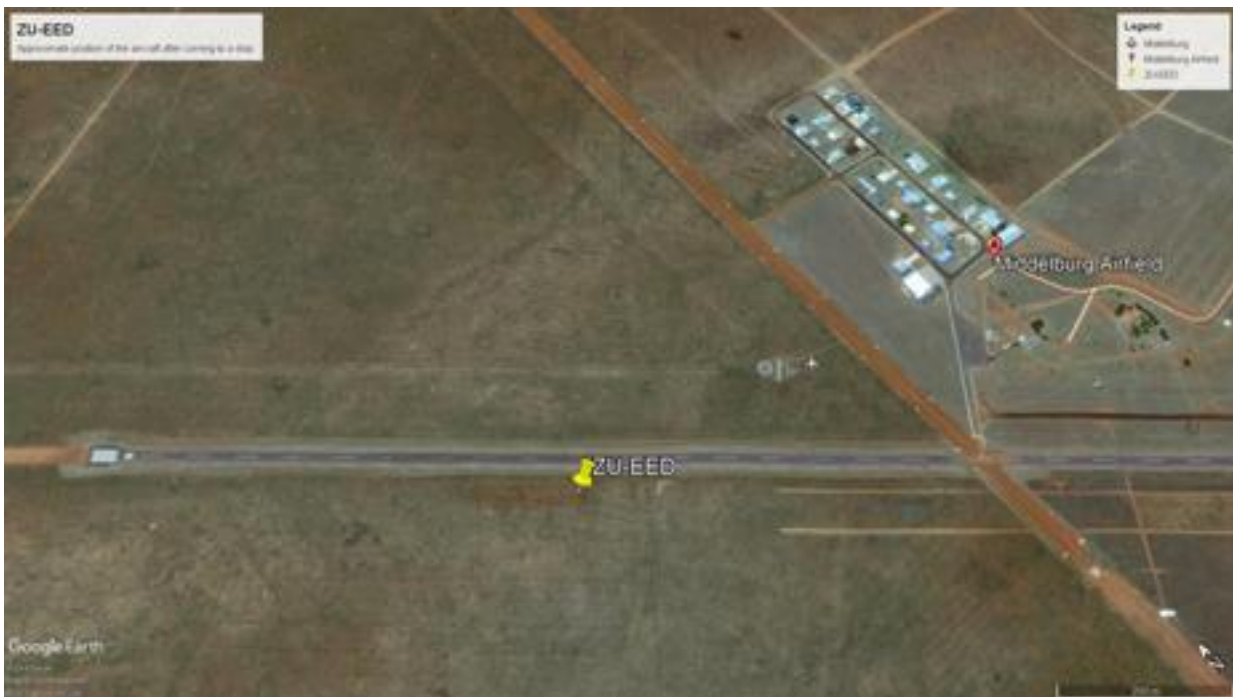
**Figure 1:** Final position of the aircraft at FAMB (Google Earth overlay)

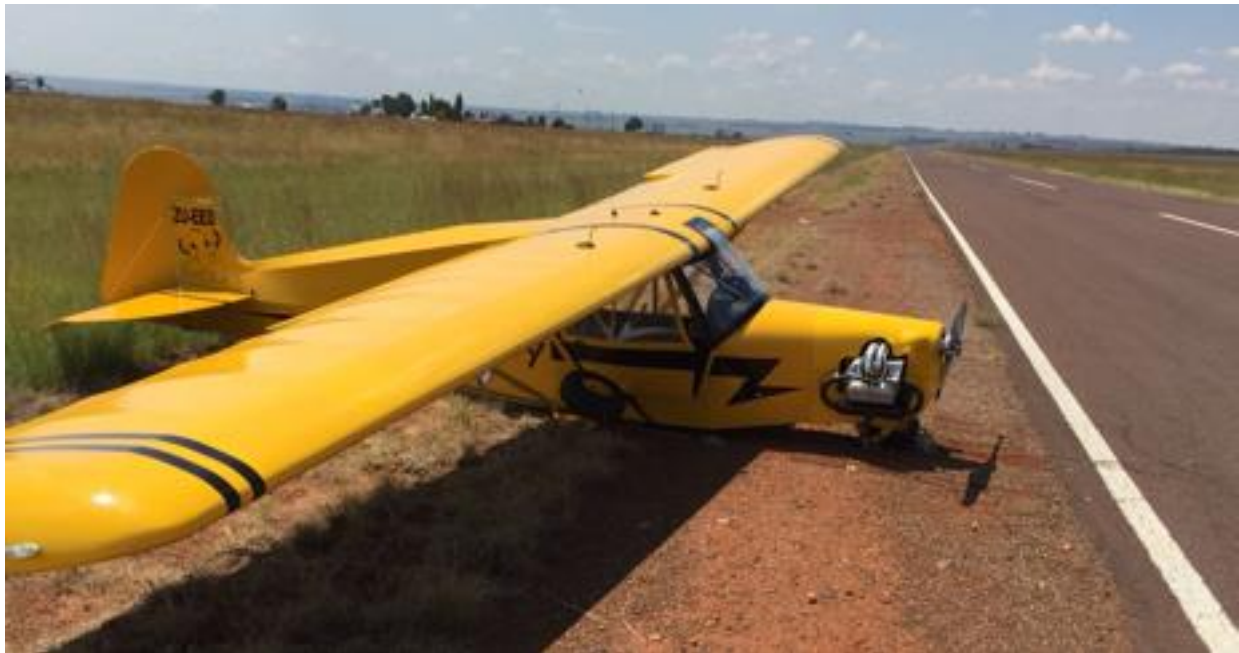
**Figure 2:** Damage to the landing gear (photograph courtesy of Mr J Bronkhorst)

The probable cause of the incident was due to an unsuccessful forced landing with the aircraft impacting the ground at a high rate of descent.

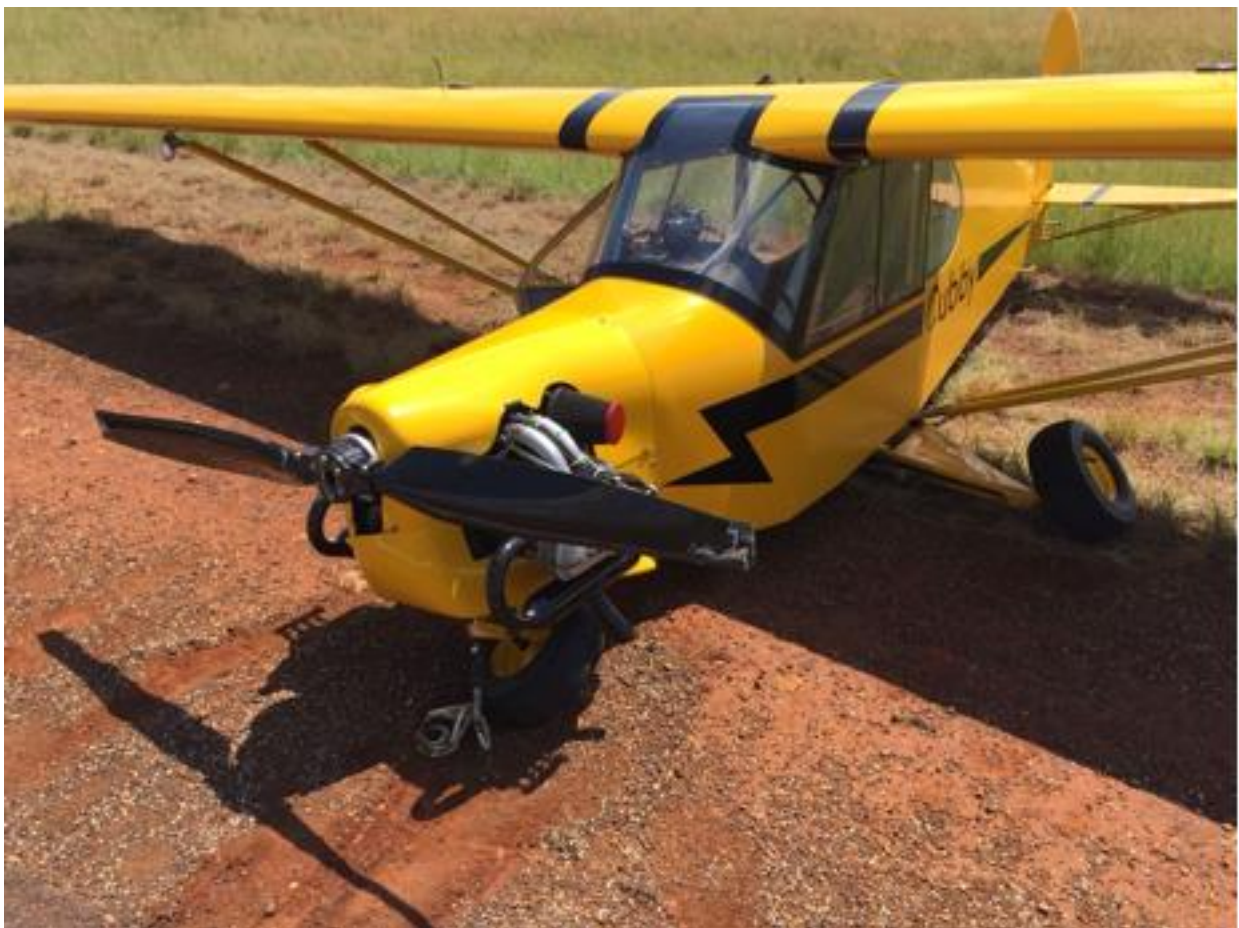
**Figure 3:** Damage to the landing gear and propeller (photograph courtesy of Mr J Bronkhorst)

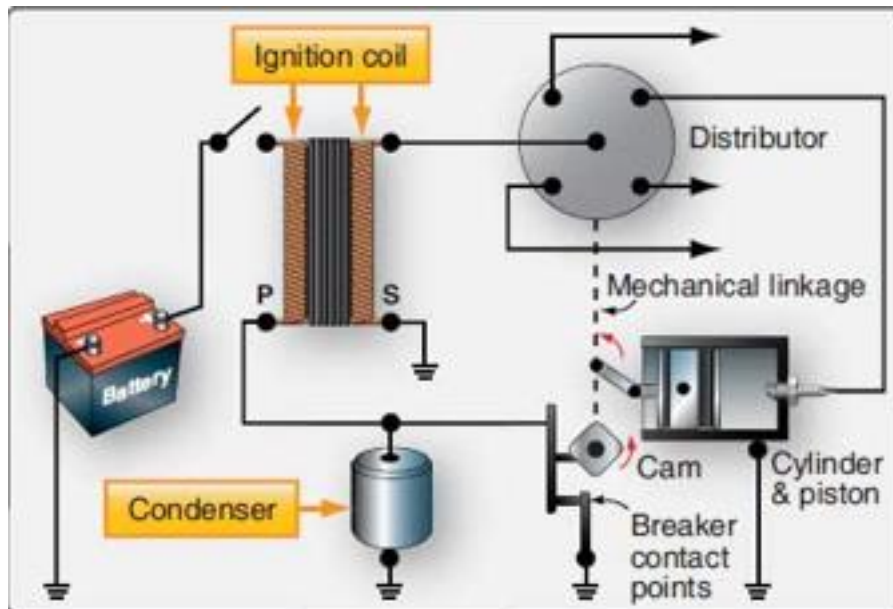
**Figure 4:** A simple ignition system similar to the one used by the aircraft. A break in the connection between the distributor and the spark plugs will render the engine inoperative (source: [www.flightmechanic.com](http://www.flightmechanic.com))

The contributing factor was failure of the ignition lead fitted on the engine. Due to the engine being a single ignition source system, a failure of the lead would cut off the spark required to create combustion in the cylinders, and therefore shut down the engine.

It is recommended that aircraft operators that operates this type of aircraft fitted with engine that operate using a single ignition source should have a more frequent inspection schedule related to the ignition system.

It is recommended that aircraft operators that operates this type of aircraft fitted with engine that use a single ignition source, replace the ignition lead during the annual inspection or 100 hours whichever comes first.
