AIRCRAFT INCIDENT SHORT REPORT

CA18/3/2/1198: ZU-BLM, Incident

Aircraft registration : ZU-BLM

Aircraft manufacturer and model : Pulsair

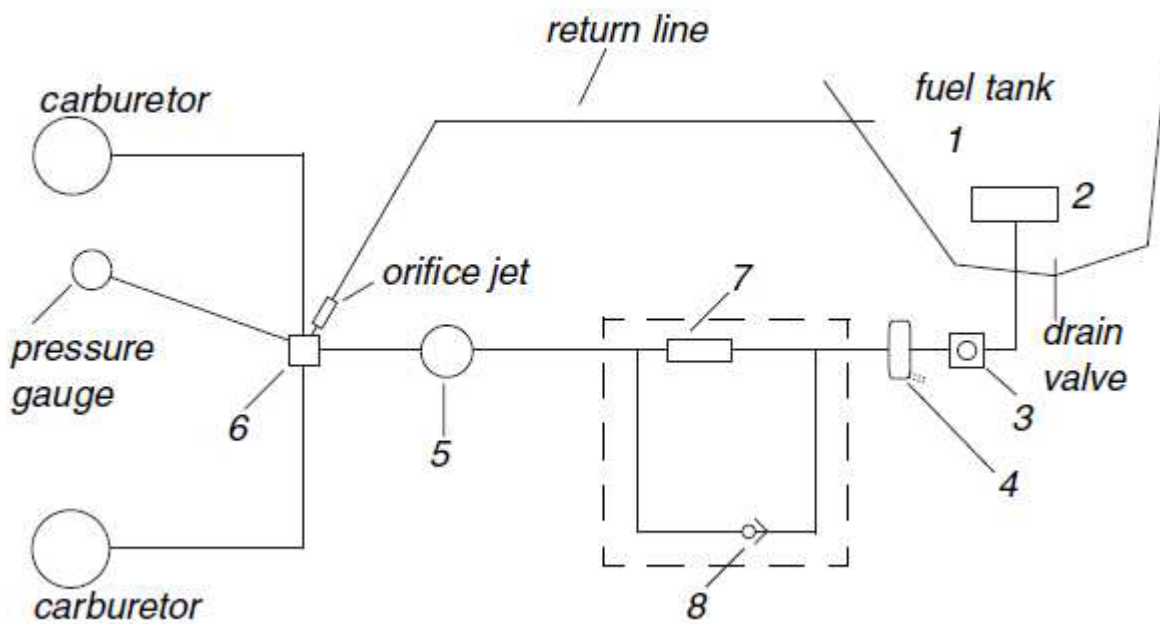
Figure 1 below shows the flow of fuel from fuel tank (1) via a coarse filter (2) the fire

cock (3) and fine filter (4) to the mechanical fuel pump (5). From the pump, fuel passes on via the fuel manifold (6) to the two carburetors. The return-line diverts fuel flows back to the fuel tank and suction side of the fuel system.

NOTE: The return line serves to avoid formation of vapour lock.

Figure 1: Shows the fuel system diagram.

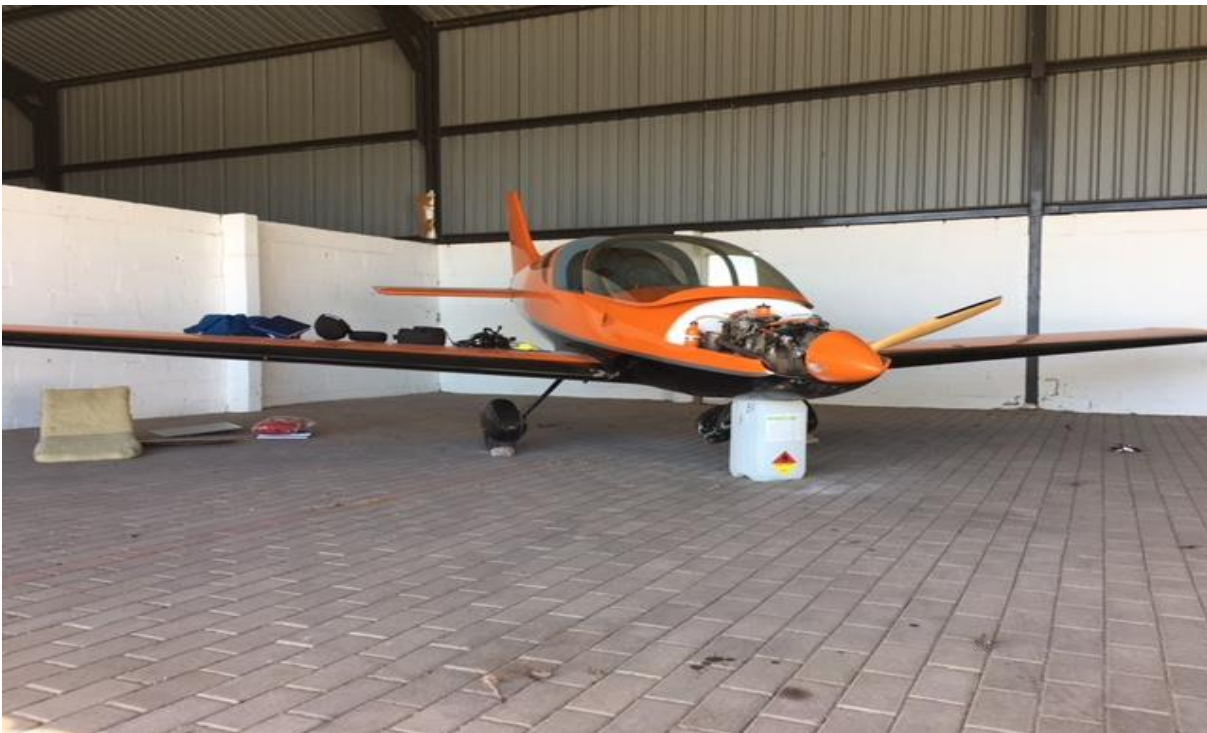
Damage to aircraft : Bent nose wheel and propeller strike.

- 1.2 The aircraft landed hard on the extended runway centre line collapsing the nose gear and the propeller struck the ground. The aircraft skidded for about 300 metres after RWY20. The two occupants were not injured during the incident sequence and disembarked the aircraft unassisted. The aircraft sustained damage to the nose wheel and propeller. The aircraft was recovered to a hangar where an Aircraft Maintenance Engineer (AME) investigated the cause of the loss in engine power.

Figure 2: The aircraft after recovery.
