AIRCRAFT INCIDENT SHORT REPORT

CA18/3/2/1200: ZS-JYD, Incident

Aircraft registration : ZS-JYD

Aircraft manufacturer and model : Beechcraft Baron 58

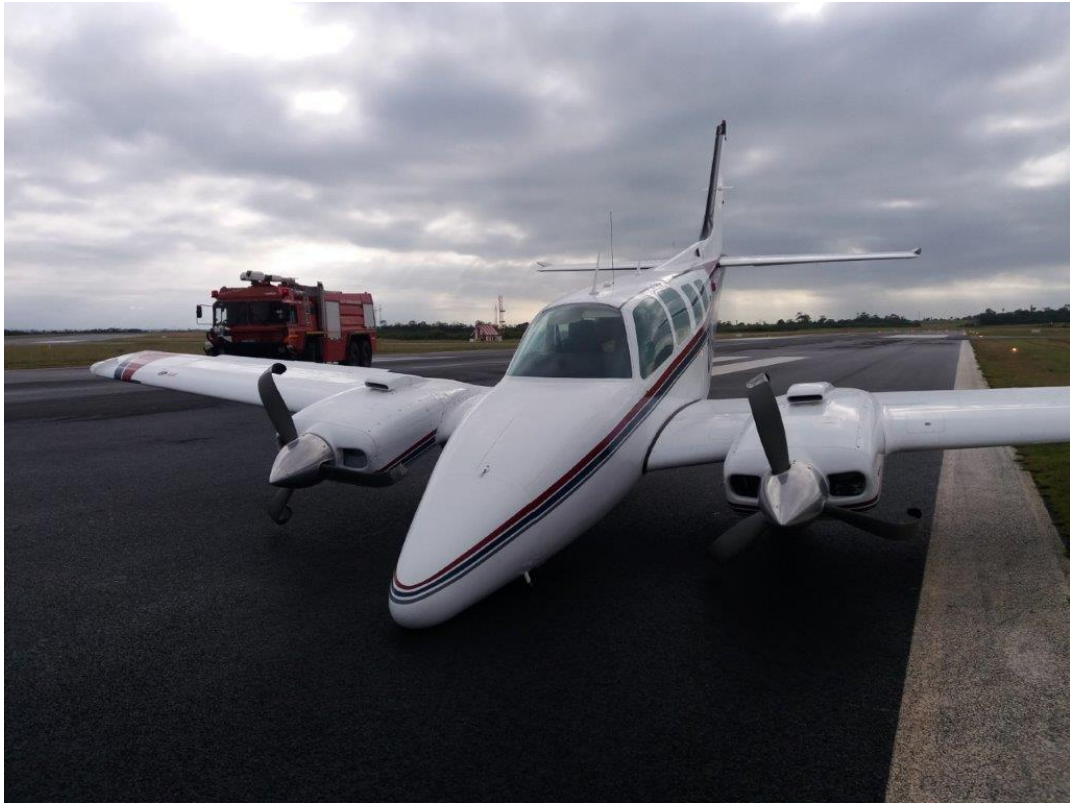
1.2 The pilot reported that, the entire flight was uneventful, however during the landing roll on Runway 29 the nose gear collapsed and the propeller blades struck the ground and bent. The aircraft skidded with the nose section on the runway until it came to rest on the left hand side of runway 29.

Figure 1: Shows aircraft's final position

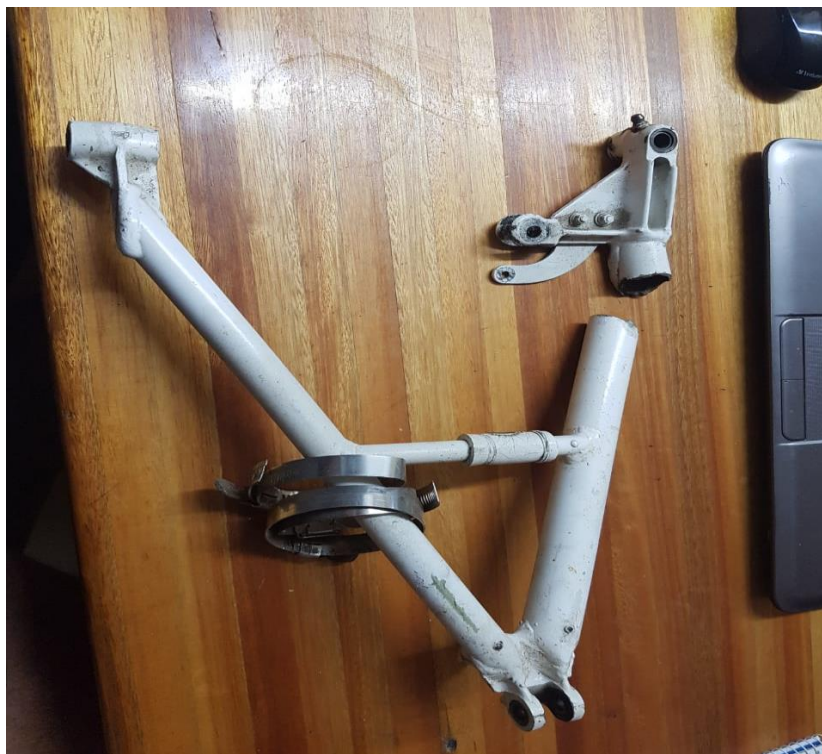
1.4 The investigation revealed that the cause of the incident was that the nose gear retraction brace assembly failed most probably as a result of a hard landing.

- 3.4 The weather conditions were fine at the time of the occurrence.
- 3.5 The nose landing gear collapsed during the landing roll.
- 3.6 During aircraft recovery, it was discovered that the nose brace assembly had fractured and this resulted in the nose gear collapsing.

Figure 3: Broken brace assembly

4.1 The cause of the incident was as a result of unsuccessful landing following the nose gear brace assembly failure due to stress most probably as a result of a hard landing.

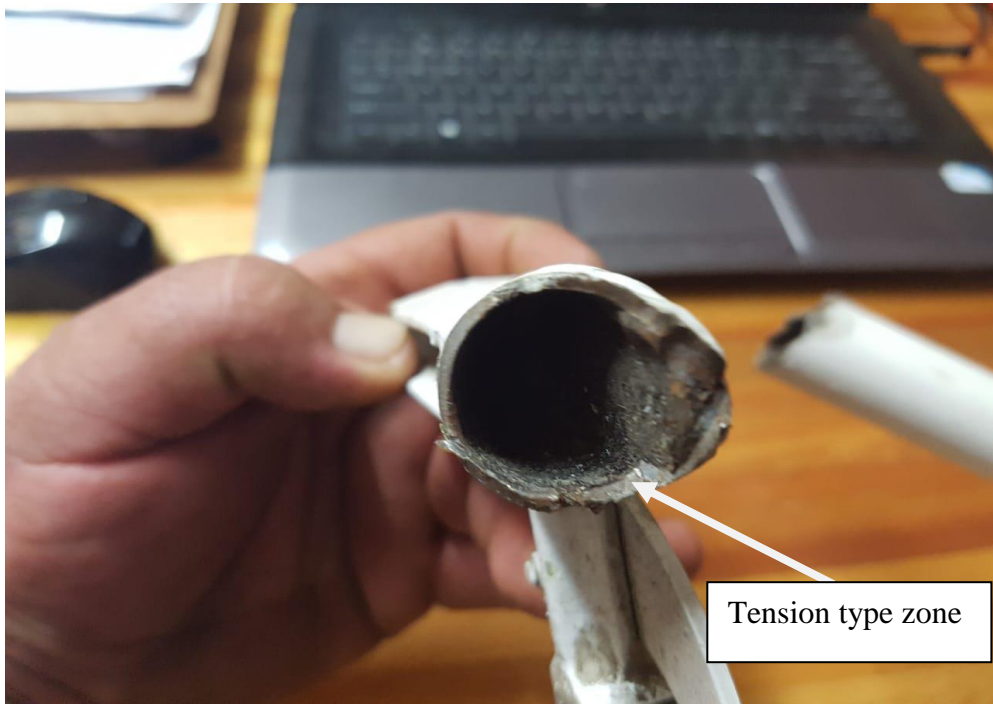
Figure 4: Shows damage to the metal

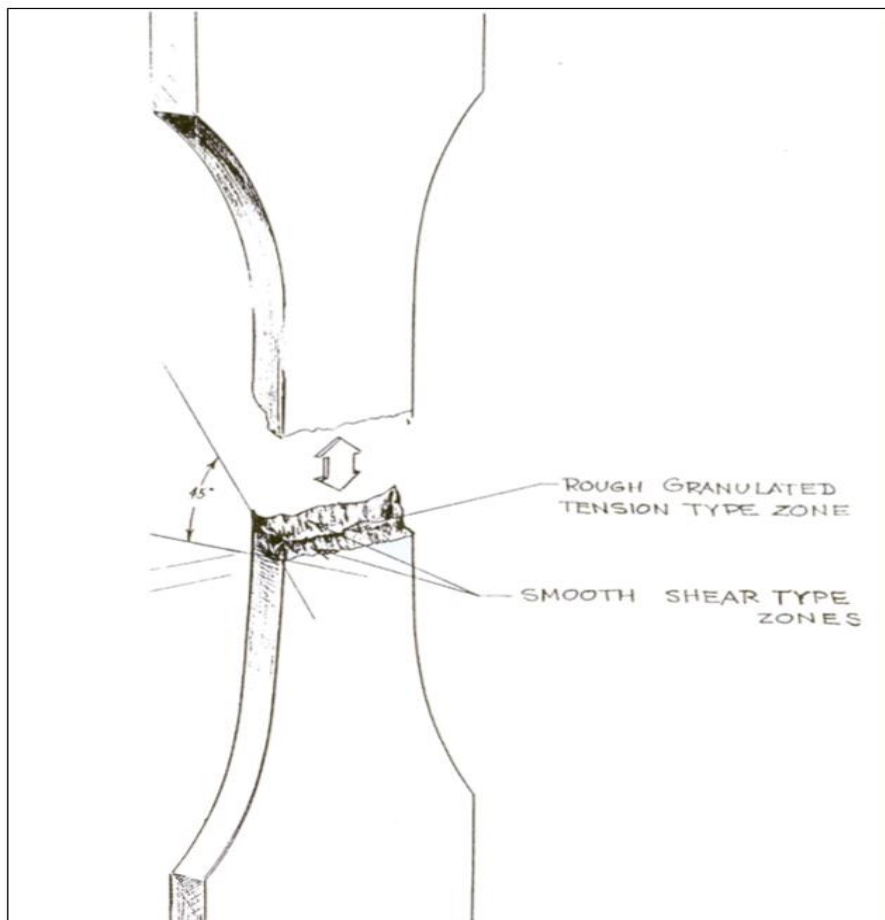
Figure 5: Tension failure in thin, highly ductile material

Referring to the picture above, a tension load will produce both tension and shear stress. The maximum tension stress will occur on a plane perpendicular to the tension load and will be equal to the tension load divided by the cross-sectional area perpendicular to the load. The tension stress is referred to as the “primary” stress. Maximum shear stress will occur on a plane 45° to the tension load and will be equal to one-half the tension stress. The shear stress is referred to as the secondary stress. In the failure of a ductile material, both the tension zone and the shear zone can usually be seen.

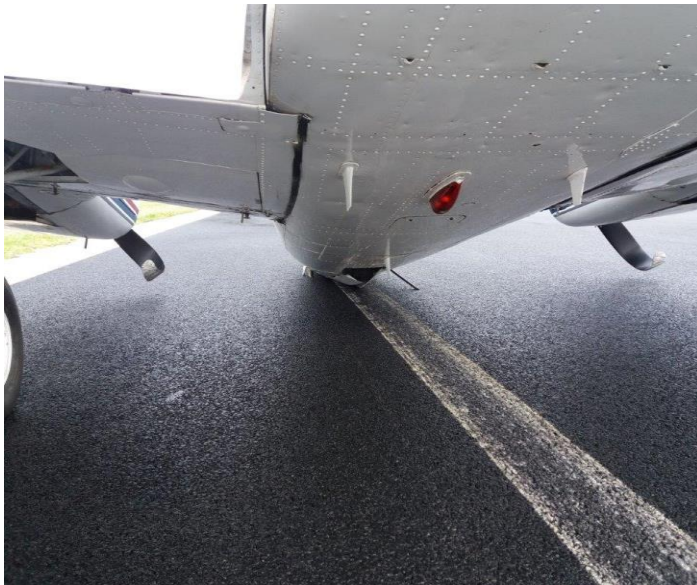
2.4 The aircraft sustained damage to propellers, the nose wheel assembly and the nose cone.

Figure 6: Shows the aircraft after the incident
