AIRCRAFT INCIDENT SHORT REPORT

CA18/3/2/1201: While the ZS-HAI helicopter was hovering in ground effect, the fan-wheel assembly failed and the helicopter was landed safely without further damage or injury.

Aircraft registration : ZS-HAI

Aircraft manufacturer and model : Robinson Helicopter Company, R22 Beta

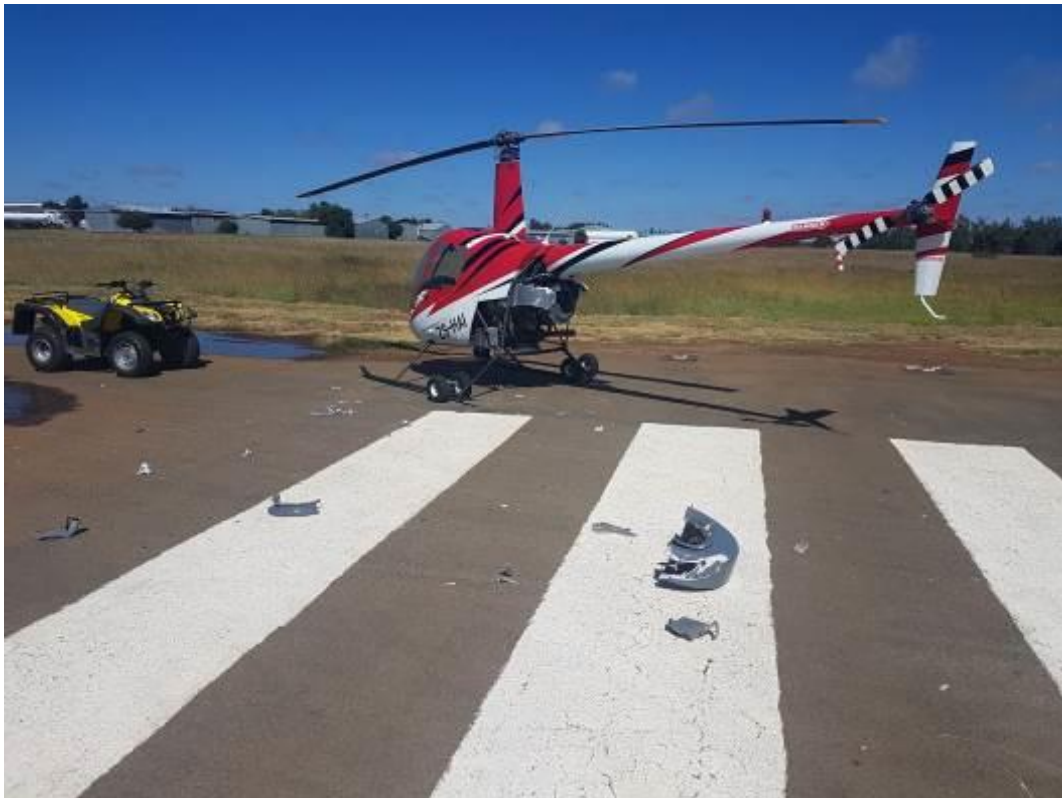
2.1.3 Once on the ground, he closed the throttle and could see debris lying on the runway. He proceeded to shut down the helicopter and, after disembarking, he conducted a walk-around inspection and saw that the fan-wheel assembly had failed.

Figure 1: Debris from the fan-wheel assembly and the scroll scattered on the apron area

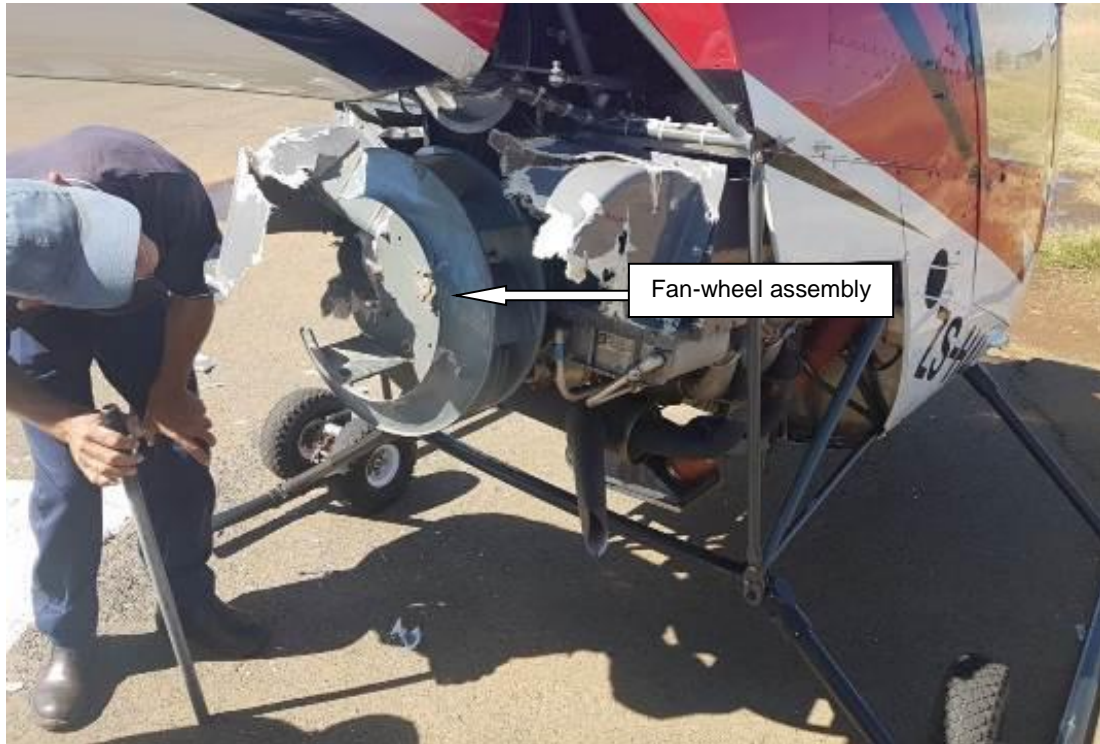
Figure 2: A closer view of the failed fan-wheel assembly

- 3.8 The investigation determined that while the helicopter was hovering in ground effect (IGE), the fan wheel assembly failed. The failure of the fan wheel assembly was attributed to the failure of the fan-wheel blades due to a fatigue crack that had propagated on one of the fan-wheel blades.

- 4.1 Failure of the fan wheel assembly due to a fatigue crack, which propagated at the leading edge of the blade near the weld.

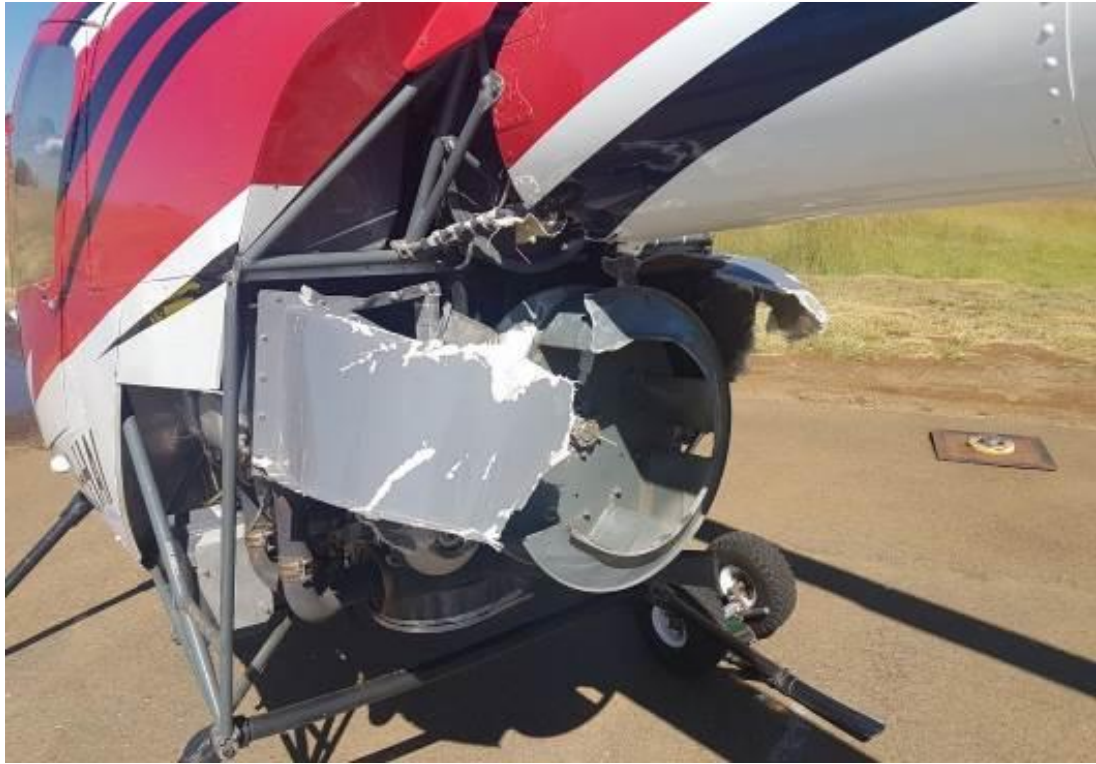
Figure 3: Another view of the damage caused by the fan-wheel assembly

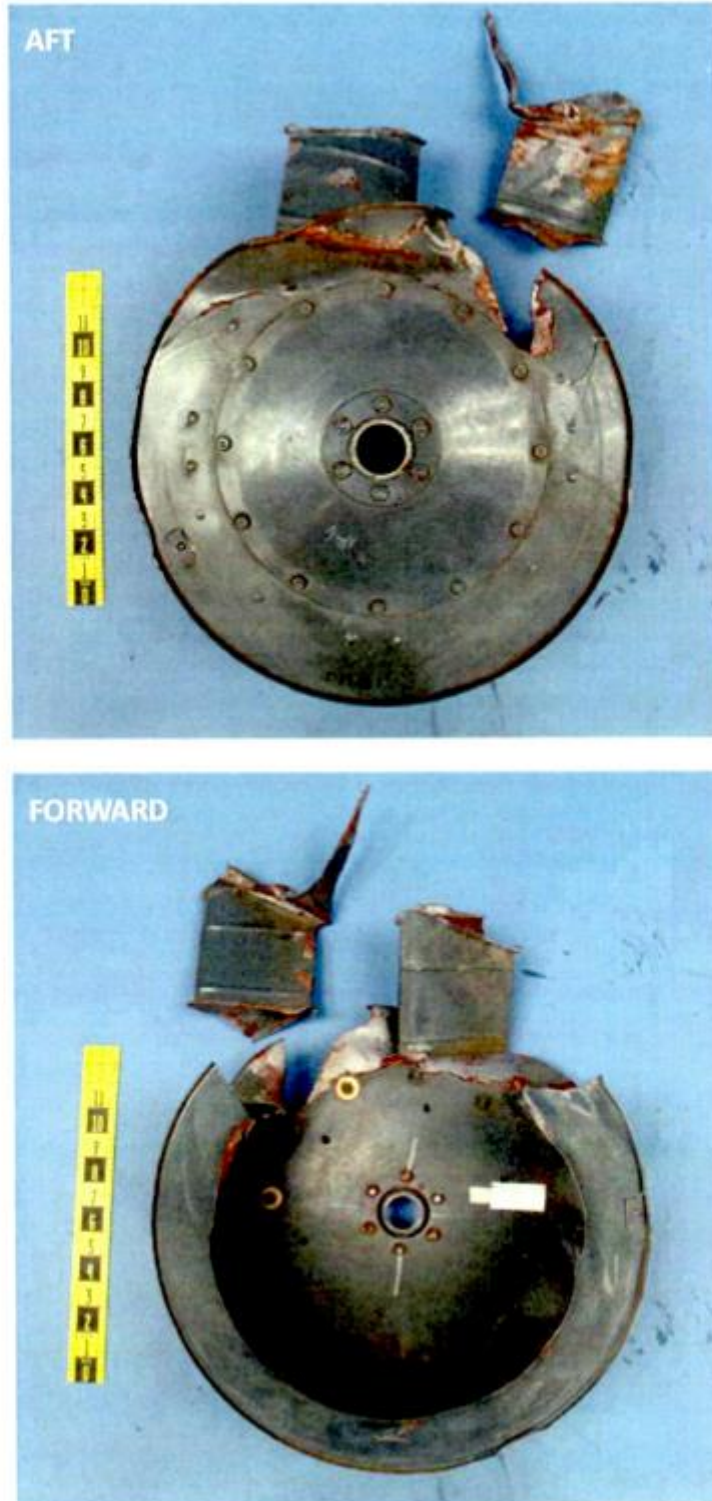
The cooling fan from a Robinson R22 helicopter engine was submitted with a separated blade, as shown in Figures 1 and 2. The deformation indicated the separation originated near the leading edge of the blade where it was welded to the aft rim. The fracture surface was adjacent to the toe of the weld, as shown in Figure 3.

Figure 1: Overall photos of the separated cooling fan as viewed from the aft (top) and forward (bottom) sides.

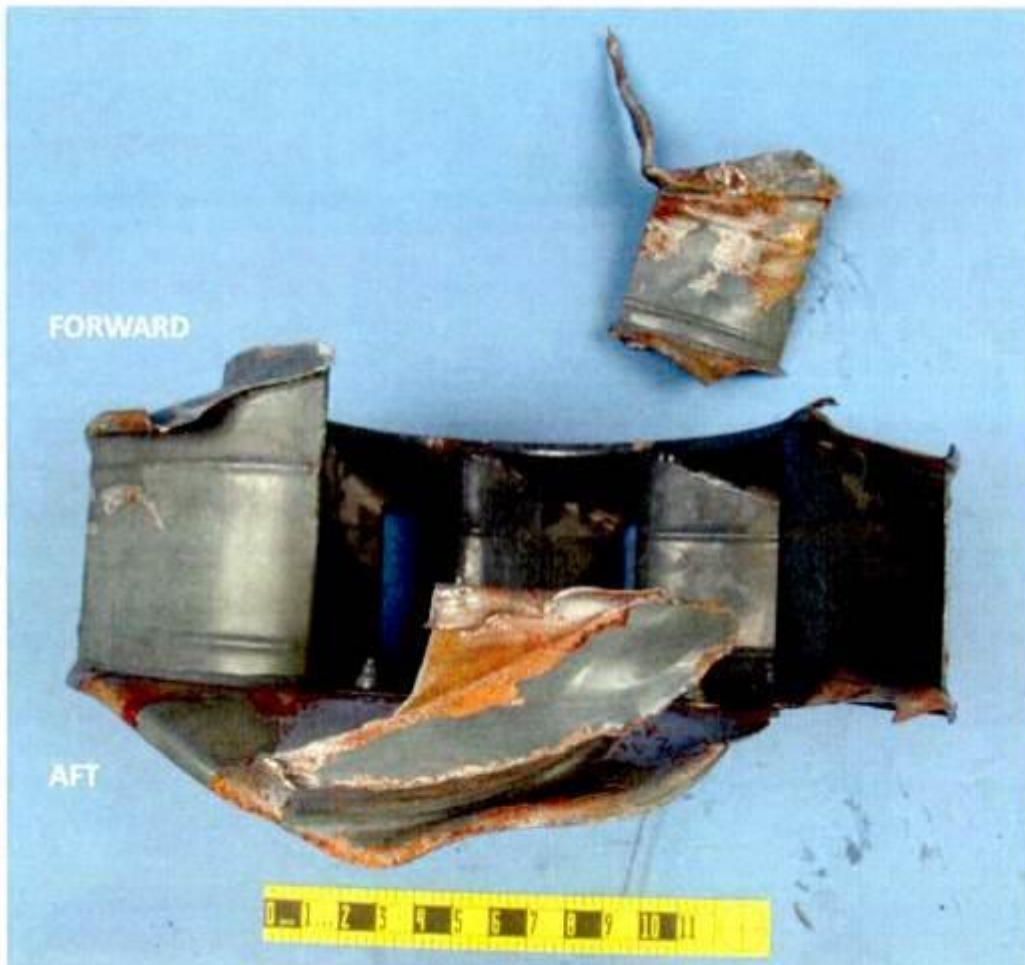
Figure 2: Overall photo of the separated cooling fan as viewed from the outer diameter.

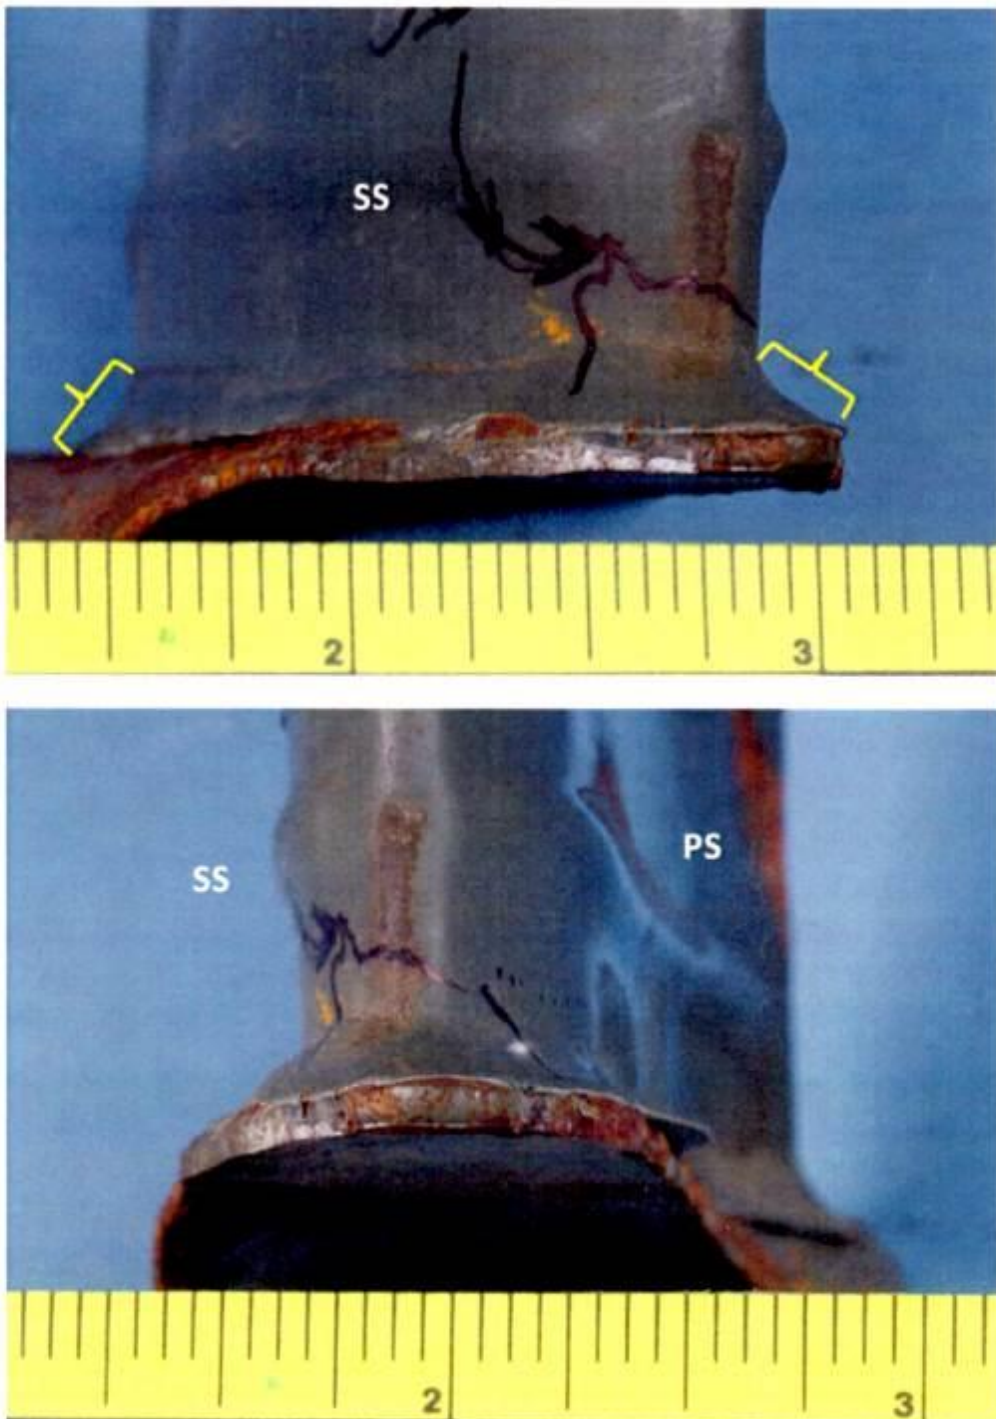
Figure 3: Close-up photos of the fracture surface at the aft side of the blade leading edge. The yellow brackets indicate the weld on the blade.

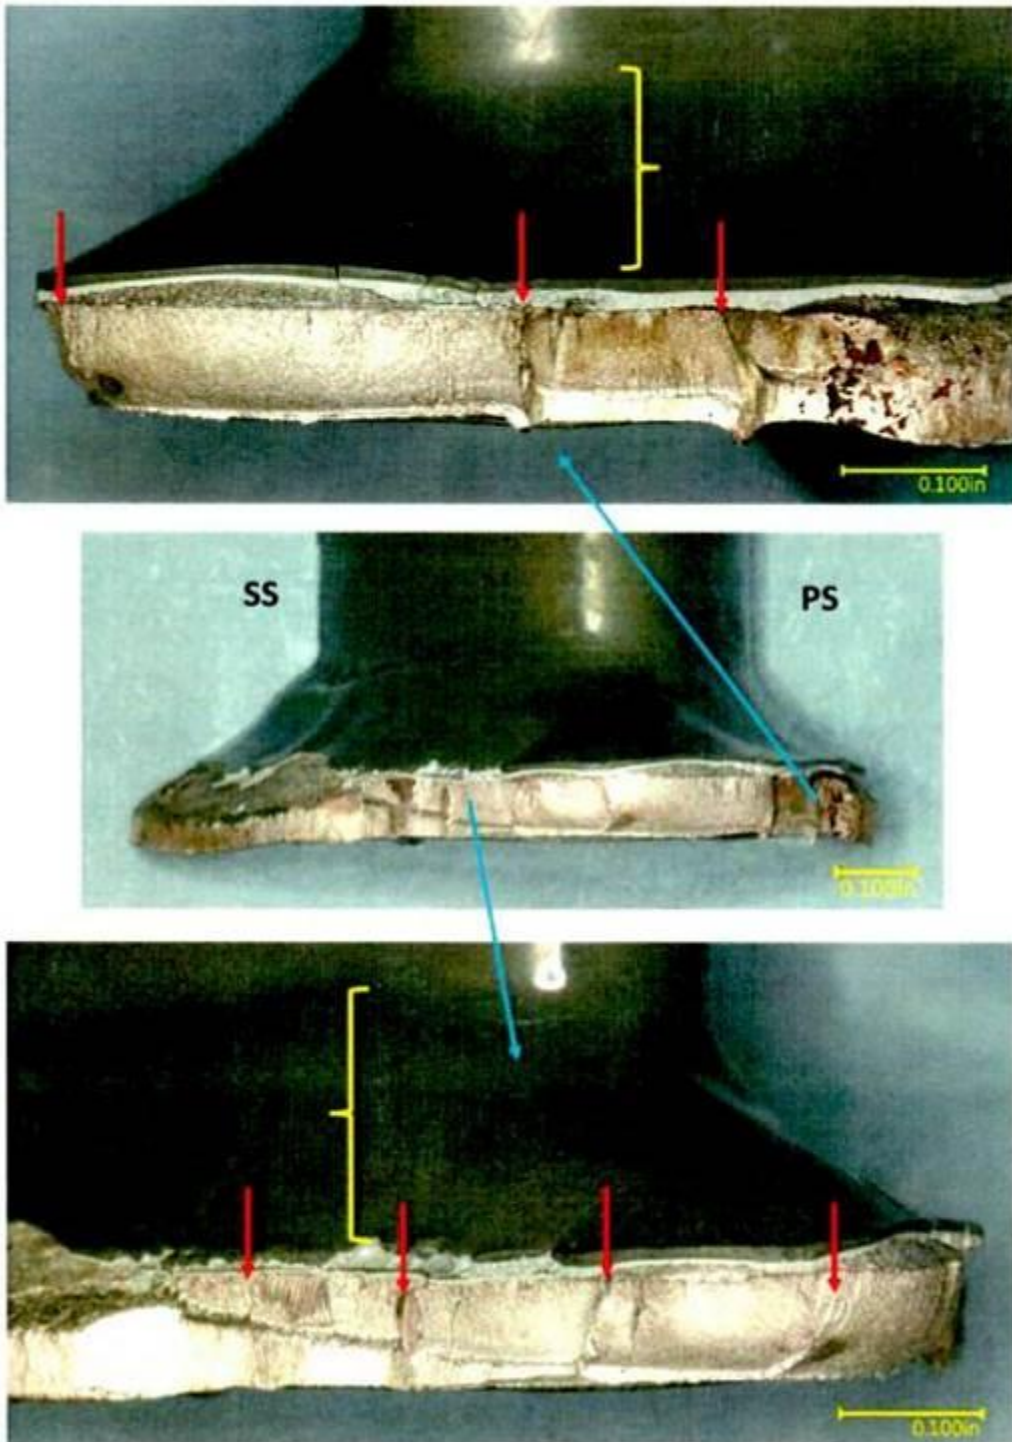
There were multiple thumbnail-shaped patterns emanating from the toe of the weld (yellow brackets in Figures 4 and 5) at the inboard edge of the fracture surface. The largest thumbnail-shaped pattern was at the approximate tip of the blade leading edge, and had a diffuse initiation zone (purple bracket, Figure 5).

Ratchet marks, indicated by red arrows in Figure 4, were observed on the fracture surface that extended around the pressure and suction sides of the blade. Black arrows in Figure 5 point to a shear lip visible along the outboard edge of the fracture surface.

The thumbnail-shaped patterns and ratchet marks are consistent with multiple initiation fatigue cracking. The fracture surface features indicate the fatigue cracking emanated from the inboard weld toe at the leading edge of the blade, and propagated through most, but not all, of the aft rim thickness before the blade separated.

Figure 4: Digital microscope images showing the cleaned fracture surface on the blade. The yellow bracket indicates the weld on the blade. The red arrows point to ratchet marks.

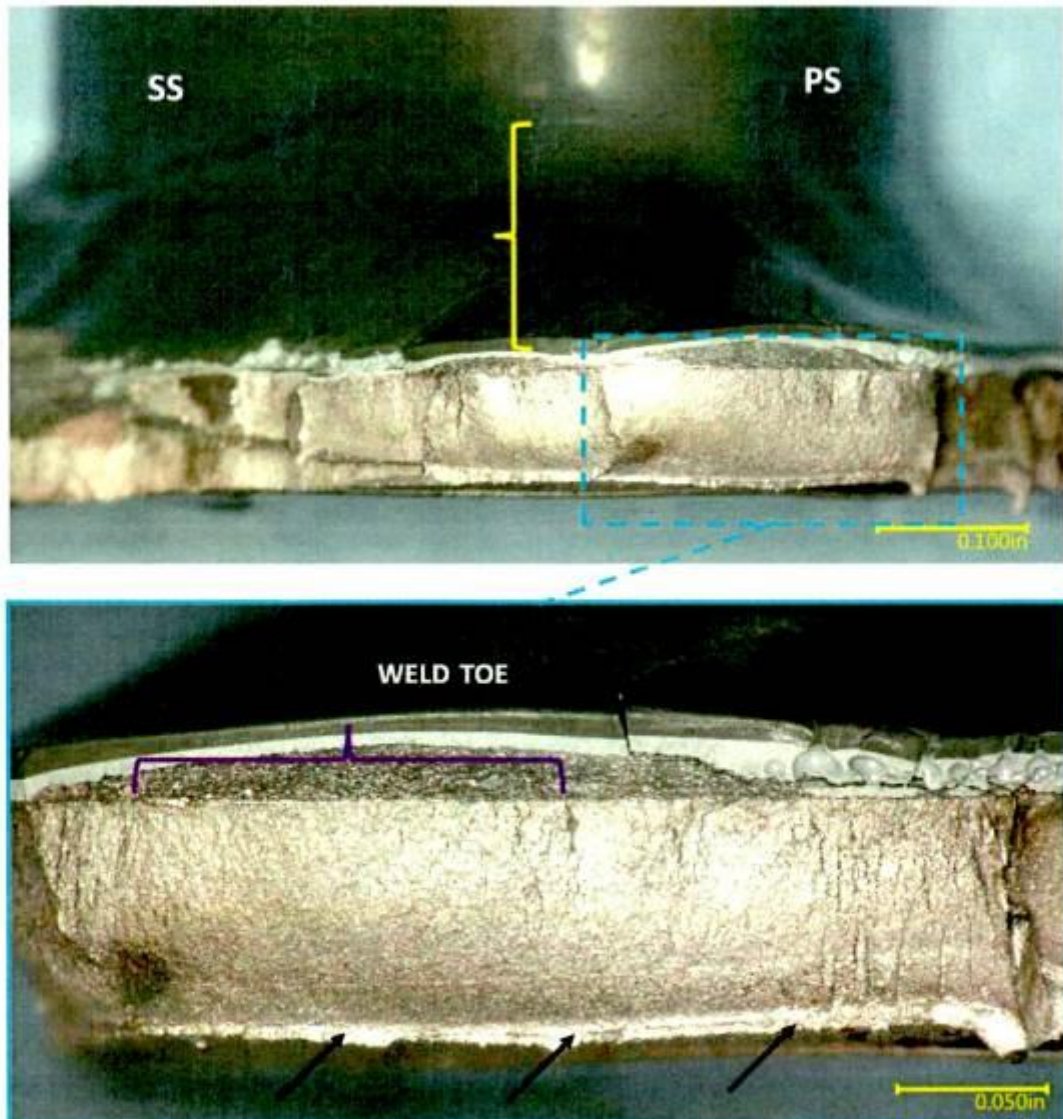
Figure 5: Digital microscope images showing the cleaned fracture surface on the blade. The yellow bracket indicates the weld on the blade. The purple bracket indicates a diffuse fatigue cracking initiation region, while the black arrows point to a shear lip.
