AIRCRAFT INCIDENT REPORT AND EXECUTIVE SUMMARY

Reference:	CA18/3/2/1202	
Aircraft Registration	ZS-KGW	Date of Accident	26 March 2018		Time of Accident	0445Z
Type of Aircraft	Beechcraft B200		Type of Operation		Private (Part 91)	
Pilot-in-command Licence Type		Commercial Pilot's Licence	Age	52	Licence Valid	Yes
1st Officer Licence Type		Commercial Pilot's Licence	Age	40	Licence Valid	Yes
Pilot-in-command Flying Experience		Total Flying Hours	9105		Hours on Type	2 434.4
1st office Flying Experience		Total Flying Hours	4 471.2		Hours on Type	1 913.6
Last point of departure		Wonderboom Airport (FAWB), Gauteng Province				
Next point of intended landing		OR Tambo International Airport (FAOR), Gauteng Province				
Location of the accident site with reference to easily defined geographical points (GPS readings if possible)						
At FAWB on Runway 29 at a point with GPS Coordinates, S25°39'13" E028°13'28"						
Meteorological Information		Wind direction: variable, air speed: calm, air temperature: 12°C, visibility: 10 km

AIRCRAFT INCIDENT REPORT

Name of Owner : Tacet Transport (Pty) Ltd
Name of Operator : Multimedia Entertainment Group (Pty) Ltd
Manufacturer : Beechcraft
Model : B200
Na

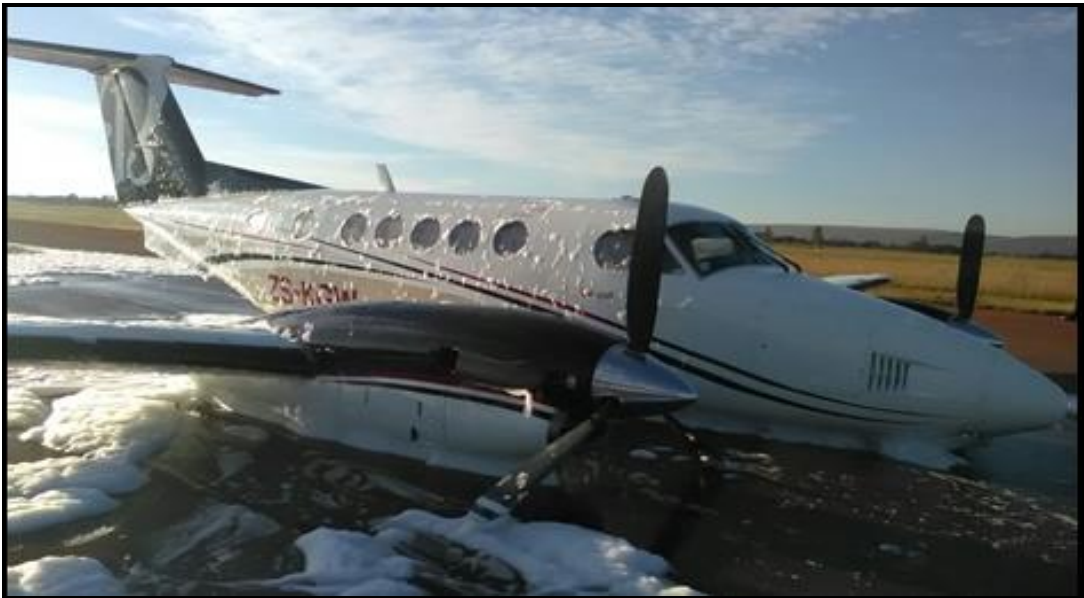
1.1.2 They then requested a fly-by for the aerodrome fire and rescue to verify whether the gear was retracted, as per cockpit indication, and this was confirmed. The crew then joined the circuit for landing on runway 29. The aircraft was then configured for an emergency landing, during which the engines were shut down at approximately 100 m from the threshold of runway 29 and then feathered propellers manually. The aircraft landed wheels-up and skidded for approximately 450 m before coming to a full stop approximately 350 m from the runway 24 threshold with runway 29. The wheels-up landing was executed successfully. The aircraft sustained damage to two propeller blades on each engine assembly, landing gear doors and under cargo compartment port.

Figure 1: The aircraft as it was found at the accident site

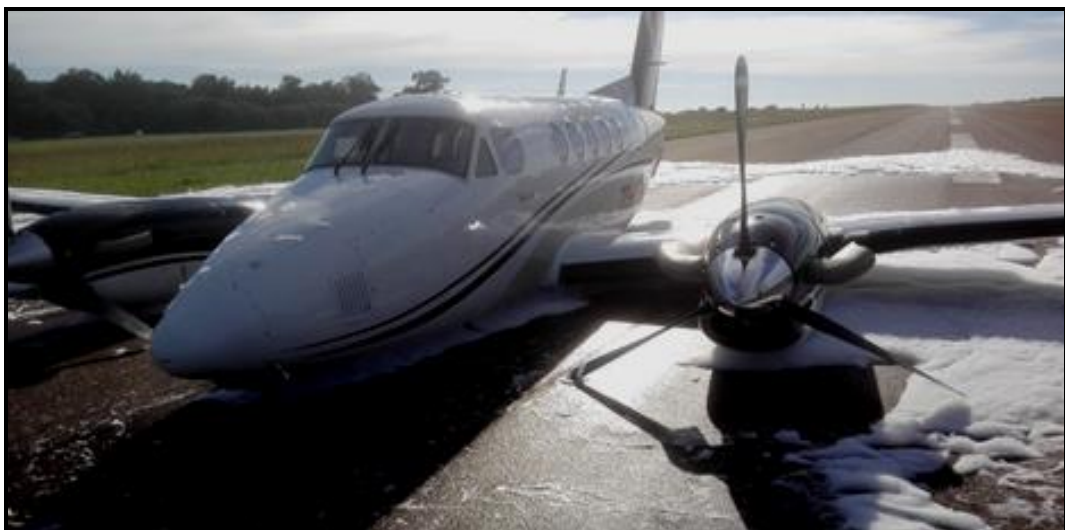
1.3.1 The aircraft sustained damage to two propeller blades on each engine, the landing gear doors and under cargo compartment port. Refer to 1.12 for Wreckage and Impact Information.

Figure 2: Aircraft on its belly surrounded by the foam

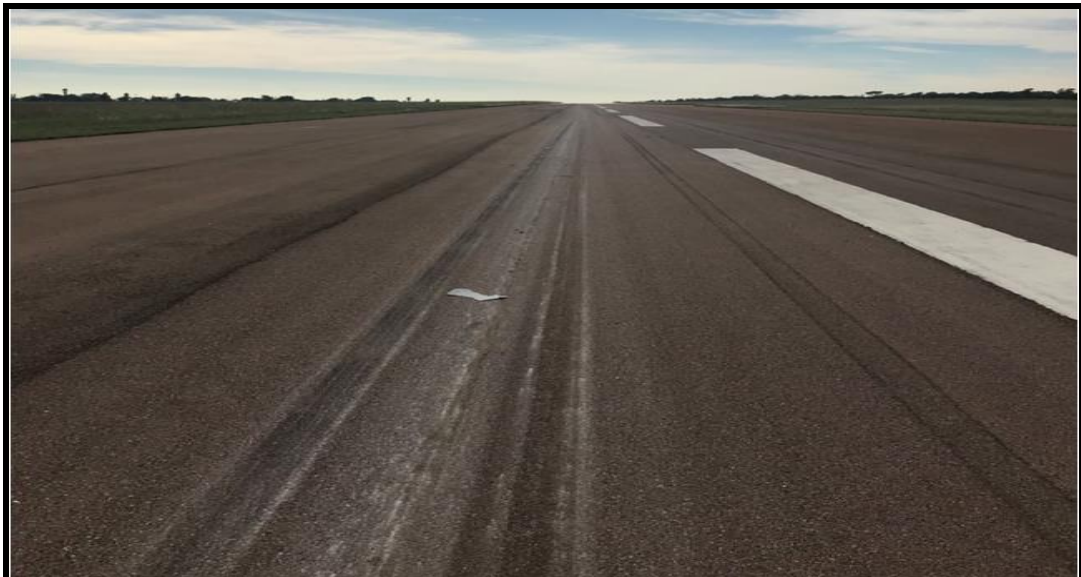
- 1.4.1 Runway damage was limited to scratch marks as a result of the aircraft skidding for a distance of approximately 450 m.

1.12.1 The aircraft accident occurred during a wheels-up landing on RWY 29 at FAWB. The aircraft contact with runway caused scrape marks for a distance of approximately 450 m along the runway surface. No serious damage was noticed on the runway surface.

Figure 5: The scratch marks on the runway

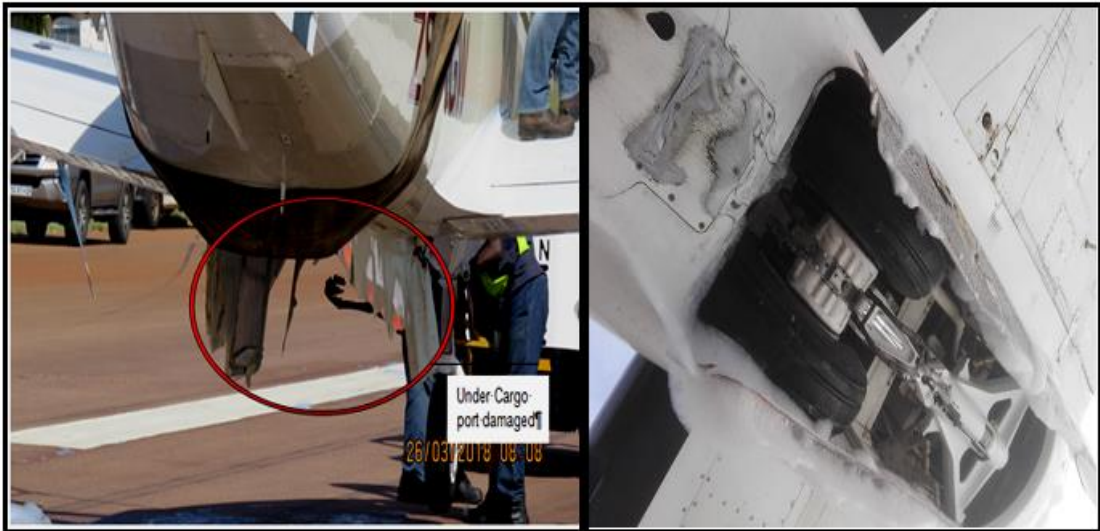
1.12.2 The aircraft's under cargo port received extensive damage due to contact with the runway surface.

Figure 6: Damage on the under cargo port and the main landing gear doors

- 1.12.4 The landing gear doors and the bottom of the engine cowlings damaged due to surface scraping during the wheels-up landing. This damage only occurred after some distance, after the under cargo port had been completely damaged, and the aircraft dropped to make contact with surface on its belly and the two engine cowlings.
- 1.12.5 Preliminary onsite investigation observation showed that the retraction chain got jammed against the airframe assembly, causing the landing gears to jam during extension and retraction attempts. The chain had a slaggy tension on top with the bottom chain under tension.
- 1.12.6 It was observed that the sleeve on the nose gear retraction/extension actuator had come off during operation.

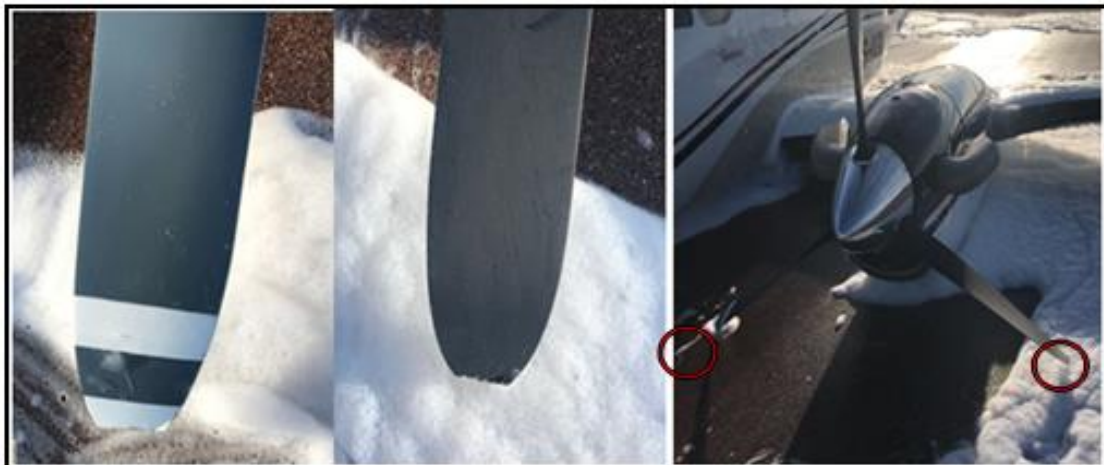
1.12.3 More damage was noticed on the two bottom positioned propeller blade tips on each engine. The damage was consistent with damage caused by surface scraping when the engines are not turning. The aircraft was equipped with a three-bladed propeller on each engine.

Figure 7: Damage to four propeller blades; two on each engine side

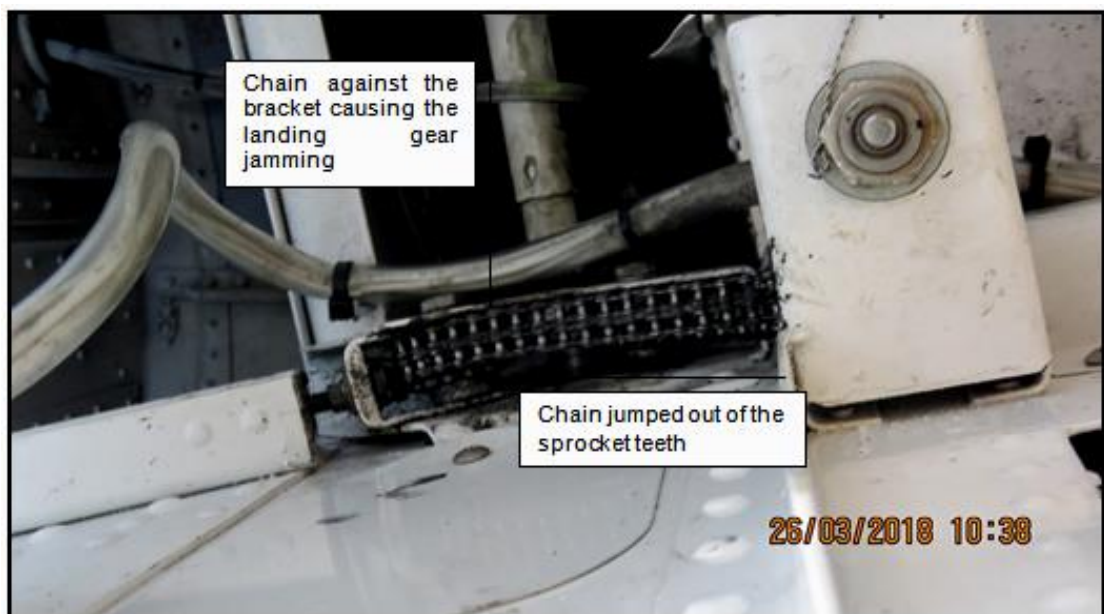
Figure 8: The jammed retraction chain

- 1.16.1 The preliminary investigation determined that the cause of the landing gear not extending was due to a jammed extension/retraction chain in the nose wheel well. (See: Figures 4 and 8.)
- 1.16.2 Figures 9 and 10 were extracted from the aircraft type illustrated part catalogue (IPC). The red circle shows where the retraction/extension chain got jammed against component 675 (bracket) and the bracket chain lightener. The retraction/extension chain consists of a set of two chains combined together, running on a sprocket (520) that consists of two sets of teeth. During the investigation, it was observed that the chain jumped out of one set of sprocket teeth onto the other, causing the chain to be against bracket 675.

On initial inspection, it was found that the nose gear forward operating chain was jammed against the assembly bracket. The chain had moved out of the sprocket due to misalignment. This prevented the gear from operating either normally or during emergency procedure. Further inspection revealed that the right-hand actuator support bearing and inner sleeve had egressed out of the bearing plate. With the chain tension to the short chain driven torque shaft, the outboard small end of the torque shaft disengaged from the side wall bearing in the landing gear bay. Chain tension was able to distort the actuator mounting and cock the torque shaft, thereby misaligning the chain, which then tempered the chain tensioner sprocket and caused the chain entrapment. (See: Figure 8.) Figure 12 shows the actual position of the actuator assembled in a normal condition.

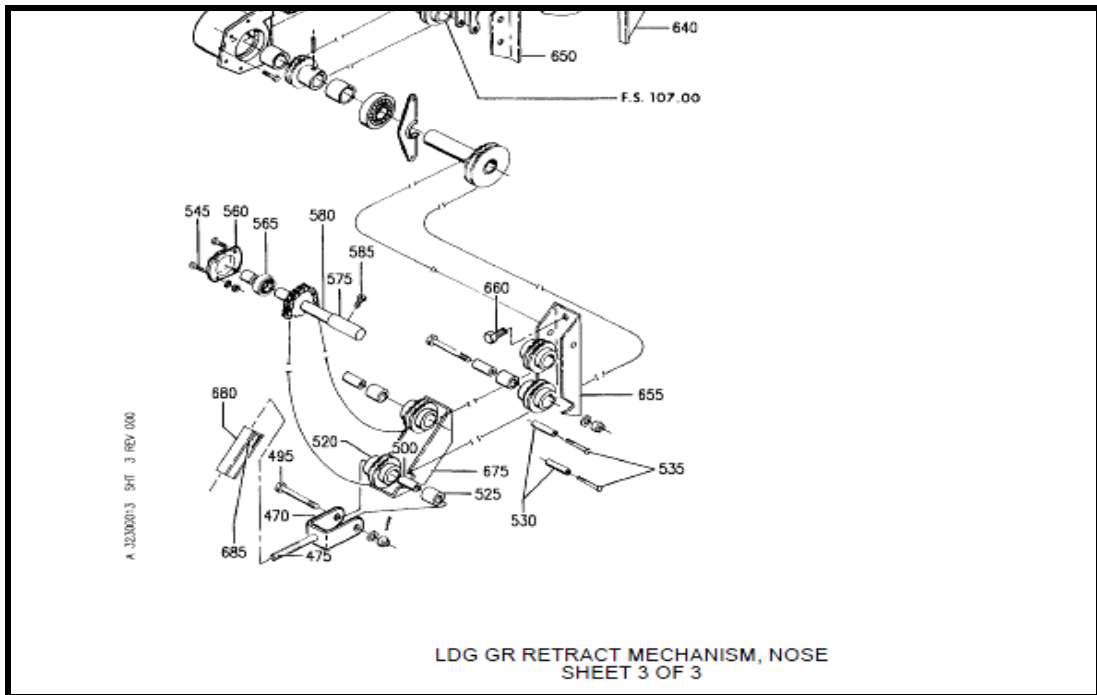
Figure 10: The affected area of the retract mechanism

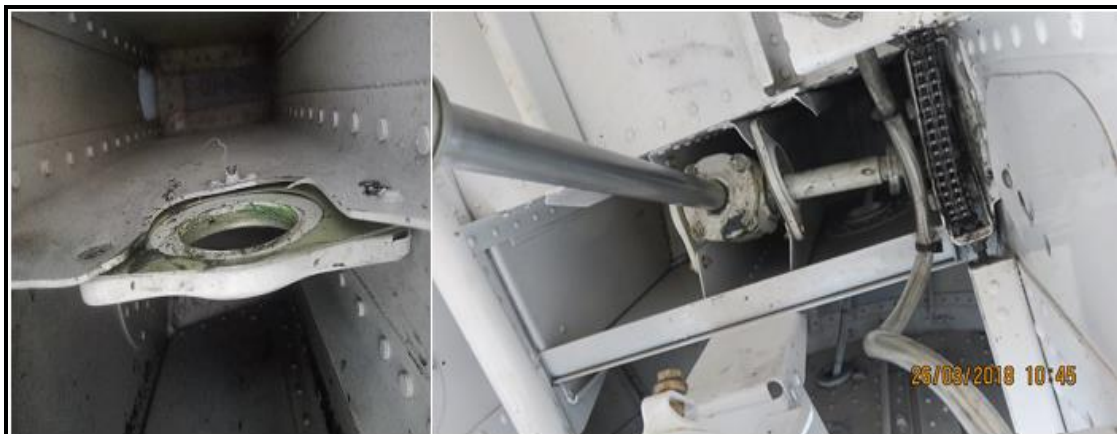
Figure 11: The actuator assembly bracket that got damaged

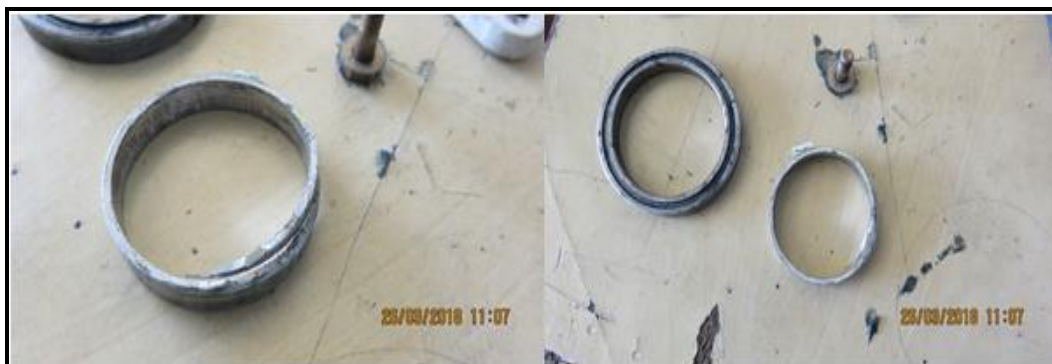
1.16.4 The sleeve acts as a spacer that helps to keep the actuator in position within the bearing assembly. The two brackets hold the actuator in position during assembly and operation as shown in Figure 12. If the sleeve is removed, the space induced will allow the actuator to move sideways (rotate along its longitudinal axis) during operation. The sleeve also holds the actuator in position to allow the chain-driven shaft to connect to the actuator inserted through the spline fitting. (For parts names as numbered, refer to Appendix A.)

Figure 13: The damaged sleeve as it was found

- 2.6 It is possible that the sleeve came out during operation as there is nothing securing it as per the design. Its movement is only during extension or retraction of the landing gear. The inner sleeve might have egressed out of the bearing plate, allowing the actuator to have movement due to the chain tension exerted by the actuator driving torque shaft. The actuator came off from its assembly bracket position forcefully, which explains the loud noise the pilot said he heard from the nose wheel bay during landing gear extension.

This caused the misalignment of the actuator driving shaft sprocket. The chain then moved in the direction in which the force was favourable and came against the assembly bracket, causing an entrapment (jam). It could be that the sleeve gradually egressed over a period of time during operation.

- 3.1.3 The sleeve of the nose landing gear actuator came out of its position during operation. This allowed the actuator to move out of its assembly position, causing the misalignment of the driving shaft.

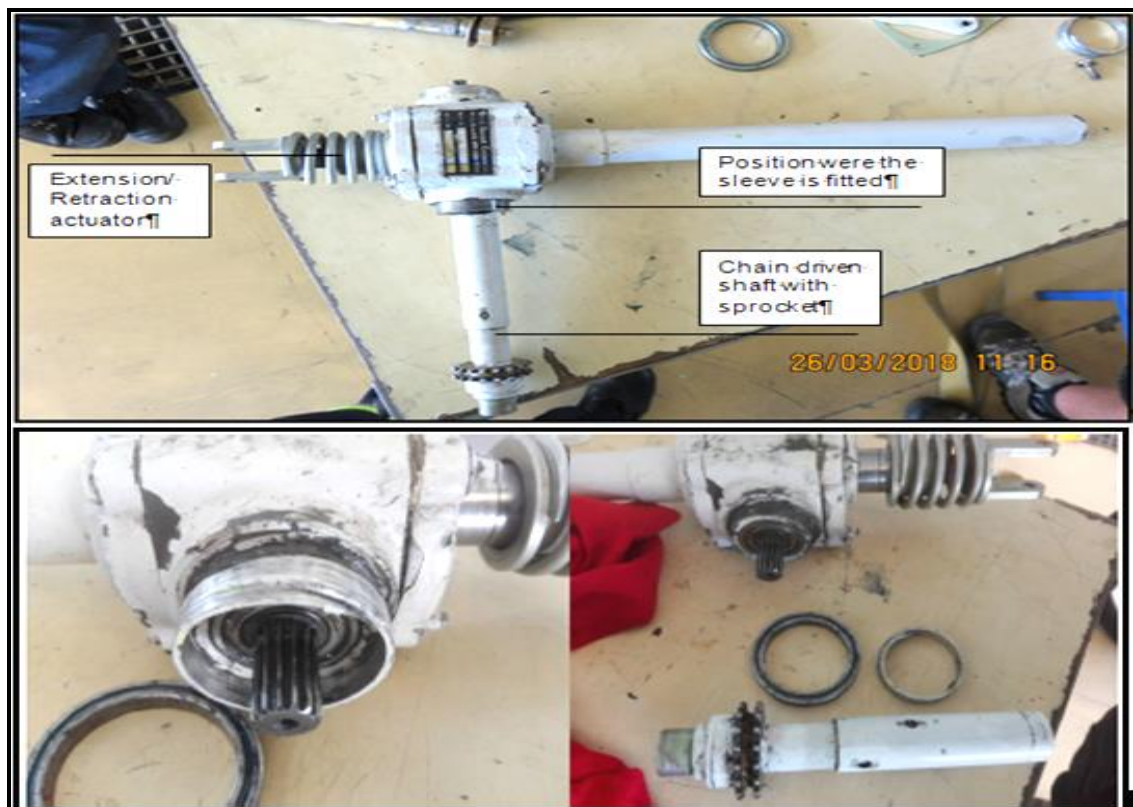
1.16.6 According to the engineer (who is rated and has been working on landing gear type overhaul for over years, following the incident he inspected the chain for wear and conducted tension tests; all was in order. Measurements for the chain length were taken against tension calculations and all was in order. All steps from the maintenance manual were followed during the mandatory periodic inspection (MPI) maintenance carried out prior to the incident.

Figure 15: The actuator and damaged sleeve
